**CORTE MADERA STREAM CROSSING INVENTORY AND FISH PASSAGE  
EVALUATION**

**FINAL REPORT**

**Prepared for the Friends of the Corte Madera Creek Watershed**

**Ross Taylor and Associates**

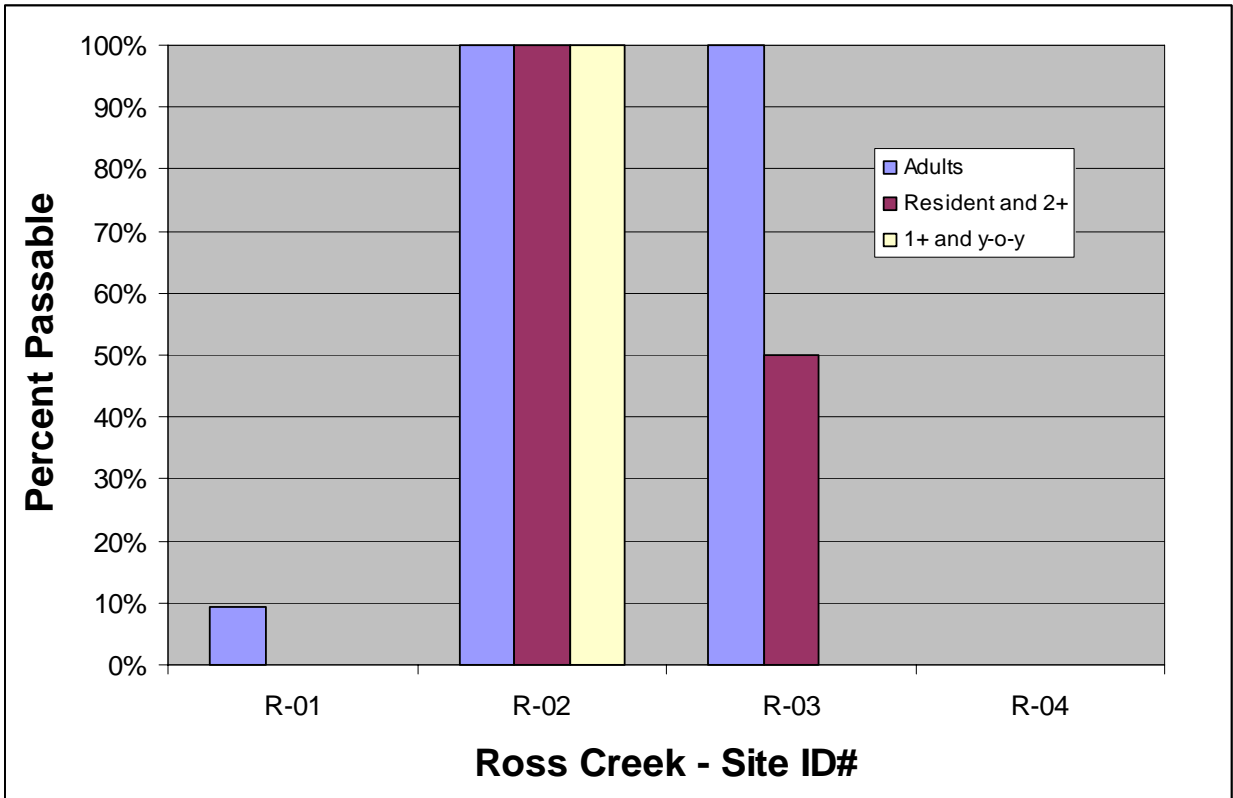
Each of the four Corte Madera Creek tributaries (Ross, San Anselmo, Sleepy Hollow, and Fairfax creeks) had stream crossings that ranged from failing to meet passage criteria for all age-classes of anadromous salmonids to providing high levels of good passage conditions (Figures 8-11). Both Ross and Fairfax creeks have stream crossings located near their mouths that severely reduce or prevent steelhead from utilizing these tributaries for spawning and rearing (Figures 8 and 11).

**Figure 8.** Passage evaluation results for four stream crossings in Ross Creek, Corte Madera Creek watershed, Marin County, CA.

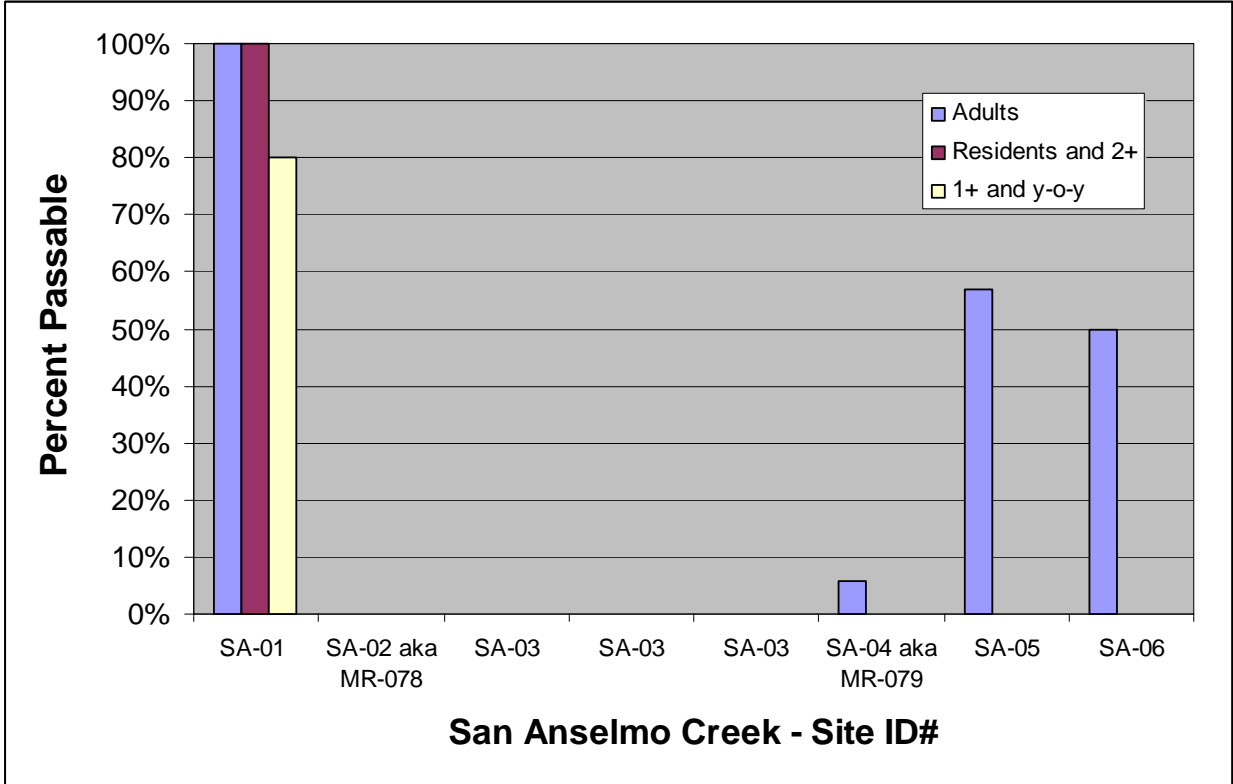
**Figure 9.** Passage evaluation results for six stream crossings in San Anselmo Creek, Corte Madera Creek watershed, Marin County, CA. SA-03 is comprised of two-bay box and arch.

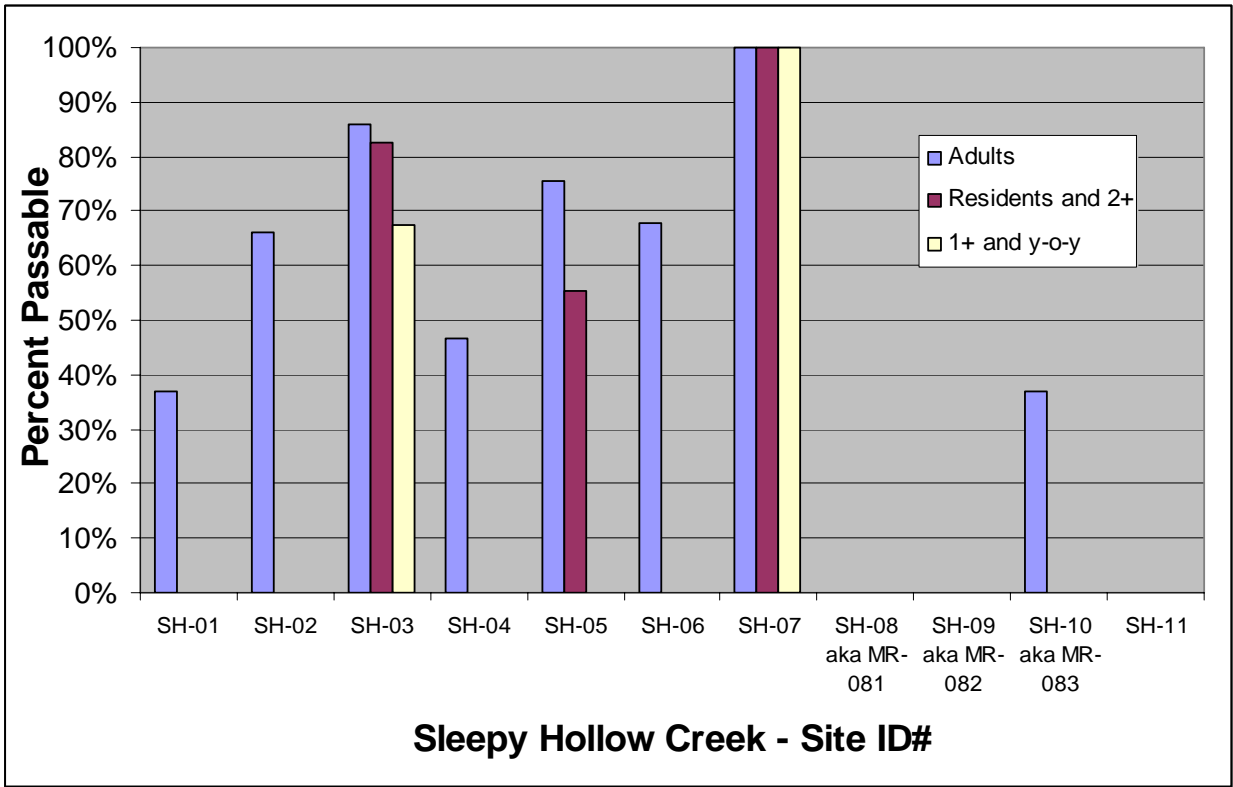
**Figure 10.** Passage evaluation results for 11 stream crossings in Sleepy Hollow Creek, Corte Madera Creek watershed, Marin County, CA.

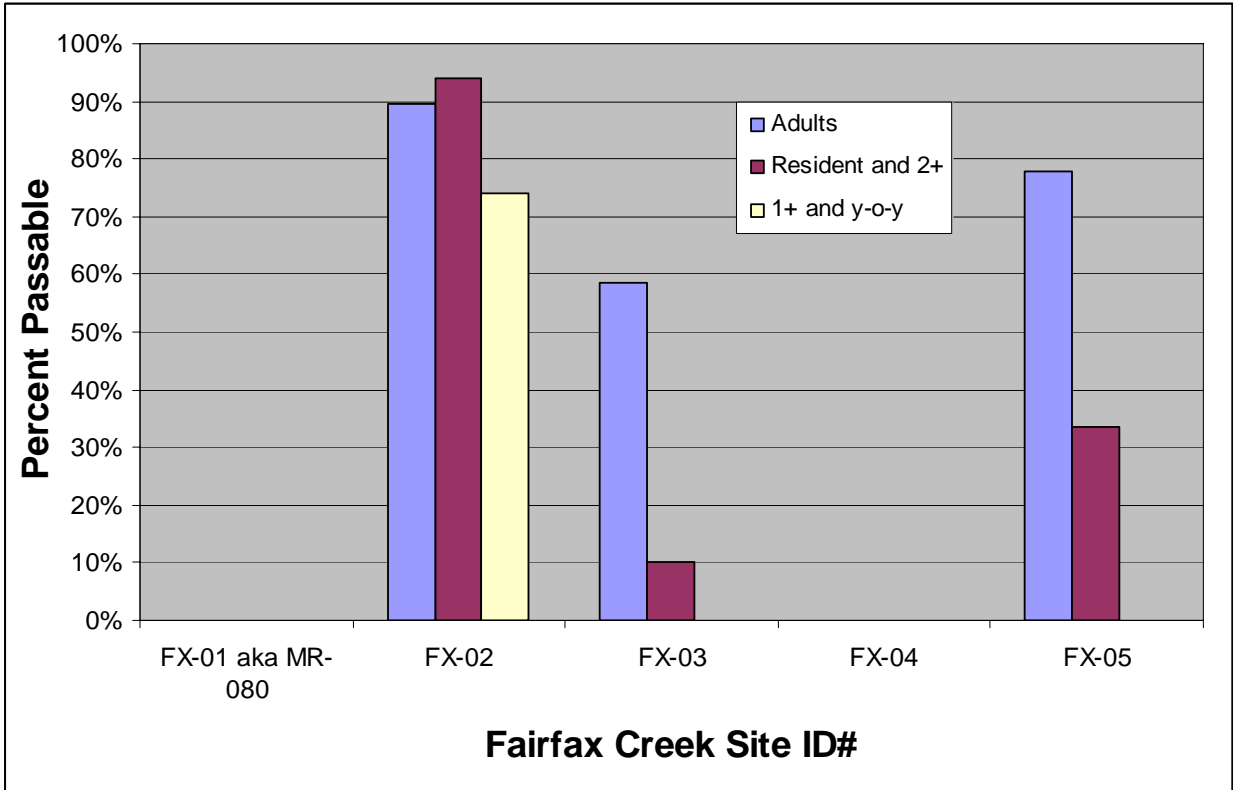
**Figure 11.** Passage evaluation results for five stream crossings in Fairfax Creek, Corte Madera Creek watershed, Marin County, CA.
