**CATALOG OF STREAM CROSSINGS WITH CULVERTS AND
OTHER MANMADE IMPEDIMENTS TO FISH PASSAGE
LOCATED ON ANADROMOUS STREAM REACHES WITHIN
FAIRFAX CREEK, CORTE MADERA CREEK WATERSHED,
MARIN COUNTY, CA.**

Prepared for Friends of the Corte Madera Creek Watershed

**By
Ross Taylor and Associates**

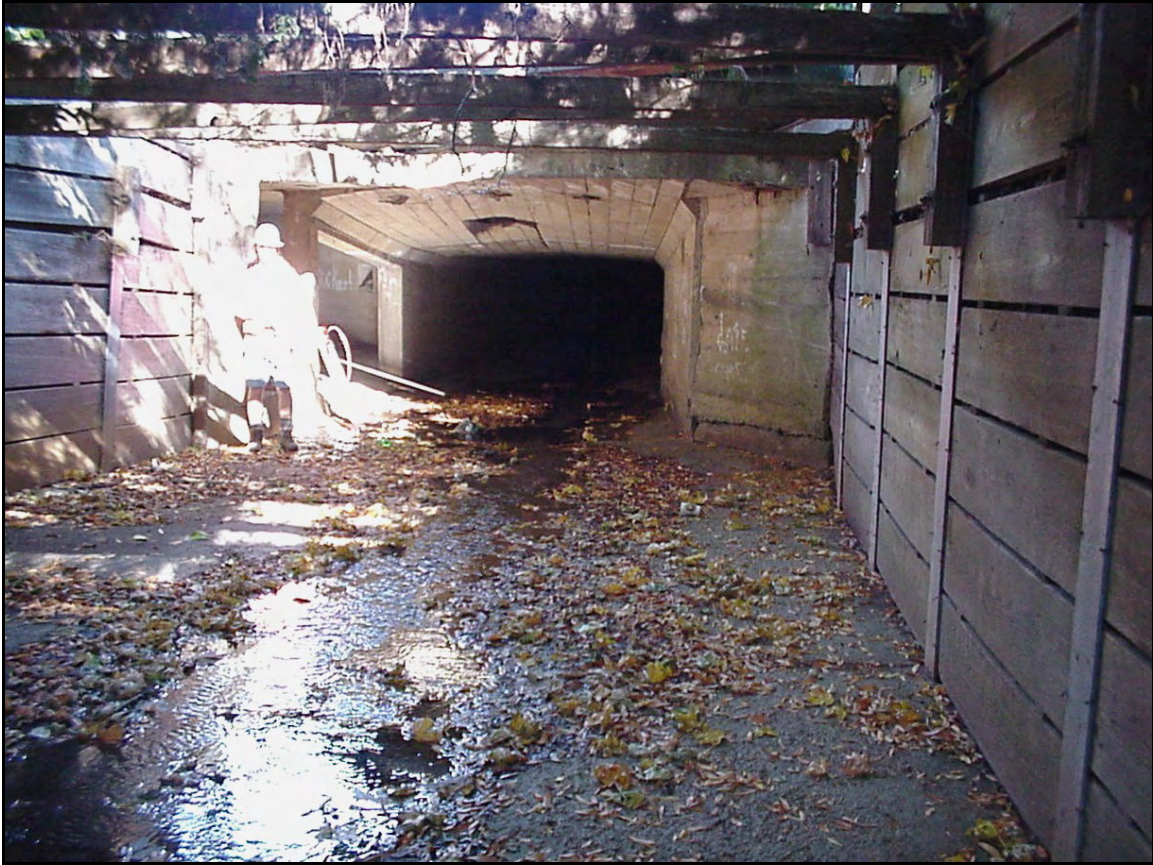
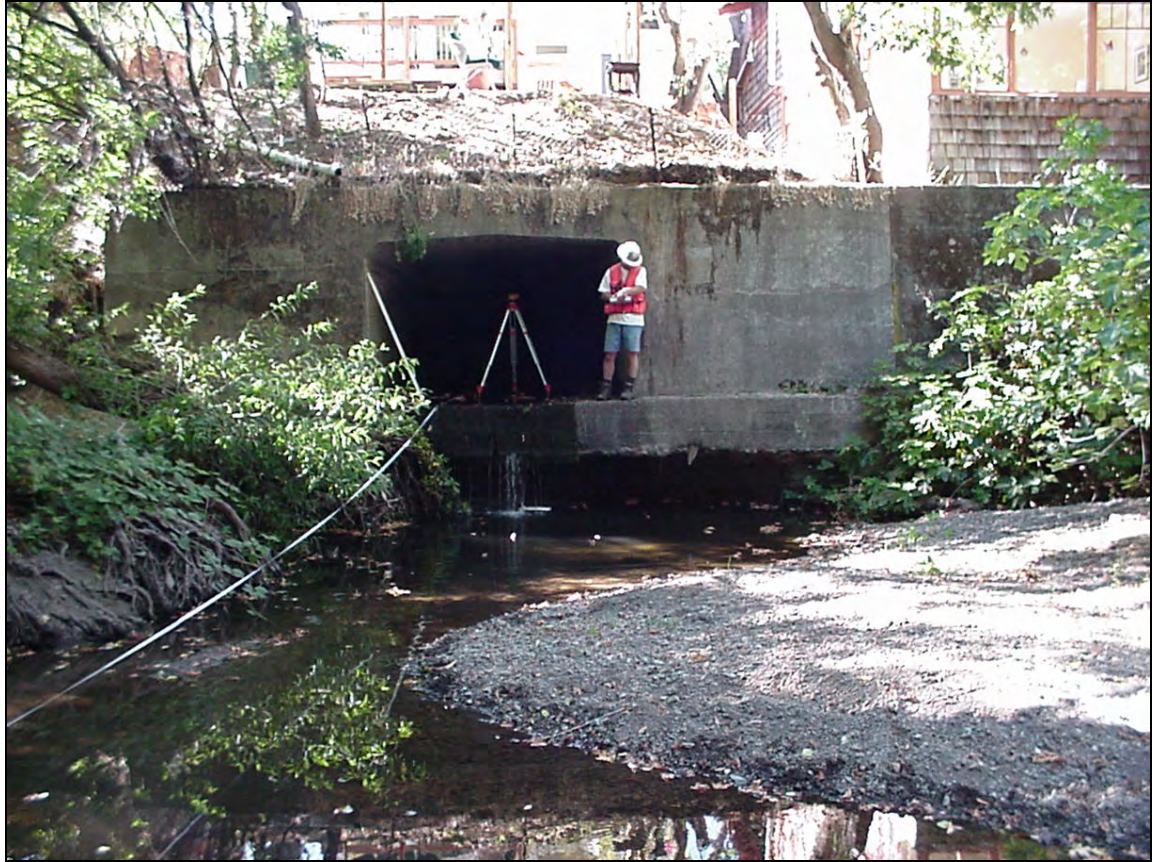
Site ID# FX-01 aka MR-080: Fairfax Creek/Bolinas Avenue; San Anselmo Creek; Corte Madera Creek

Crossing Type: Box culvert, Concrete. **Corrugations:** None. **Dimensions:** 6.35' H x 9.9' W. **Length:** 458.0' **Slope:** 0.94% **Modifications:** None. **Rustline Height:** N/A **Average Active Channel Width:** 11.1' **Fill Estimate:** 3,014 Cubic Yards. **Overall Condition:** Fair– culvert invert worn to rebar. **Sizing:** Extremely Undersized; HW/D = 1 on a storm flow with approximately a six-year recurrence interval. Bolinas Avenue is overtopped on approximately a 29-year storm flow.

Drainage Area Upstream of Crossing: 3.56 square miles. **Estimated Migration Flows:** anadromous adult salmonids = 3.0–99.1 c.f.s; resident/2+ = 2.0-25.7 c.f.s.; 1+/y-o-y = 1.0-11.2 c.f.s. **Passage Evaluation: RED:** the Green-Gray-Red filter determined this crossing failed to meet passage criteria for all species of adult salmonids and all age classes of juveniles due to a residual drop at the outlet >3.0'. The long (>450') flat concrete floor make it highly unlikely that an adult steelhead could pass through the culvert even if it was able to leap into the culvert.

Preferred Treatment: Treatment options at this site are problematic because of several factors. A retrofit is probably not feasible because the box culvert is undersized and currently the inlet overtops on less than a 10-year storm flow, thus further reduction of capacity by baffles or weirs is not recommended. The crossing’s outlet is within 25 feet of the confluence of Fairfax Creek and San Anselmo Creek, thus there is insufficient room for a series of downstream weirs to raise tail-water elevation. A full replacement may be cost-prohibitive due to the length of the existing crossing; however flood-flow capacity could be improved with a new crossing. This box culvert has effectively eliminated Fairfax Creek as a steelhead spawning and rearing tributary of Corte Madera Creek.

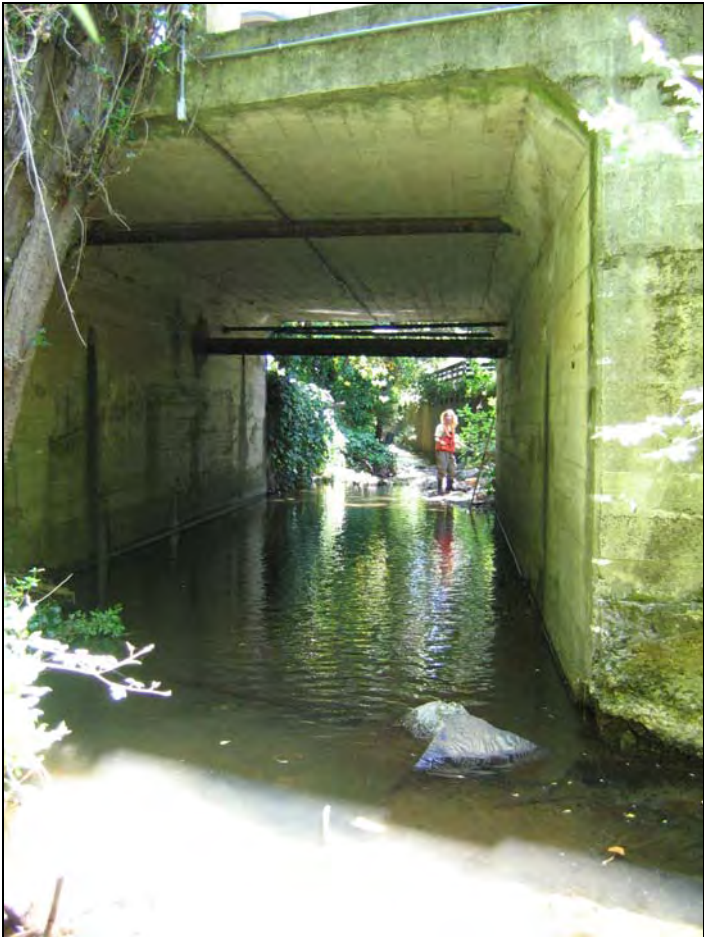
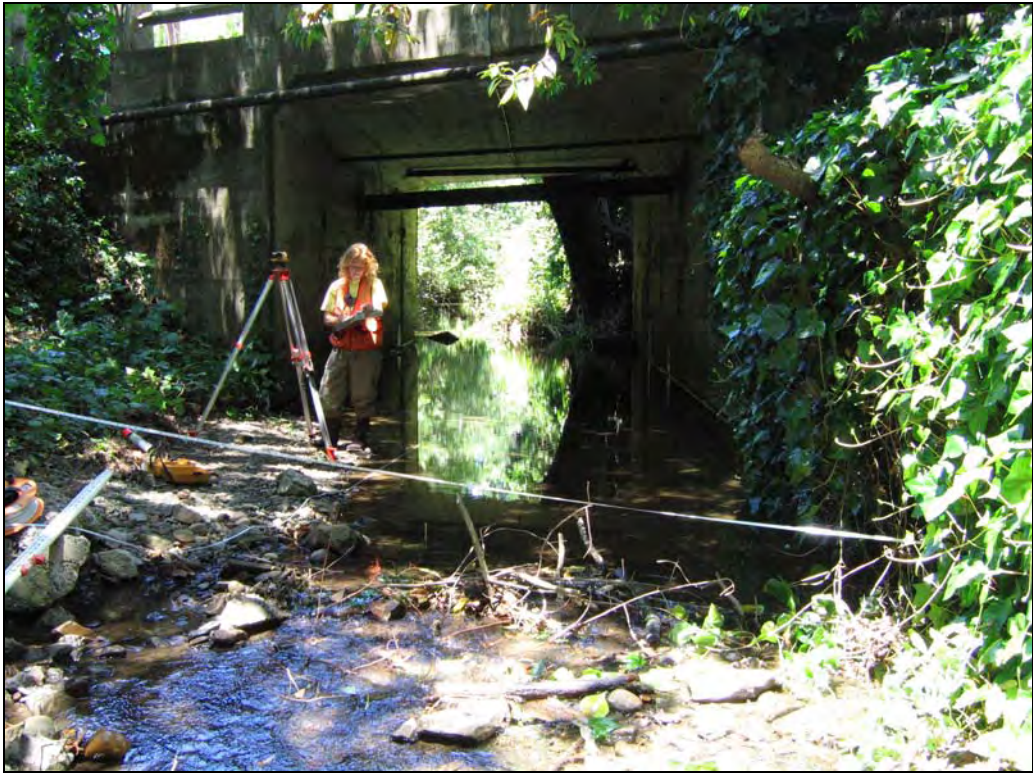
Site ID# FX-02: Fairfax Creek/Scenic Road; San Anselmo Creek; Corte Madera Creek

Crossing Type: Box culvert, concrete. **Corrugations:** None. **Dimensions:** 11.1' H x 14.0' W
Length: 40.0' **Slope:** 0.03% **Modifications:** None. **Rustline Height:** N/A **Average Active Channel Width:** 14.0' **Fill Estimate:** 650 Cubic Yards. **Overall Condition:** Good. **Sizing:** Properly sized; HW/D = 1 on a storm flow with more than a 100-year recurrence interval.

Drainage Area Upstream of Crossing: 3.13 square miles. **Estimated Migration Flows:** anadromous adult salmonids = 3.0–87.2 c.f.s; resident/2+ = 2.0–22.6 c.f.s.; 1+/y-o-y = 1.0–9.8 c.f.s. **Passage Evaluation: GRAY:** as determined by the first-phase evaluation filter due to inadequate residual depths at the culvert inlet and outlet. FishXing estimated that the crossing met the 8-16-16 ft/sec swimming/leaping velocities and 0.5 minimum depth passage criteria for adult anadromous salmonids for 90% of the estimated migration flows (11.8–87.2 c.f.s.), met passage criteria for resident trout/2+ juveniles for 94% of the estimated migration flows (3.2–22.6 c.f.s.) and met passage criteria for 1+/y-o-y juvenile salmonids for 74% of the estimated migration flows (3.2–9.7 c.f.s.).

Preferred Treatment: No treatment is recommended at this site because the box culvert currently provides ample passage for all age classes of anadromous salmonids, is properly-sized for storm flow conveyance, and is in good condition. Recommend periodic inspection for maintenance and to ensure that culvert remains back-watered.

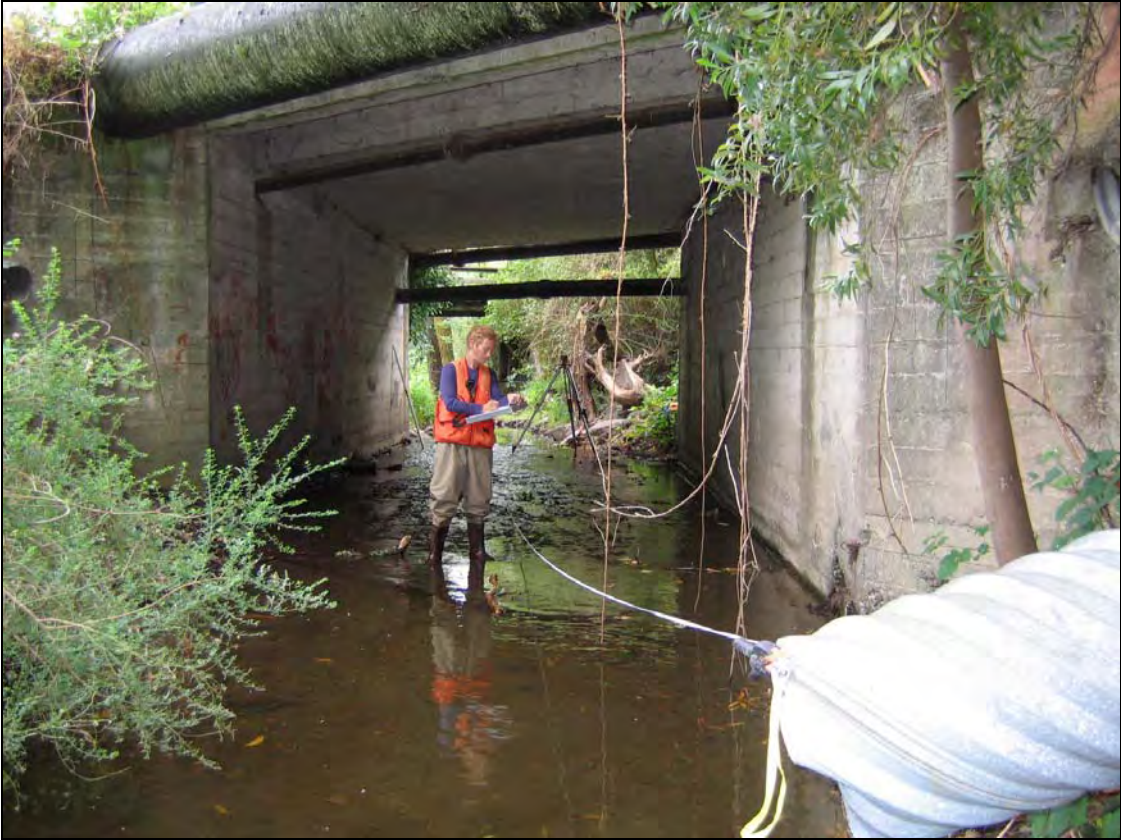
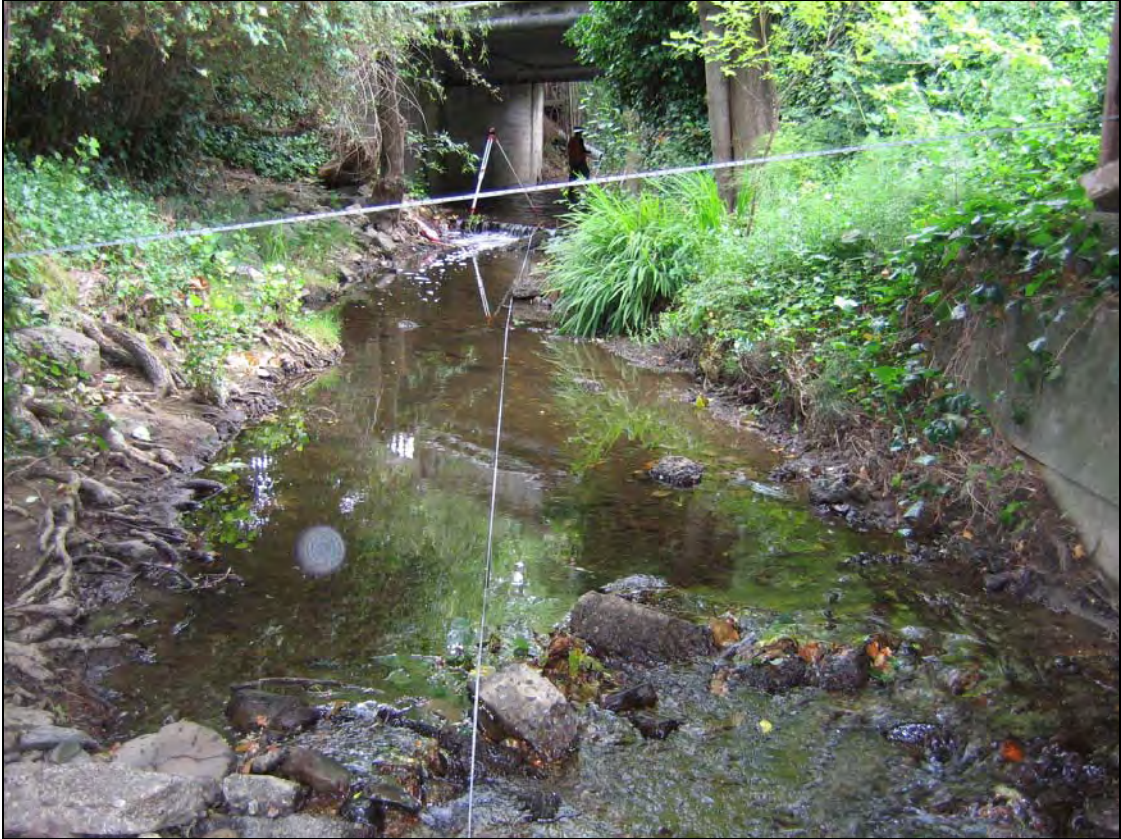
Site ID# FX-03: Fairfax Creek/Olema Road; San Anselmo Creek; Corte Madera Creek

Crossing Type: Box culvert, Concrete. **Corrugations:** None. **Dimensions:** 10.3' H x 14.0' W
Length: 44.0' **Slope:** 0.64% **Modifications:** None. **Rustline Height:** N/A **Average Active Channel Width:** 13.1' **Fill Estimate:** 546 Cubic Yards. **Overall Condition:** Good. **Sizing:** Properly Undersized; HW/D = 1 on a storm flow with more than a 100-year recurrence interval.

Drainage Area Upstream of Crossing: 2.75 square miles. **Estimated Migration Flows:** anadromous adult salmonids = 3.0–76.6 c.f.s; resident/2+ = 2.0-19.8 c.f.s.; 1+/y-o-y = 1.0-8.6 c.f.s. **Passage Evaluation: GRAY:** as determined by the first-phase evaluation filter due to inadequate residual depths at the culvert inlet and outlet. FishXing estimated that the crossing met the 8-16-16 ft/sec swimming/leaping velocities and 0.5 minimum depth passage criteria for adult anadromous salmonids for 59% of the estimated migration flows (33.5-76.6 c.f.s.), met passage criteria for resident trout/2+ juveniles for 10% of the estimated migration flows (17.9-19.8 c.f.s.) and failed to meet passage criteria for 1+/y-o-y juvenile salmonids due to leap at outlet at lower migration flows and excessive velocities at the upper range of migration flows.

Preferred Treatment: Recommend raising the tail-water elevation with two or three boulder weirs to back-water this box culvert. However, two more serious impediments to fish passage in Fairfax Creek should be treated first (FX-01 and then FX-04).

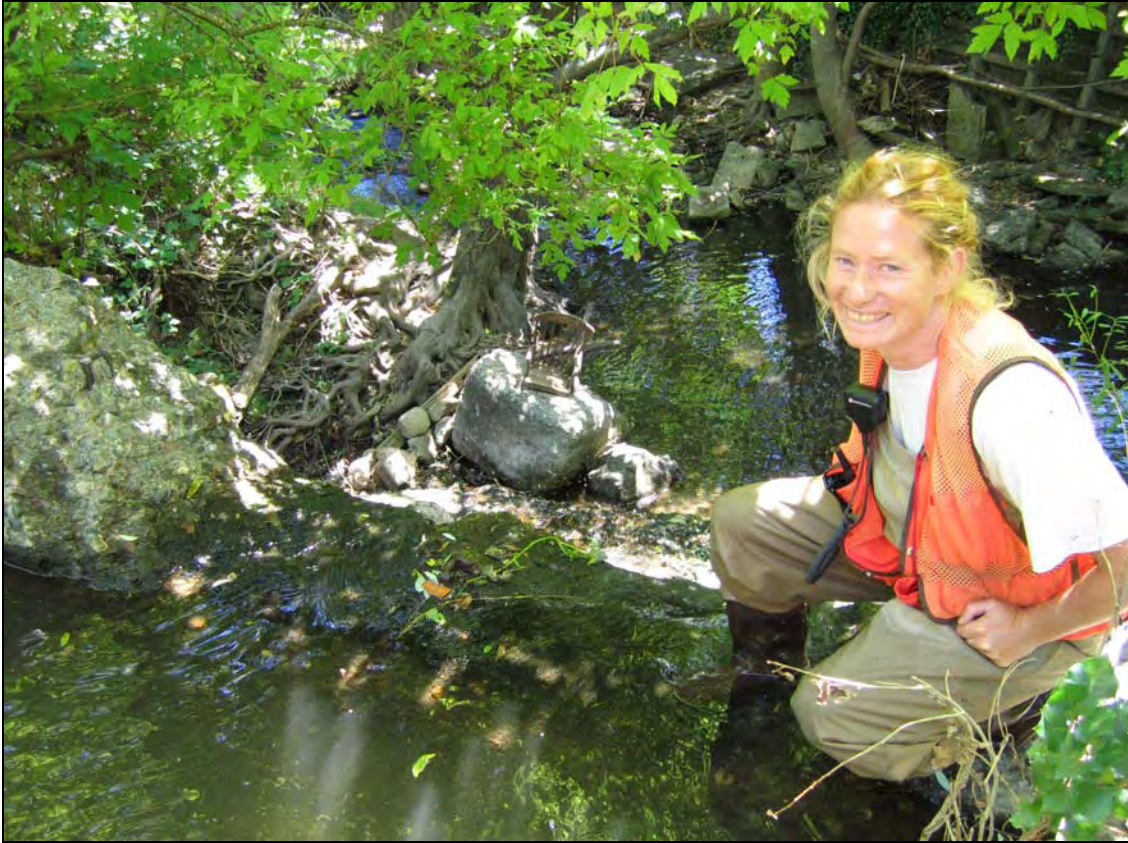
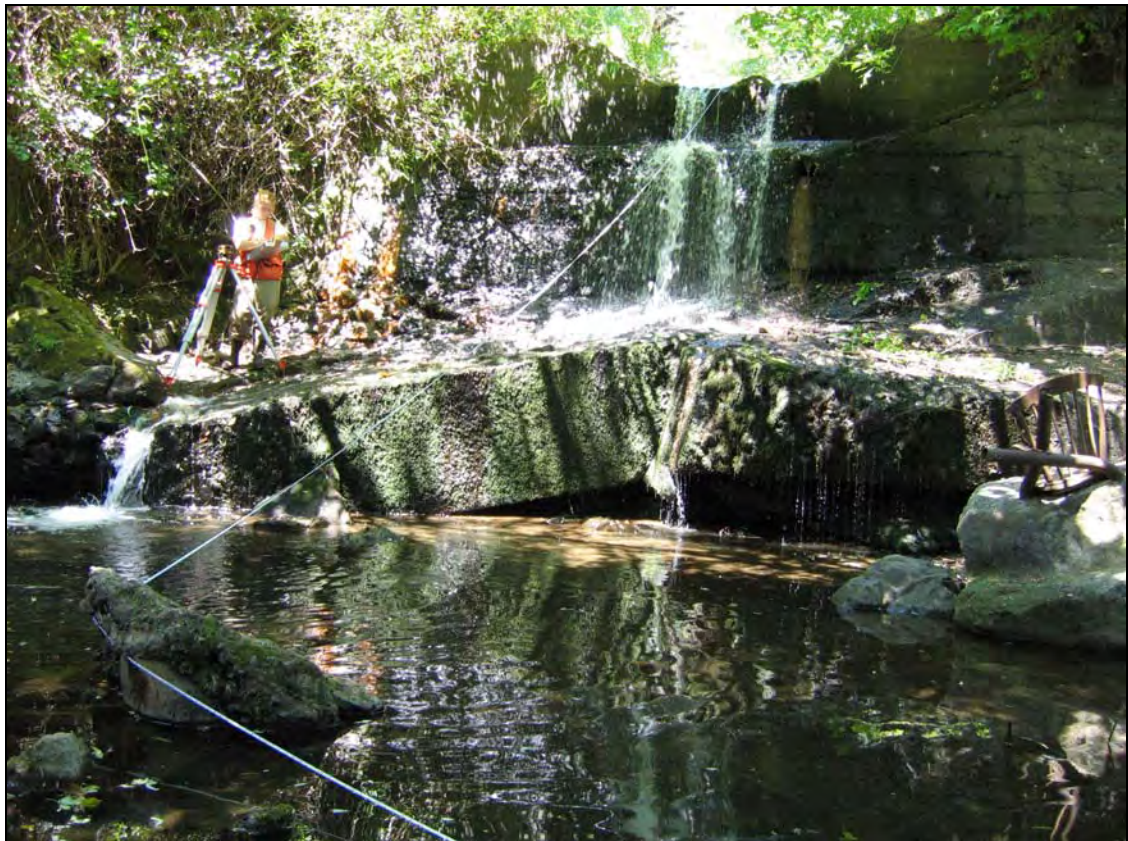
Site ID# FX-04: Fairfax Creek/Olema Dam; San Anselmo Creek; Corte Madera Creek

Crossing Type: Dam, concrete set on natural bedrock outcrop. **Corrugations:** N/A.
Dimensions: dam spans a 22.0' width and is 2.5' thick. The low-flow notch cut into the dam is approximately nine feet in width. **Length:** 16.0' from upstream edge of dam to downstream edge of bedrock outcrop. **Slope:** N/A **Modifications:** None. **Rustline Height:** N/A **Average Active Channel Width:** 15.8' **Fill Estimate:** Not applicable. **Overall Condition:** Fair, noticeable cracks in dam face and possible slumping. **Sizing:** Not applicable since a dam is an open structure with no top or sides to limit flow.

Drainage Area Upstream of Crossing: 2.22 square miles. **Estimated Migration Flows:** anadromous adult salmonids = 3.0–61.8 c.f.s; resident/2+ = 2.0-16.0 c.f.s.; 1+/y-o-y = 1.0-7.0 c.f.s. **Passage Evaluation:** **RED:** as determined by the first-phase evaluation filter for the excessive drop over the dam. FishXing was utilized to assess changes in drop height at varying discharges. At 10 c.f.s. drop = 13.2'; at 30 c.f.s. drop = 12.7'; at 62 c.f.s. drop = 12.3'; at 100 c.f.s. drop = 12.0'; and at 150 c.f.s. drop = 11.8'. Total drop occurs in two stages: flow drops from lip of dam onto bedrock outcrop, length of outcrop is 11 feet (sheet-flow), followed by a final drop into a large downstream pool.

Preferred Treatment: Recommend exploring options for dam removal and channel restoration. However, the culvert at the mouth of Fairfax Creek (FX-01) should first be treated to restore adult steelhead passage up to Olema Dam. Consideration must be made to potential effects of channel re-grade to private properties adjacent to the stream channel as well as upstream crossings.

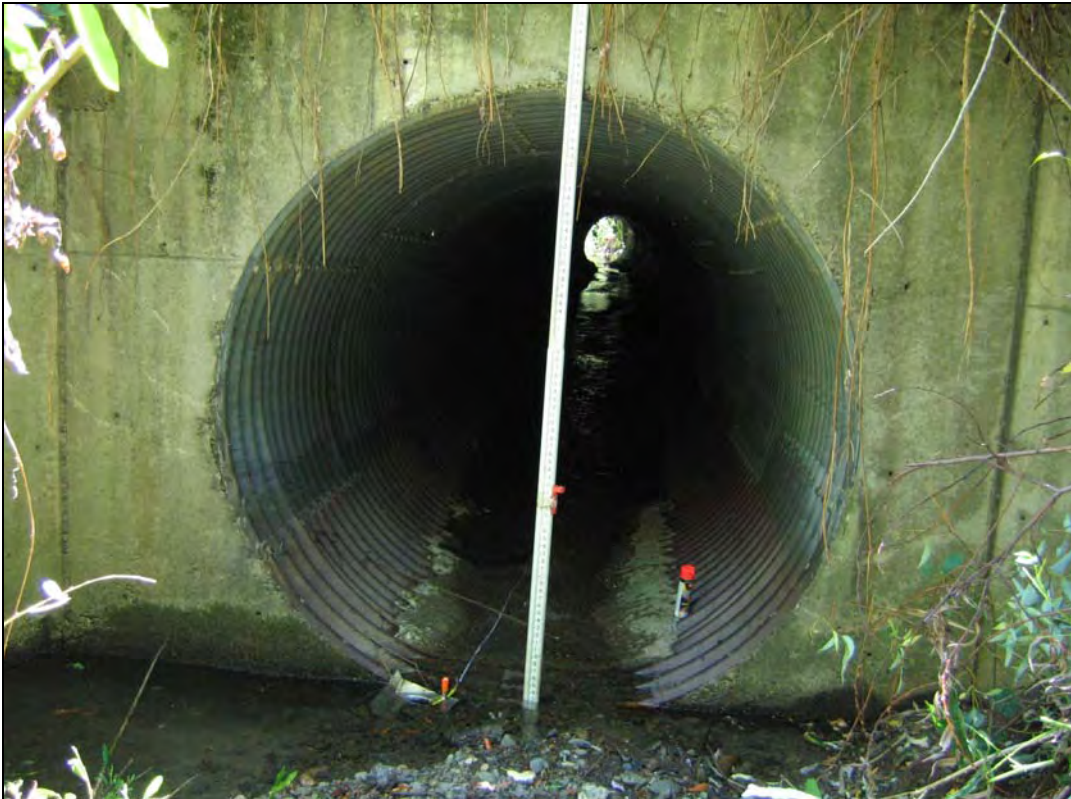
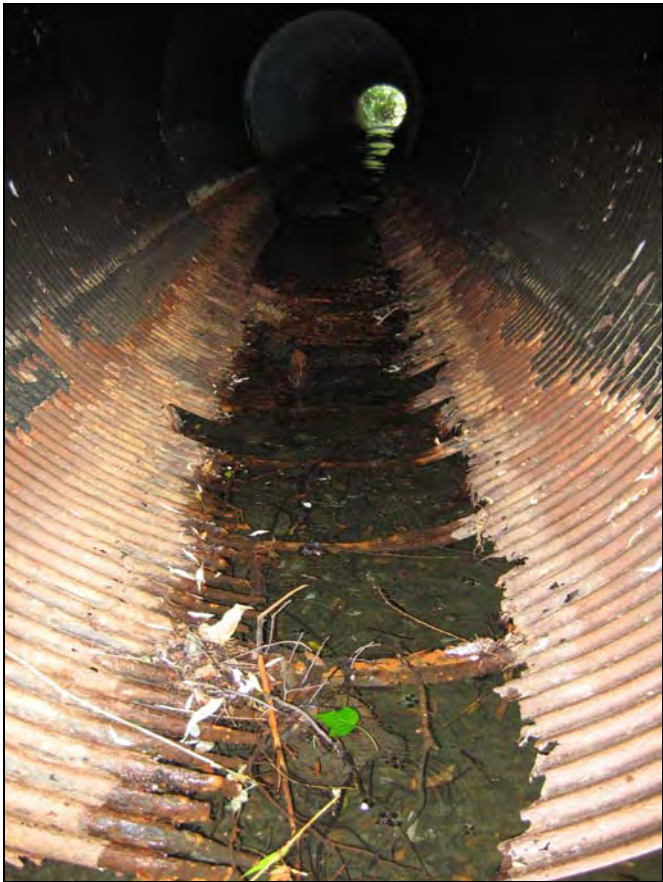
Rustline Height: 1.8'. **Average Active Channel Width:** 15.4' **Fill Estimate:** 1,531 cubic yards. **Overall Condition:** Extremely poor, lower 40.6' has rusted-through invert, some sagging of culvert too. **Sizing:** Undersized, HW/D = 1 on a storm flow between a 10 and 25-year recurrence interval.

Drainage Area Upstream of Crossing: 2.04 square miles. **Estimated Migration Flows:** anadromous adult salmonids = 3.0–56.8 c.f.s; resident/2+ = 2.0-14.7 c.f.s.; 1+/y-o-y = 1.0-6.4 c.f.s. **Passage Evaluation: GRAY:** as determined by the first-phase evaluation filter due to inadequate residual depths at the culvert inlet and outlet. FishXing estimated that the crossing met the 8-16-16 ft/sec swimming/leaping velocities and 0.5 minimum depth passage criteria for adult anadromous salmonids for 78% of the estimated migration flows (5.4-47.3 c.f.s.), met passage criteria for resident trout/2+ juveniles for 34% of the estimated migration flows (2.0-5.7 c.f.s.) and failed to meet passage criteria for 1+/y-o-y juvenile salmonids (leap and velocity). Actual passage conditions may be worse due unfavorable hydraulic conditions created by the damaged outlet and the paved invert.

Preferred Treatment: Due to poor condition and inadequate sizing, recommend replacement with a properly-sized open-bottom arch or an embedded circular SSP culvert. Project should be implemented primarily for maintenance purposes. Poor candidate for treatment with grant funds.
