Pilot Project Ross Valley Watershed Geomorphology GIS Database Final Report August 30, 2010

Prepared by:
Gerhard Epke
2010 Watershed Intern
(831) 332-1324
24 Bolinas Ave
San Anselmo, CA 94960

Project Description

This document describes a set of geodatabases that link spatial information to photographs of creek channels within the Ross Valley watershed.

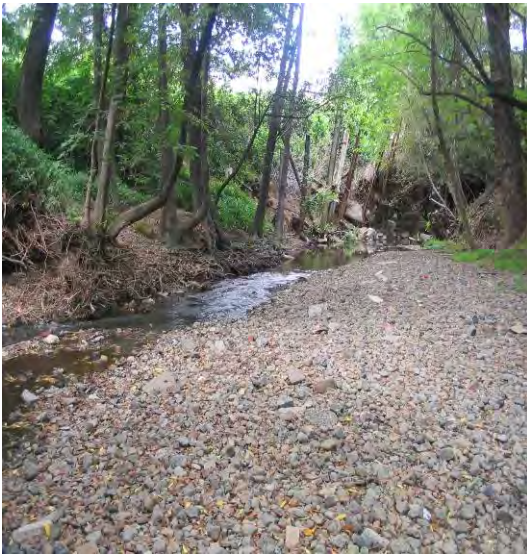
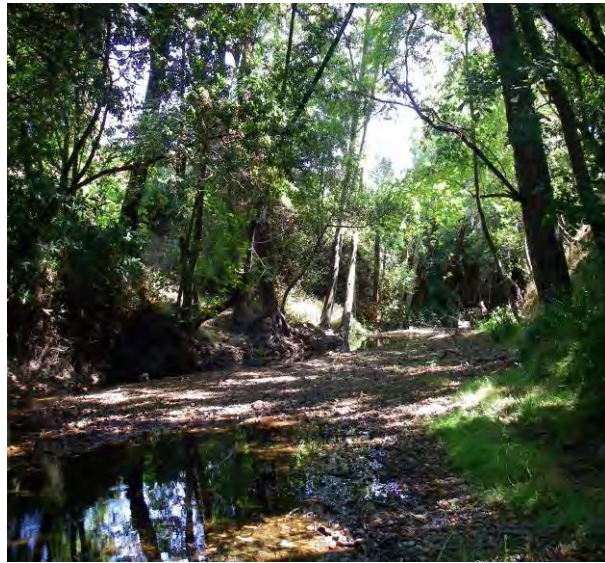
Figures A-1 a: picture 32460 DS TO CL from 2006 (above, on left)
b: SA_32460 from 2010 (on right)

In San Anselmo Creek behind the Fairfax post office. Most photographs, like this one, show very little morphologic change.

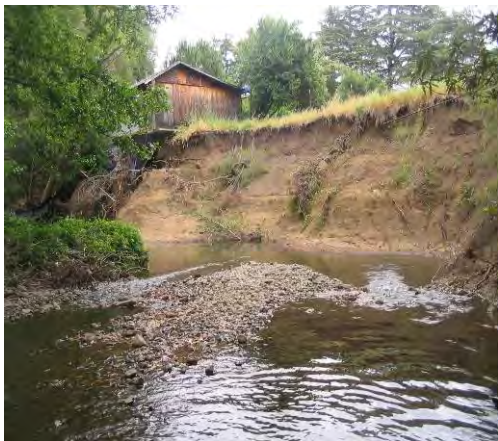
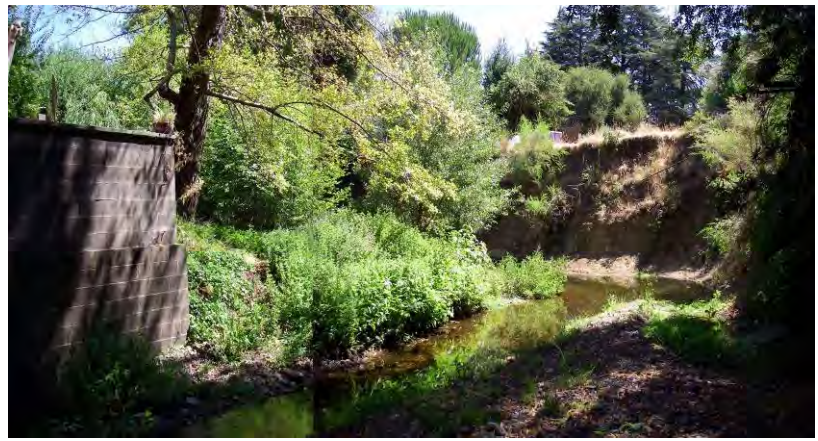
Figures A-2 a: picture 32678 DS TO RB FAILURE from 2006 (above, on left)
b: SA_32740 from 2010 (on right)

In San Anselmo Creek, 200 feet upstream, the right bank scarp has changed little in four years. Marin Town and Country Club has removed the building that was perched over the cliff, and the 2010 photograph shows the wall on the left bank that probably directed flows to the right.

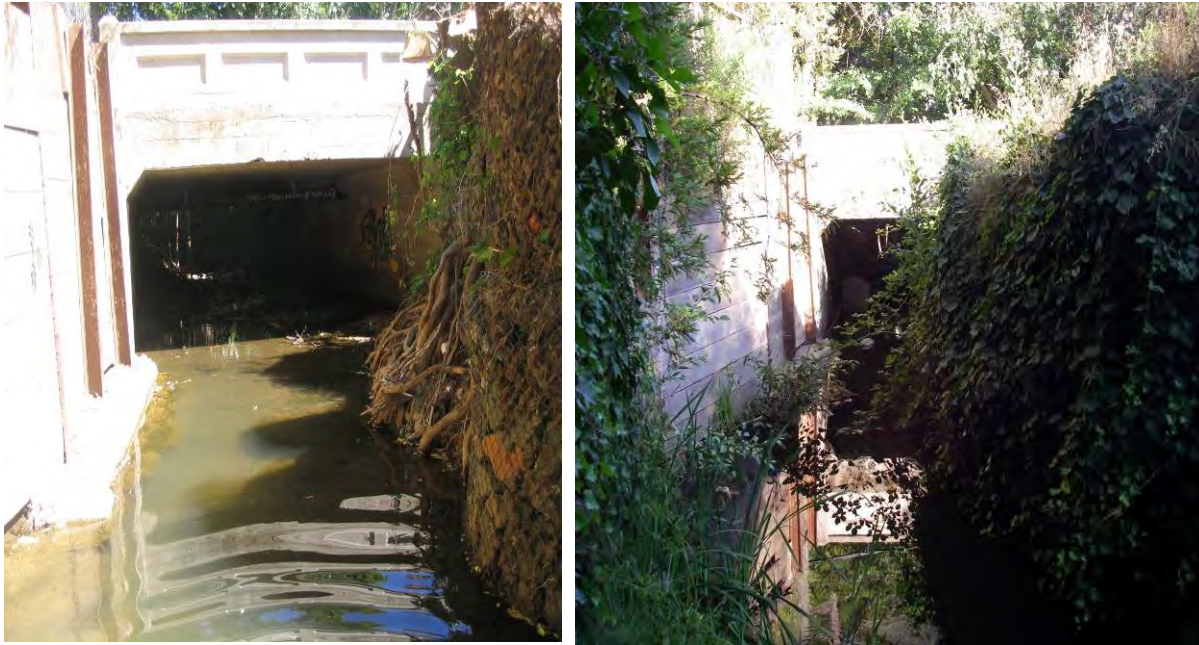
Figures A-3 a: picture 1597 DS TO MERWIN RD BDGE INLET from 2006 (on left)
b: Ffx_1625 from 2010 on right

In Fairfax creek at Merwin Rd, gabion baskets, which in 2006 were recently added as stabilization on right bank, are now very overgrown and protrude even farther into the channel.

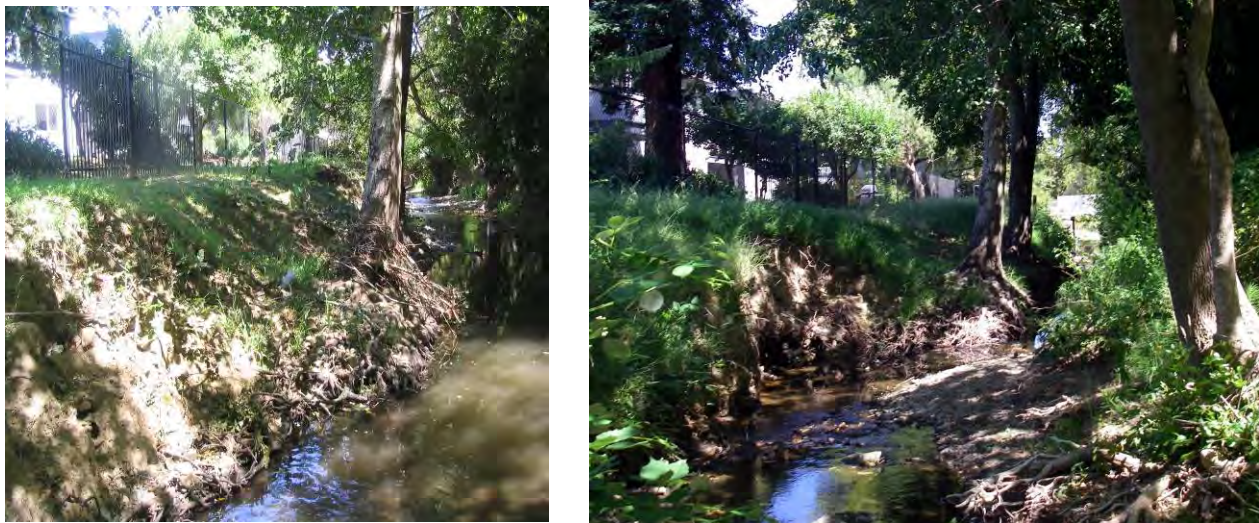
Figures A-4 a: picture 6513 DS TO LB from 2006 (on left)
b: Ffx_6475

Farther upstream on the Fairfax Creek, one instance of erosion on the left bank, possibly due to channel alterations farther upstream.

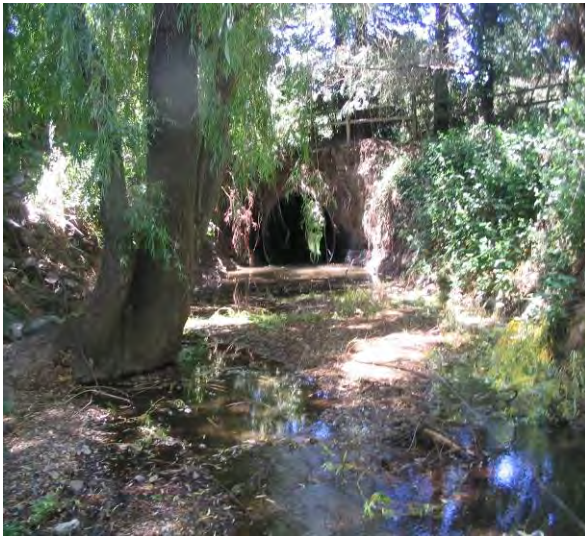
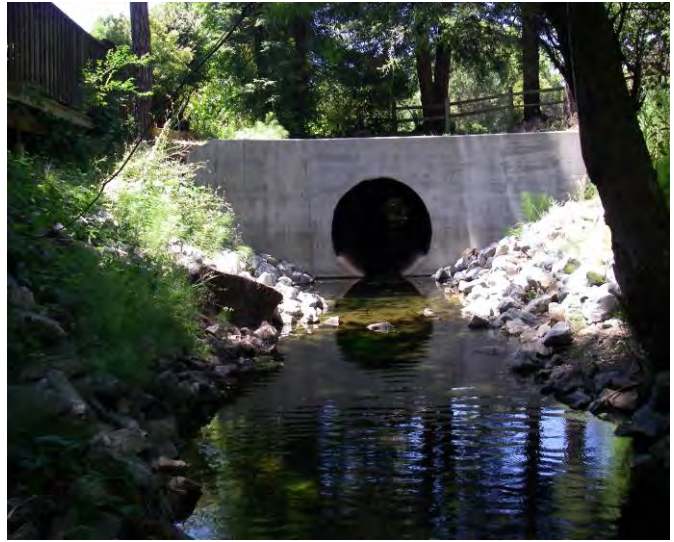
Figures A-5 a: picture 7782 US TO SFD CULVERT SITE, from 2006 (on left)
b: Ffx_7780, from 2010 (on right)

Fairfax Creek, further upstream: tree removal and streambank stabilization below the Sir Francis Drake Blvd culvert.

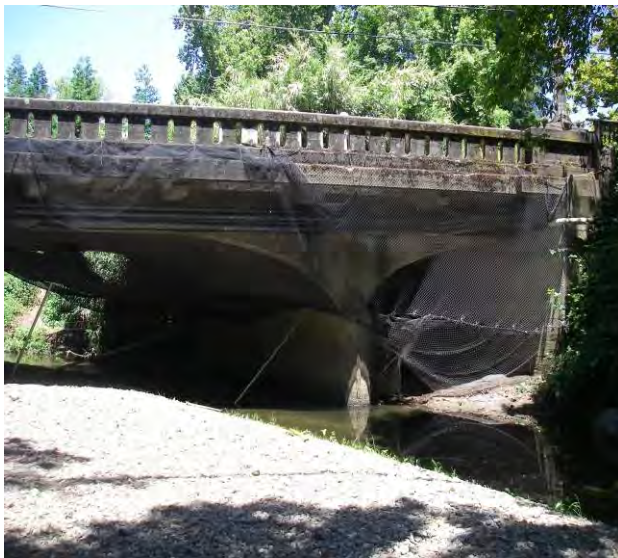
Figure A-6 picture SA_CM_37515_5
Corte Madera Creek at Lagunitas Bridge in Ross before construction.
Ross photographs do not have 2006 versions.
