2018 (YEAR 2)

# Annual Revegetation Monitoring Report for the Southeastern Creekside Marsh Culvert Replacement and Habitat Enhancement Project

Prepared by:  
Olofson Environmental Inc.

Submitted by:  
Marin County Parks  
December 2018

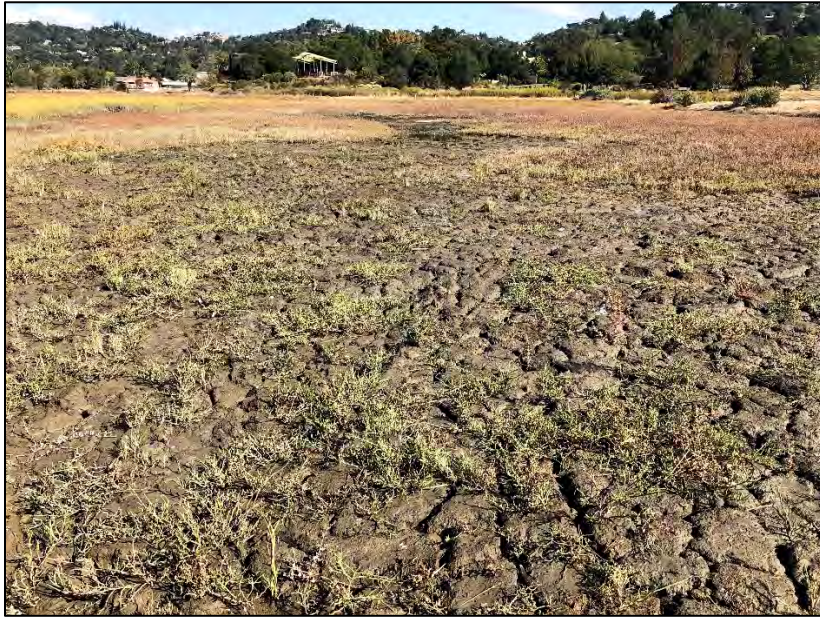
**P-5. Project Site: Soil Replacement Site**

The soil replacement restoration took place in December 2017, so it was evaluated with Year 1 criteria. The area where soil was replaced with Young Bay Mud had a percent cover of 12.7% compared to a reference area. Due to a lack of Young Bay Mud, half of the area was not restored with new soil. This area will be restored with soil amendments and planting in December 2018 and January 2019. At the time of monitoring, the Soil Amendment Area had a cover of 0%. It will be monitored next year.

Pickleweed (*Salicornia pacifica*) was the major species colonizing the soil replacement site. The site is at the same elevation as the surrounding marsh where pickleweed is the dominant species.
