# Annual Revegetation Monitoring Report for the Southeastern Creekside Marsh Culvert Replacement and Habitat Enhancement Project

2021 (YEAR 5)

Marin County Parks  
December 2021

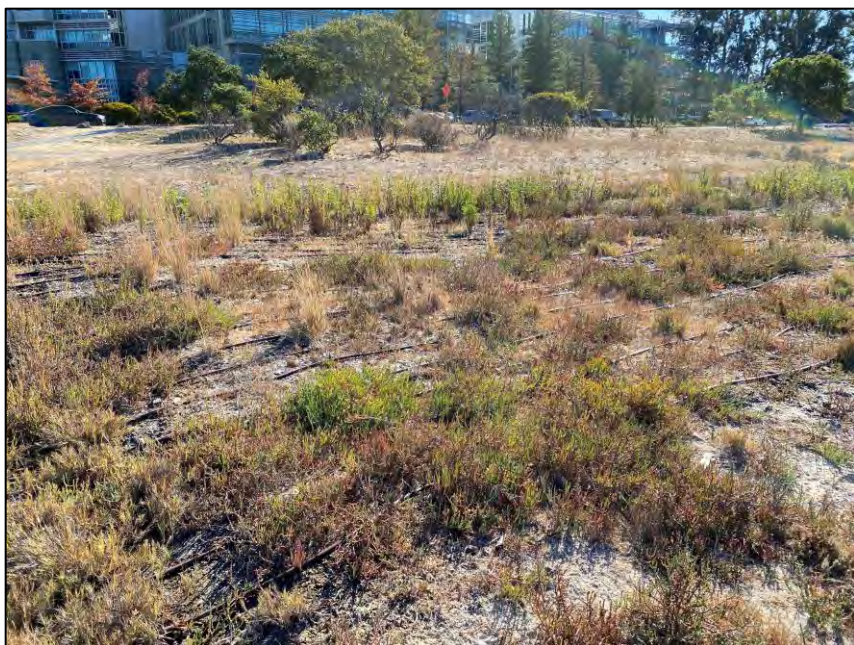
**P-7.** Project Site: Soil Amendment Site

Invasive species cover was greater than 5% in the soil amendment site. Invasive *Plantago lanceolata* was found invading the planted area. This species is found throughout the upland areas surrounding the site and grows well in disturbed soils. The University of California Cooperative Extension's Weed Research & Information Center suggests hand pulling as an effective method for controlling this species. Removal of this species is recommended immediately as well as follow up monitoring that will be conducted quarterly by OEI biologists.

OEI recommends hand removal of all *Plantago lanceolata* found in the soil amendment site. Removal will take place by Friends of Corte Madera Creek Watershed.
