# **PROSPECTS FOR IMPROVING RIPARIAN CANOPY AND PHYSICAL HABITAT FOR FISH ON ROSS CREEK**

**Geomorphic Reconnaissance Report  
March 7, 2007**

**Prepared for  
Friends of Corte Madera Creek Watershed**

**Matt Smeltzer  
Fluvial Geomorphology Consulting**

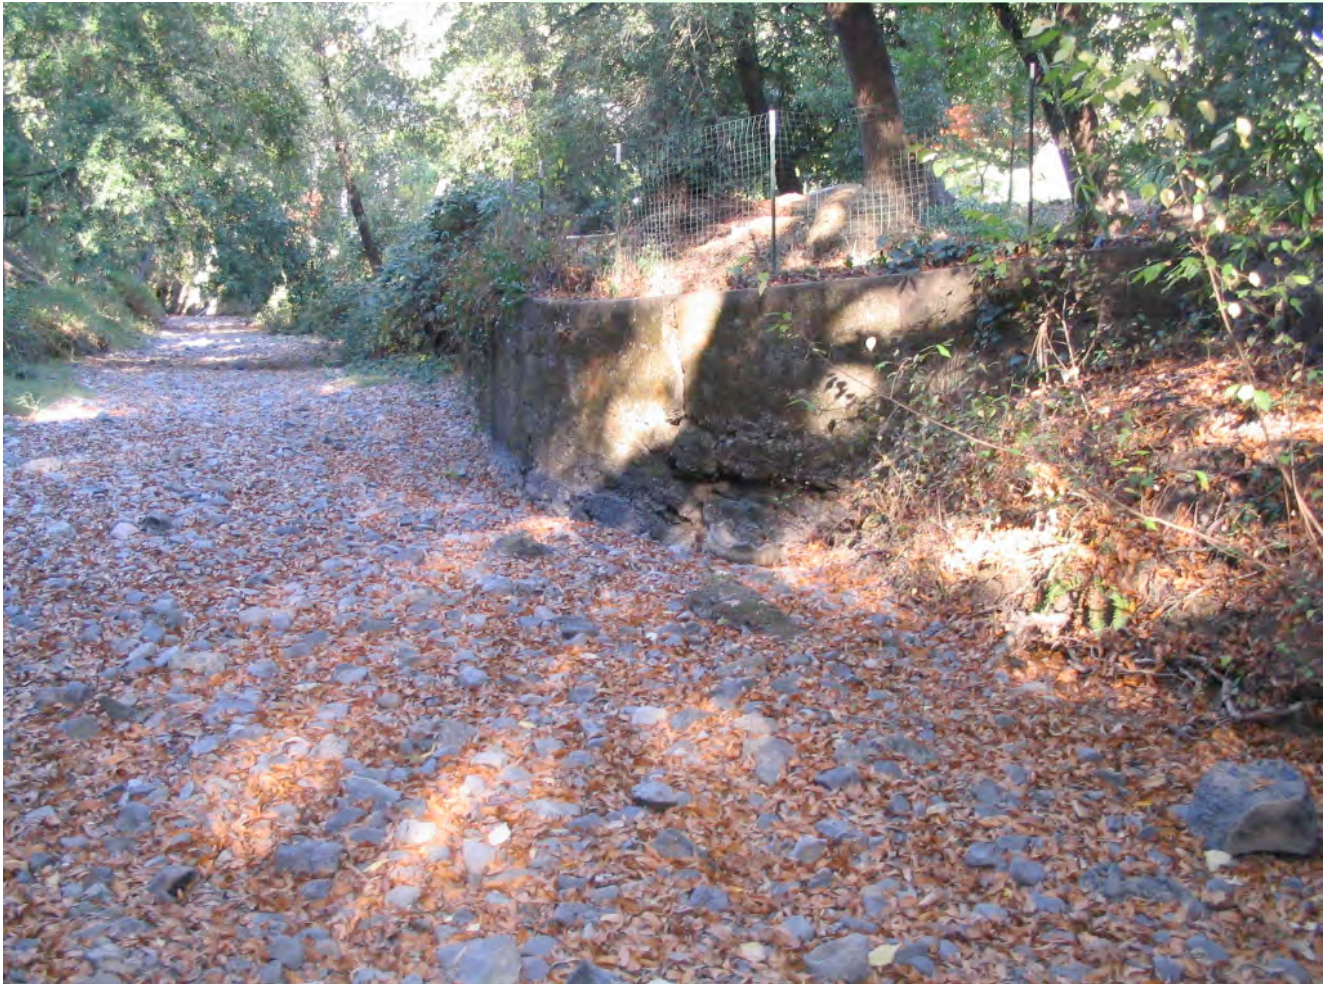
***COVER: PHOTO DOWNSTREAM TO POTENTIAL WINTER AQUATIC HABITAT  
ENHANCEMENT SITE HAB-1 (OCT 25, 2006)***

Ross Creek Project Site ID/ Subreach	Right/ Left Bank	d/s Station (ft)	u/s Station (ft)	Proj Site Length (ft)	Project Site Description	Recommended Project Actions
<b>HAB-1</b> PARK AVE-GLENWOOD	RB	4,232	4,402	170	STRAIGHT 6-7 FT HIGH VERT AND NR VERT CONC RET WALL SUBDIVIDED INTO VARIOUSLY FAILING AND FAILED/ REPAIRED CONDITION CLASSES (SITES RB S30, RB S31, RB S32) ALONG RELATIVELY STRAIGHT REACH; EXISTING RB LATERAL SCOUR POOL FORMED AT AND ALONG US END OF STRAIGHT REACH (SEE REFERT COVER PHOTO); THE EXISTING SITE RB S32 (RIPARIAN TREE CANOPY COVER IS LIMITED IN THIS REACH.	RECOMMEND REMOVING ALL OR PART OF VERT CONC RET WALL BEGINNING AT UPSTREAM END AND GRADING BANK BACK TO TYP. 1.5(H):1(V) SLOPE VAR. AS NECESSARY TO SAVE MOST OR ALL EXISTING NATIVE RIPARIAN TREES; STABILIZE WITH COMB. OF BIOTECHNICAL TREATMENTS THAT INCORPORATE CABLED RR-LWD AQUATIC HABITAT ENHANCEMENT STRUCTURES ALONG THE TOE OF THE BANK AT EXISTING LATERAL SCOUR POOL LOCATIONS AND INCREASE CANOPY COVER;
