2018 (YEAR 2)

Annual Revegetation Monitoring Report for the Southeastern Creekside Marsh Culvert Replacement and Habitat Enhancement Project

Prepared by:
Olofson Environmental Inc.

Submitted by: Marin County Parks December 2018

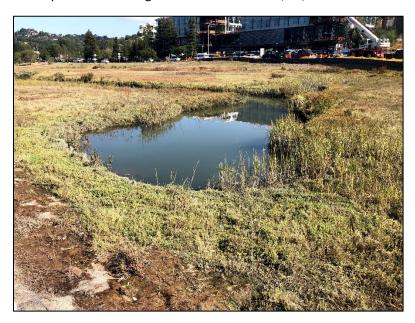
P-1. Project Site: Eastern Sampling Area

Plant survival was estimated visually at the project sites. OEI biologists monitored planting areas for signs of plant mortality. The visual survey found that survivorship of planted vegetation was above 90% at both sampling areas. The plantings have grown together and are indistinguishable from each other.

Both the Eastern and Western Sampling area continue to have high percent cover of native species in Year 2. The plantings continue to have high survivorship, and passive recruitment appears to have played a large factor in the high native plant cover.

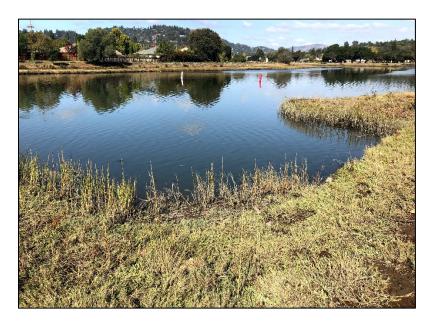
P-2. Project site: Western Sampling Area

The success criteria for Year 2 were met at both sampling areas. In the Western Sampling Area, the percent cover of native vegetation was higher in the project site than the reference site.

The Year 2 success criterion of ≥15% native vegetation cover was met at both Western and Eastern Sampling Areas. The Western Sampling Area had a cover of 116% compared to the adjacent reference site, meeting the Year 5 success criteria. The project area had a higher percent cover due to wrack that had deposited along the creek in the reference site. The Eastern Sampling Area had a native species cover of 94% compared to the reference site, meeting the Year 5 success criteria.

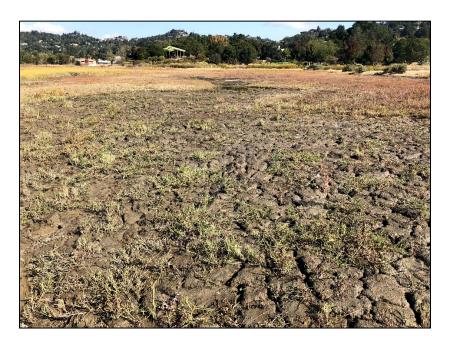
P-5. Project Site: Soil Replacement Site

The soil replacement restoration took place in December 2017, so it was evaluated with Year 1 criteria. The area where soil was replaced with Young Bay Mud had a percent cover of 12.7% compared to a reference area. Due to a lack of Young Bay Mud, half of the area was not restored with new soil. This area will be restored with soil amendments and planting in December 2018 and January 2019. At the time of monitoring, the Soil Amendment Area had a cover of 0%. It will be monitored next year.

Pickleweed (*Salicornia pacifica*) was the major species colonizing the soil replacement site. The site is at the same elevation as the surrounding marsh where pickleweed is the dominant species.

At the soil replacement site, the Year 1 success criterion of ≥5% was met where the soil was replaced with Young Bay Mud. The site where the soil was not replaced had no plant cover and was restored after monitoring occurred. This will be monitored next year when the plants have had one year of growth (3.6. Habitat Restoration Site Map).
