2019 (YEAR 3)

# Annual Revegetation Monitoring Report for the Southeastern Creekside Marsh Culvert Replacement and Habitat Enhancement Project

Marin County Parks  
October 2019

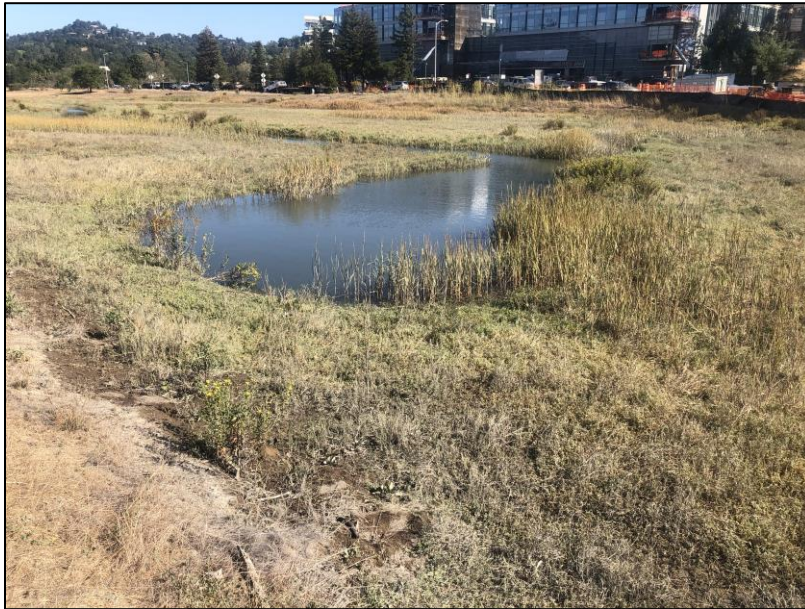
**P-1.** Project Site: Eastern Sampling Area

Plant survivorship was visually monitored at the culvert replacement site. Plant survivorship was above 90%, and the plantings have completely intermixed with passive recruitment in the project site.

The culvert replacement project site was visually monitored to ensure that the percent cover of salt marsh species was still at the Year 5 success criteria. The plantings continue to be successful and net cover appeared very high.

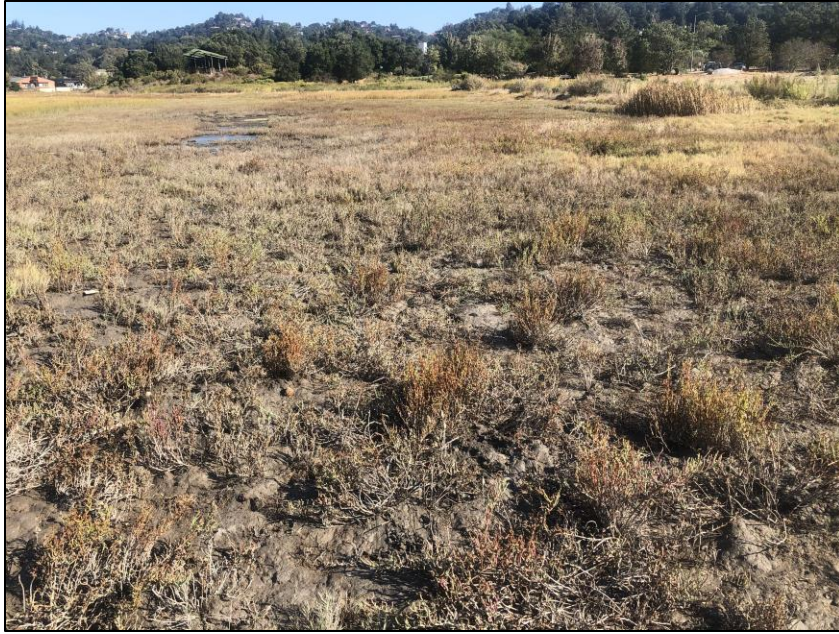
**P-5. Project Site: Soil Replacement Site**

The soil replacement restoration took place in December 2017, so it was evaluated with Year 2 criteria. The soil replacement site had a percent cover compared to a reference site of 45.1%. The soil amendment site was completed in January 2019 and evaluated using Year 1 criteria. This year it had a percent cover compared to a reference site of 43.3%.

Pickleweed (*Salicornia pacifica*) was the major species colonizing the soil replacement site. The site is at the same elevation as the surrounding marsh where pickleweed is the dominant species.

The Year 2 success criterion of  $\geq 15\%$  native vegetation cover was met at the soil replacement site. The site had a native vegetation cover of 45.1% compared to the adjacent reference site. Friends of Corte Madera Creek Watershed planted pickleweed this past year which has boosted the native cover significantly. The Young Bay Mud was become firmer and is at an elevation suitable for mid and upper elevation marsh plants to recruit.

Plant survival at the soil replacement site was very high. It was impossible to distinguish what was planted by Friends of Corte Madera Creek and what had been passive recruitment. All established plants in this area appeared healthy.

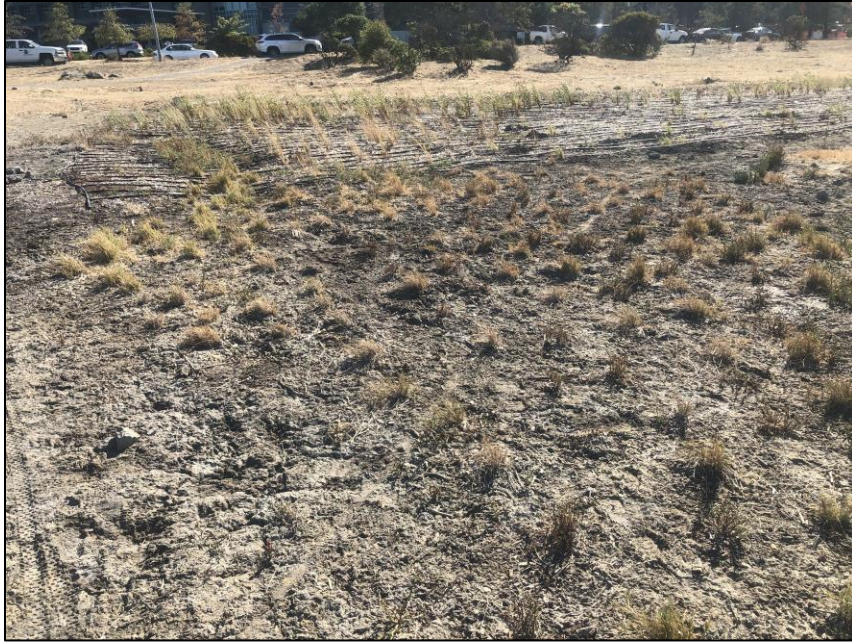
**P-7.** Project Site: Soil Amendment Site

Marsh baccharis (*Baccharis glutinosa*), creeping wild rye (*Elymus triticoides*), and pickleweed (*Salicornia pacifica*) are growing successfully in the soil amendment site. The reference site is dominated by saltgrass (*Distichlis spicata*) and annual upland grasses.

Year 1 success criterion of  $\geq 5\%$  native vegetation cover was met at the soil amendment site as well. The site had a native vegetation cover of 43.3% compared to a reference site. This area was actively planted and irrigated which has allowed plant survival to be approximately 60-70%.

Plant survival at the soil amendment site appeared to be 60-70%. The plantings have spread and are now intermixed with plants that have recruited passively. *Elymus triticoides* and *Baccharis glutinosa* were the most successful species, while only a few *Artemisia douglasiana* were found. The irrigation has been crucial for plant survival at upland elevations.
