Annual Revegetation Monitoring Report

for the Southeastern Creekside Marsh Culvert Replacement and
Habitat Enhancement Project

2023 (YEAR 7)

February 2024

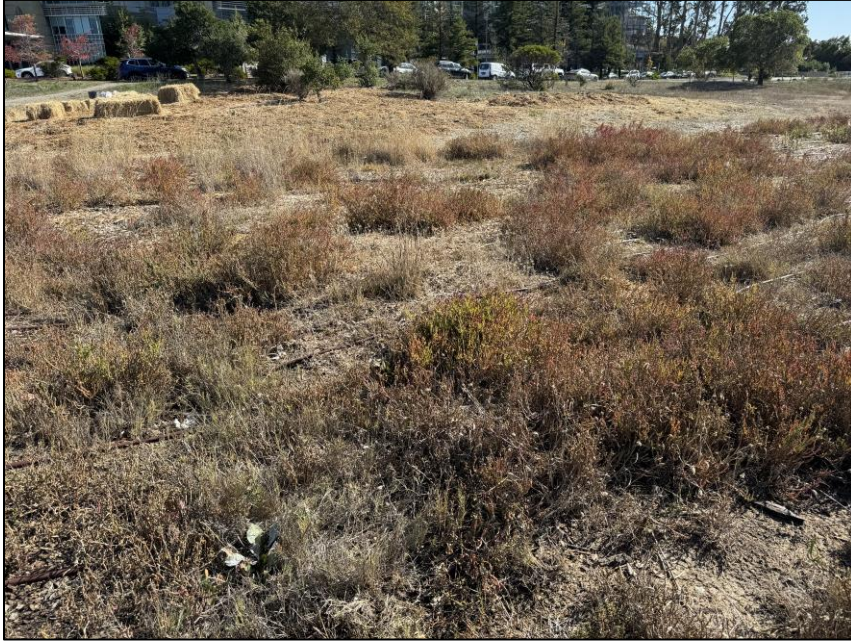
P-7. Project Site: Soil Amendment Site

Plant survivorship was visually estimated where active plantings had taken place. Plant survivorship at the soil amendment site was approximately 80%.

Year 5 success criteria of $\geq 75\%$ native vegetation cover was met at the soil amendment area (**Figure 3**). The site had a native vegetation cover of 89.1% compared to a reference site. This area was actively planted and irrigated which has allowed plant survival to be approximately 80%.

Invasive species cover was less than 5% in the soil amendment site. Invasive *Plantago lanceolata* was found within the planted area. *Plantago lanceolata* had a percent cover of 4.8, down from 8.3 when compared to 2022. The reduction of this invasive species in the soil replacement area is likely due to maintenance by Friends of Corte Madera Creek Watershed, native planting survivorship, and native plant recruitment within the site.

Plant survivorship at the soil amendment site appeared to be approximately 80%. The plantings have spread and are now intermixed with plants that have recruited passively. *Baccharis glutinosa* and *Distichlis spicata* were the most successful planted species. Plants appear to be healthy, but are still fairly small. This may be due to the harsh soils they were planted in. It is also likely that several years of drought have influenced growth of the plantings and passive recruitment of native species.
