Memorandum Iron and Manganese Levels in Ross Creek, Summer 2011

December 2011

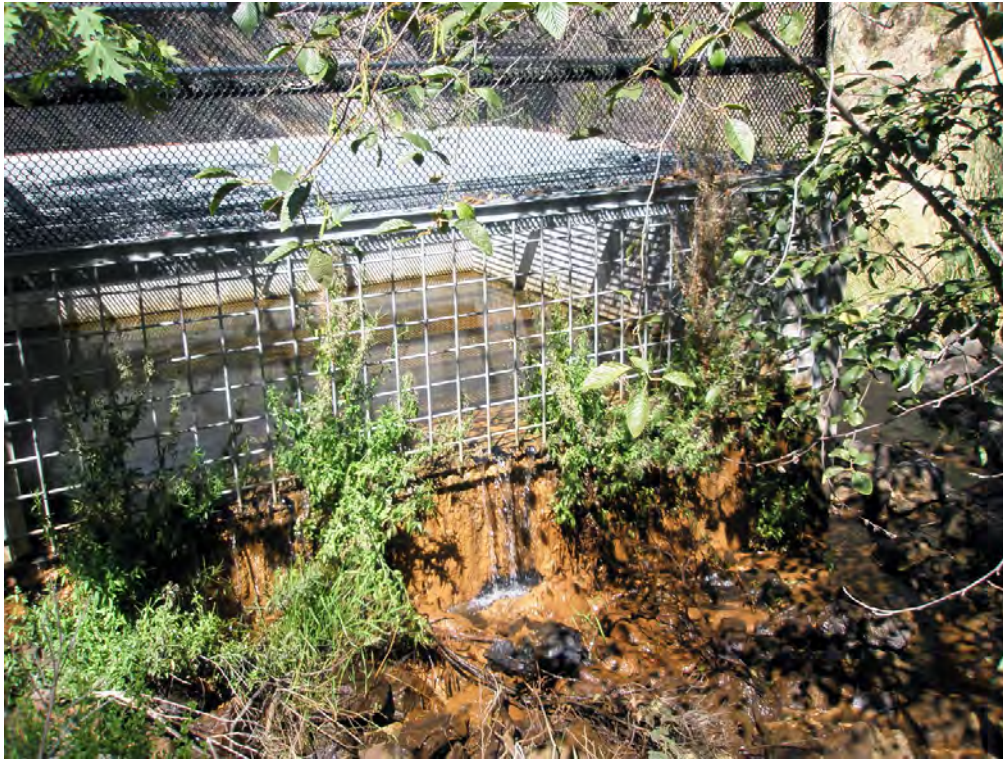
Figure 3: Vault on 9/23/11

In the summer months, Ross Creek receives water from two sources, the leaky low-level valve at the base of the Phoenix Lake Dam and groundwater inputs. The concrete vault was designed to dissipate excessive turbulence when the valve is open. The water leaving the vault is clear, but the wetted surfaces of the exterior of the vault are covered with orange deposits. This water comes from the bottom of the lake (at a depth of 35-40 feet). Between the vault and the next sampling location 45 feet downstream, the stream flow is increased by water seeping from the bottom of the dam. There are additional groundwater inputs downstream. A small perennial stream enters Ross Creek between the third and fourth sampling stations. When the first samples were taken on 6/30/2011 water was flowing briskly over the spillway; by 7/17/11, the flow over the spillway was a trickle; and flow had ceased by the time the sample was taken on 7/23/11.

Samples were collected at four locations, covering some 1,600 feet of Ross Creek (see Figure 2, at the end of the memo). At the vault, samples were taken from the water flowing over edge of the concrete vault (see Figure 3). At the other three sampling locations, water was taken from the creek. The flow in the creek was so low that all the samples were necessarily taken near to the surface of the stream. The condition of the water at RC1 on 9/23/11 is shown on Figure 4.

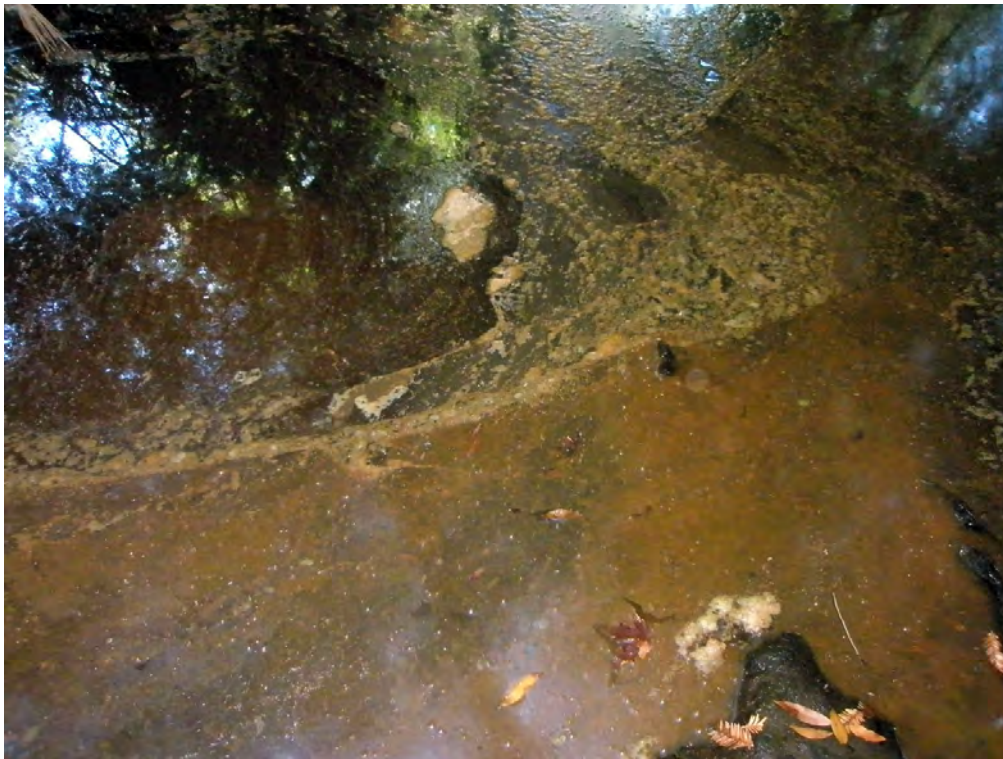
Figure 4: Site RC1 on 9/23/11

During low summer flows, the upstream 100 to 150 feet of the creek contains water that is cloudy and scum covered, rocks in the water are covered with orange deposits and filaments, and at times floccules of orange material are suspended in the slow-moving water. Further downstream, the orange material is absent, but the rocks are covered with thin black deposits. We suspected that these materials might be having a significant effect on the creek's aquatic life. In an attempt to determine the composition of these materials, and thus their possible effects, samples were taken at four locations in the creek during the summer of 2011 and analyzed for total iron (Fe) and total manganese (Mn).
