FRIENDS OF
CORTE MADERA CREEK
WATERSHED

2020 Water Quality Report

Corte Madera Creek Watershed

August 20, 2021

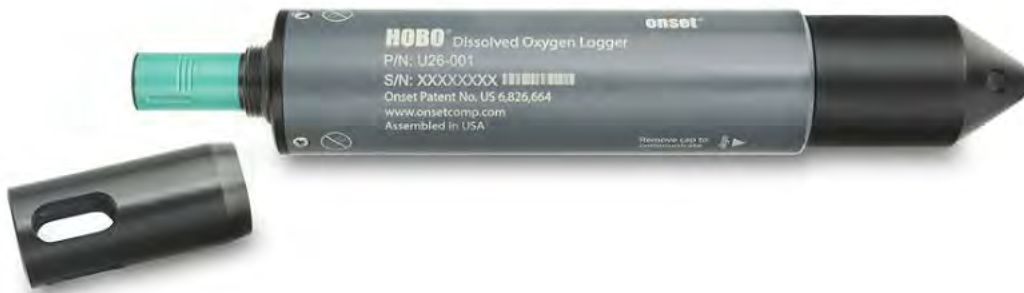
Figure 2: Diagram of the HOBO U26 Dissolved Oxygen logger

In 2020, we added three HOBO U26 Dissolved Oxygen Data Loggers (Figure 2). These optical loggers, used to monitor both temperature and DO, are calibrated before they are shipped. This logger uses optical communications for data offload in the field with the same waterproof shuttle as the temperature loggers and the data are analyzed using the Onset software.

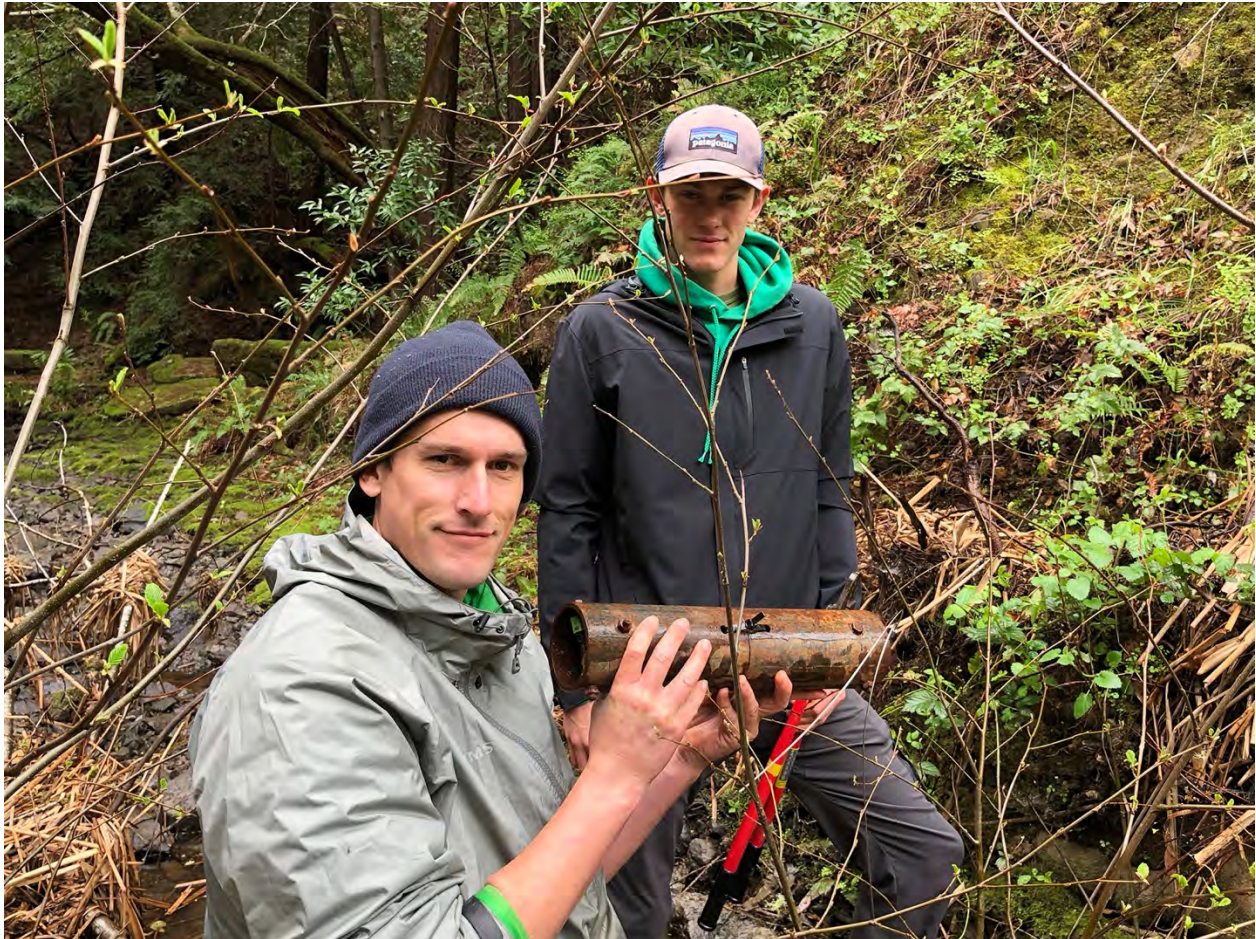
Figure 3: Preparing to install a DO logger inside protective steel pipes

These loggers are fragile and relatively expensive, so we enclosed them in steel pipes to protect them from disturbance. Figure 3 shows Parker Pringle, a board member of Friends in 2020, and Logan Smith, an intern from Archie Williams (formerly Sir Francis Drake) High School's SEA DISC Academy preparing to install logger RC0.5.

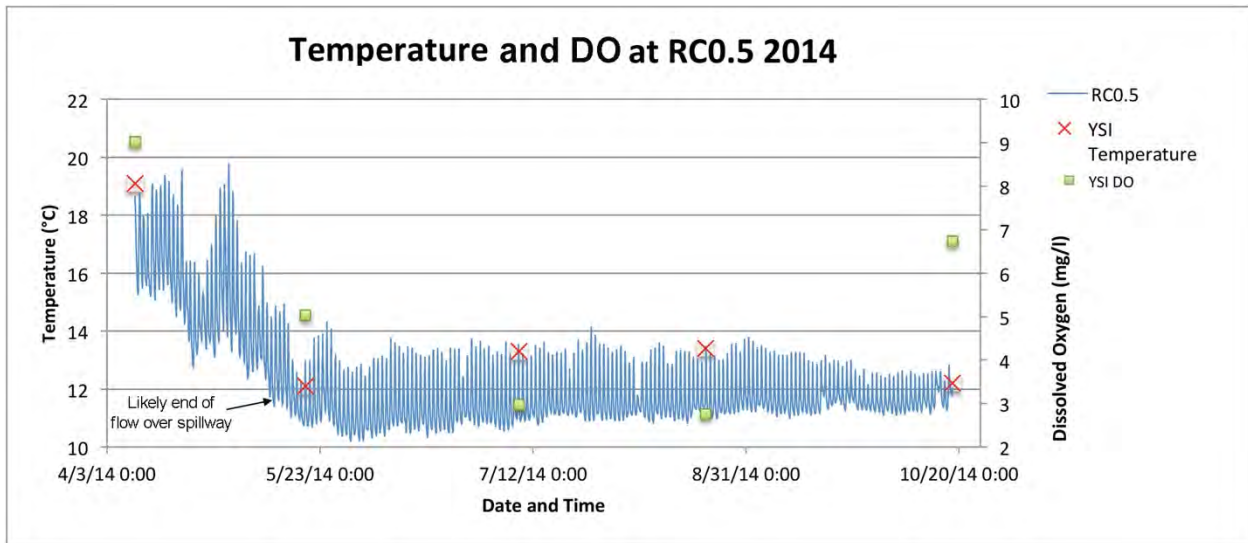
Figure 11: Plots of data at RC05 In 2014 and 2015

Phoenix Lake and Conditions in Ross Creek. After Phoenix Lake has stratified in the spring and the warm water is further heated as it flows over the spillway, water in the upper section of Ross Creek is too warm for salmonids (see Figure 11) for data from 2014 and 2015, which show this problem more clearly. The temperature immediately drops when flow over the spillway stops and the stream is dominated by leakage from the low-level release valve and groundwater inputs. This suggests that if water in upper Ross Creek becomes too warm for salmonids, releasing water from the low-level release valve until flow over the spillway ceases has the potential to benefit salmonids in Ross Creek, particularly if the water can be aerated near the low-level release valve. The added flow might also encourage smolts to move downstream before lower Ross Creek dries.

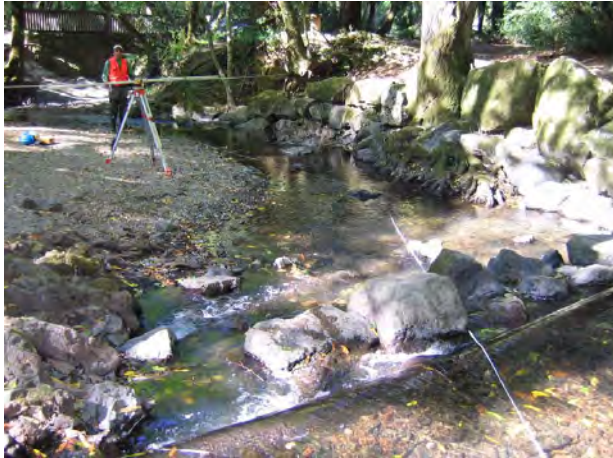
Figure 12: Water pipeline crossing Ross Creek

The pipeline shown in Figure 12 is owned by Marin Water and its removal should be coordinated with it. The much more serious barrier, shown in Figure 13, is a weir under a pedestrian bridge with an extensive upstream apron and rock walls that form a wading pool. This area is heavily

Barriers to Passage in Ross Creek: Ross Taylor & Associates conducted an assessment of barriers to salmonid passage in the watershed (RTA, 2006). Four barriers were identified in Ross Creek, including two on publicly-owned property in Natalie Coffin Greene Park. Removing these two barriers would improve habitat within the park, allowing fish to move freely in the perennial section of the creek.

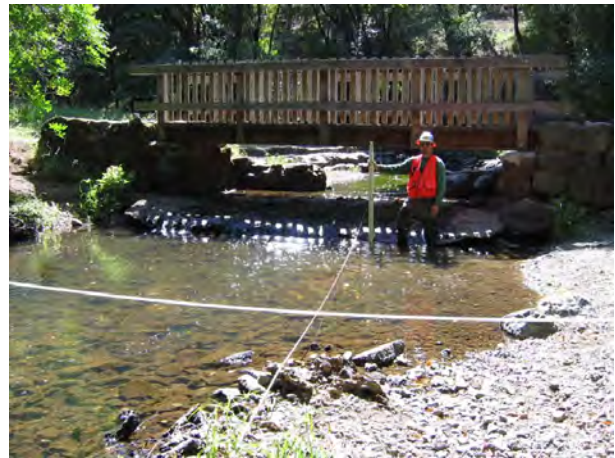
Figure 13: Pedestrian bridge with weir

used by children in the summer and treating this barrier would require close coordination with the Town of Ross.
