Annual Revegetation Monitoring Report for the Southeastern Creekside Marsh Culvert Replacement and Habitat Enhancement Project

2020 (YEAR 4)

Marin County Parks
December 2020

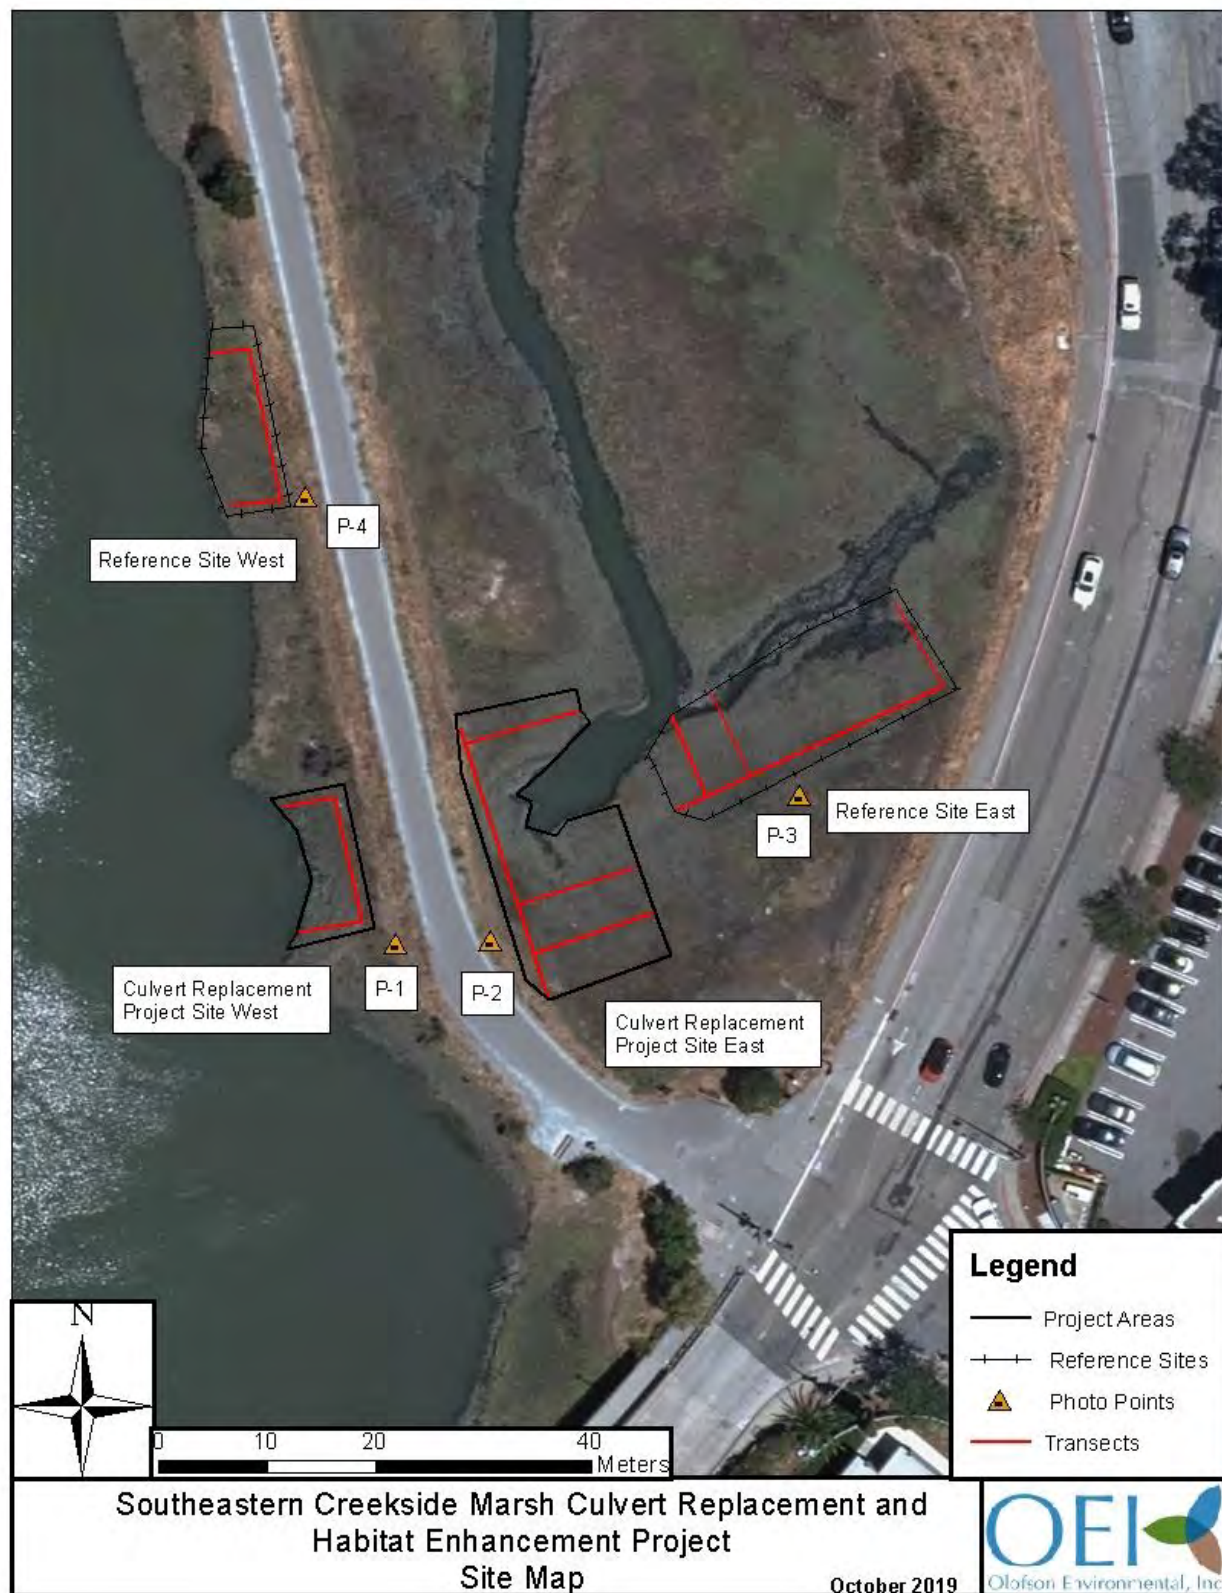
Figure 2. Culvert Replacement Project Site Map

The project area encompasses salt marsh habitats on both sides of the berm where construction occurred. Temporary impacts, including removal of salt marsh vegetation, occurred in 0.14 acre of estuarine wetland in Creekside Marsh and Corte Madera Creek. The salt marsh vegetation was replanted in the project area. In addition, upland areas removed by berm excavation were seeded with native grasses (**Figure 2**).

The culvert replacement project site (**Figure 2**) was not evaluated quantitatively this year. Year 5 success criteria were achieved last year for percent cover of native species and presence of invasive species.

The culvert replacement project site (**Figure 2**) was not monitored quantitatively because all Year 5 success criteria were reached last year in Year 2. Photo point monitoring, plant survival, and invasive species monitoring were completed this year to ensure no major plant die offs or invasive species occurred that could jeopardize the success of the culvert replacement project site.

The culvert replacement project site (**Figure 2**) was visually monitored to ensure that the percent cover of salt marsh species was still at the Year 5 success criterion. The plantings continue to be successful and net cover appeared similar to the surrounding marsh.

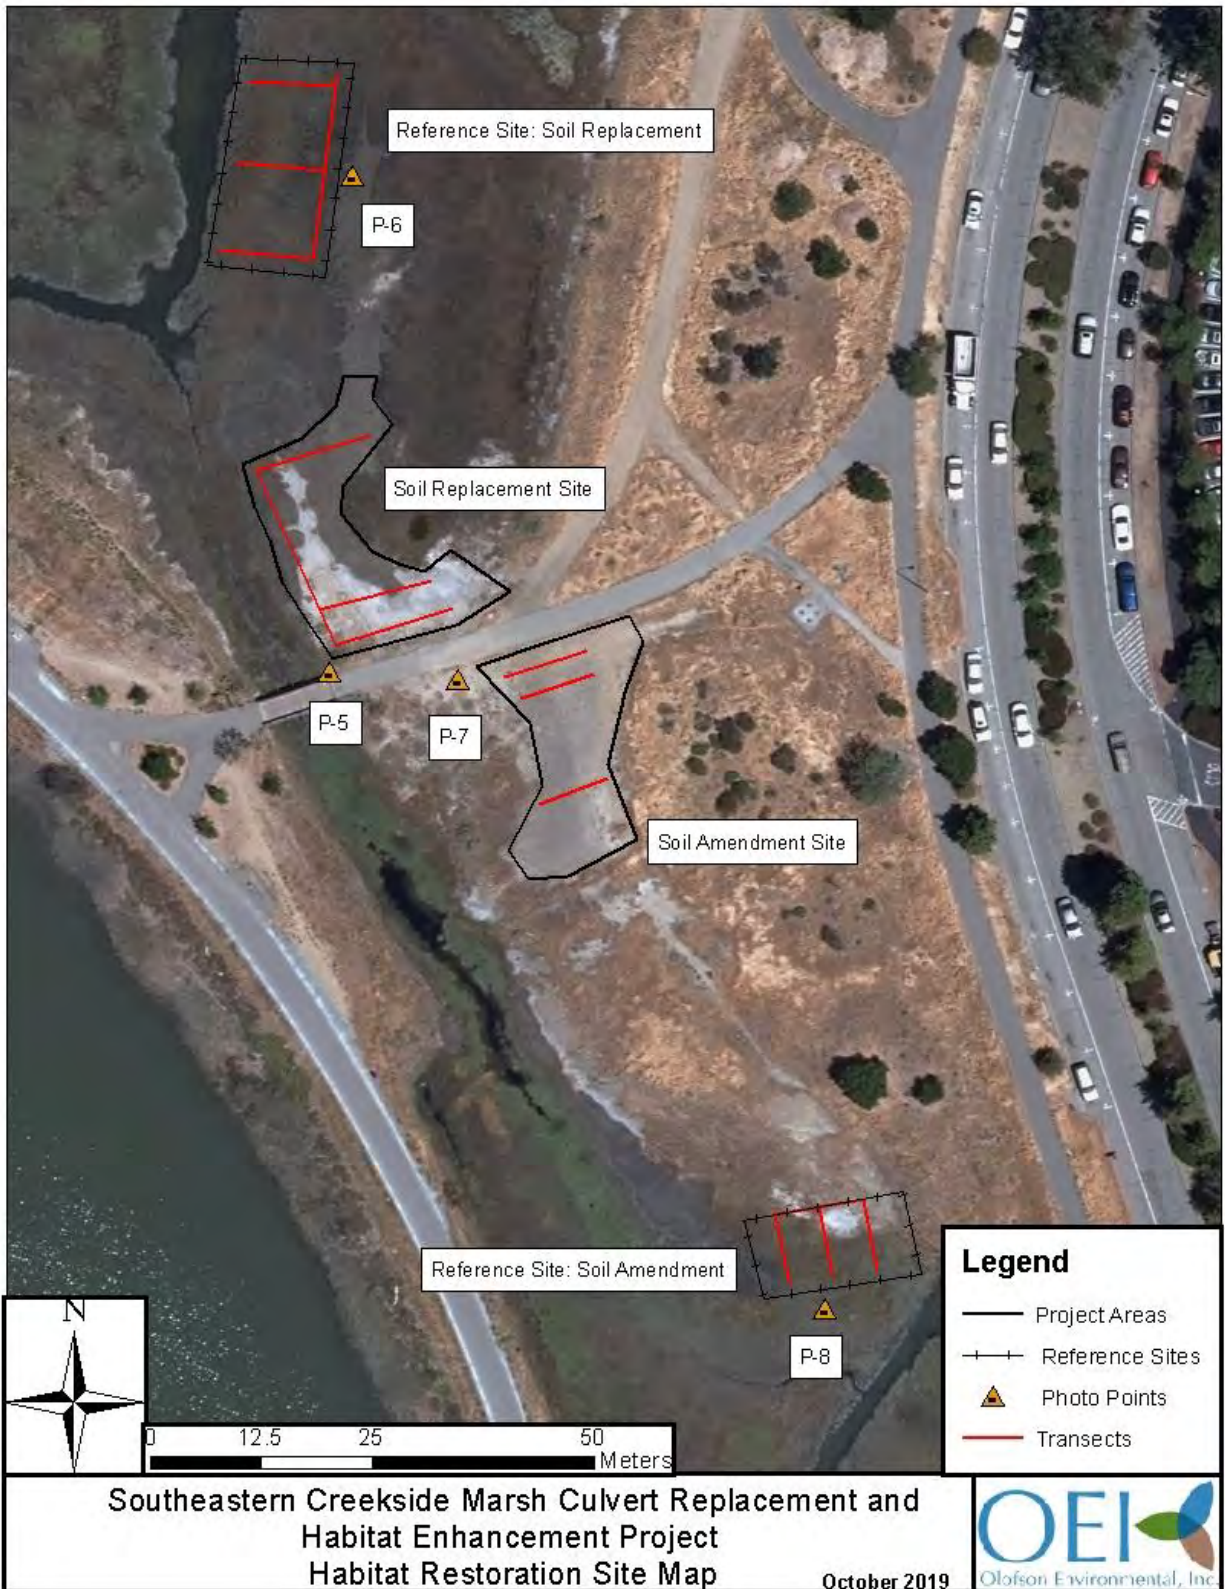
Figure 3. Habitat Restoration Site Map

In December 2017, the second component of the project was completed (**Figure 3**). An area of marsh approximately 8,290 square feet had compacted soil, unsuitable to support salt marsh vegetation. The top eight inches of soil was removed and replaced with Young Bay Mud. The mud was placed at the same elevation as the surrounding marsh. Due to the lack of available Young Bay Mud, only half of the proposed 8,290 square feet restoration site was treated in this way.

The soil replacement habitat restoration was evaluated using the point line intercept method (**Figure 3**). A primary transect of 30m was established and 3 secondary transects of 9m each were placed perpendicularly to it. The three 9m transects were sampled every half meter yielding 54 data points. A reference site was established north of the area at similar elevation to compare the percent cover of the restoration site.

The soil amendment habitat restoration was evaluated using the point line intercept method (**Figure 3**). Three 9m transects were established from low to high elevations and were sampled every half meter. A reference site was established south of the restoration area at a similar elevation.

The Year 3 success criterion of $\geq 30\%$ native vegetation cover was met at the soil replacement site (**Figure 3**). The site had a native vegetation cover of 73.5% compared to the adjacent reference site. Pickleweed had been planted by Friends of Corte Madera Creek Watershed in 2018 that helped boost percent cover of native species. The Young Bay Mud was become firmer and is at an elevation suitable for mid and upper elevation marsh plants to recruit.

Year 2 success criterion of $\geq 15\%$ native vegetation cover was met at the soil amendment site as well (**Figure 3**). The site had a native vegetation cover of 59.6% compared to a reference site. This area was actively planted and irrigated which has allowed plant survival to be approximately 60-70%.

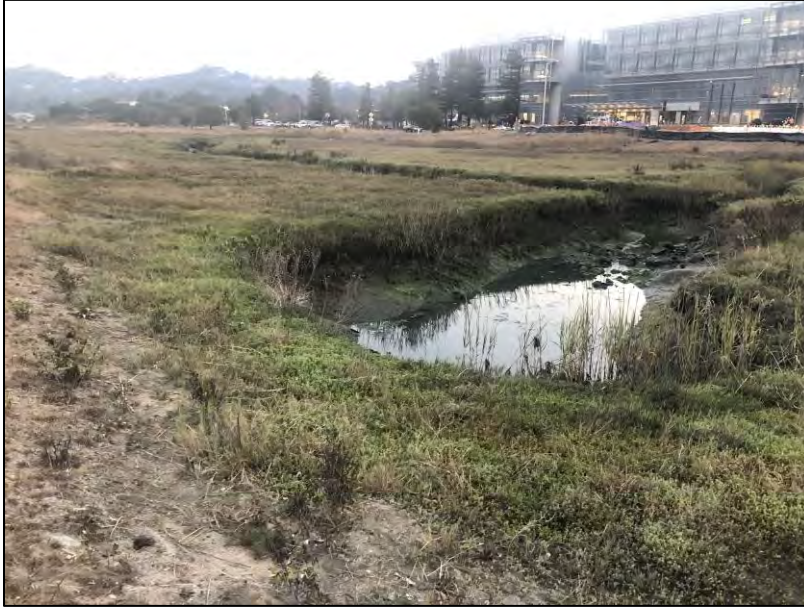
P-1. Project Site: Eastern Sampling Area

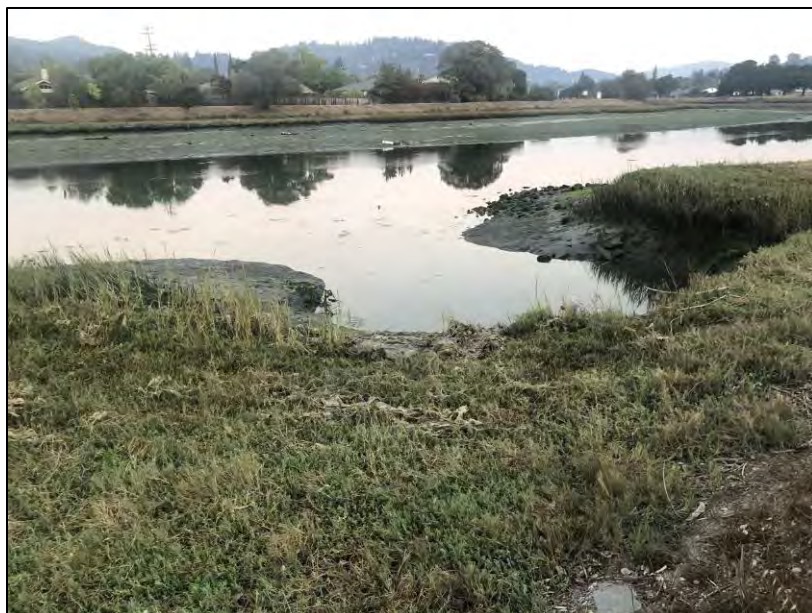
P-2. Project site: Western Sampling Area

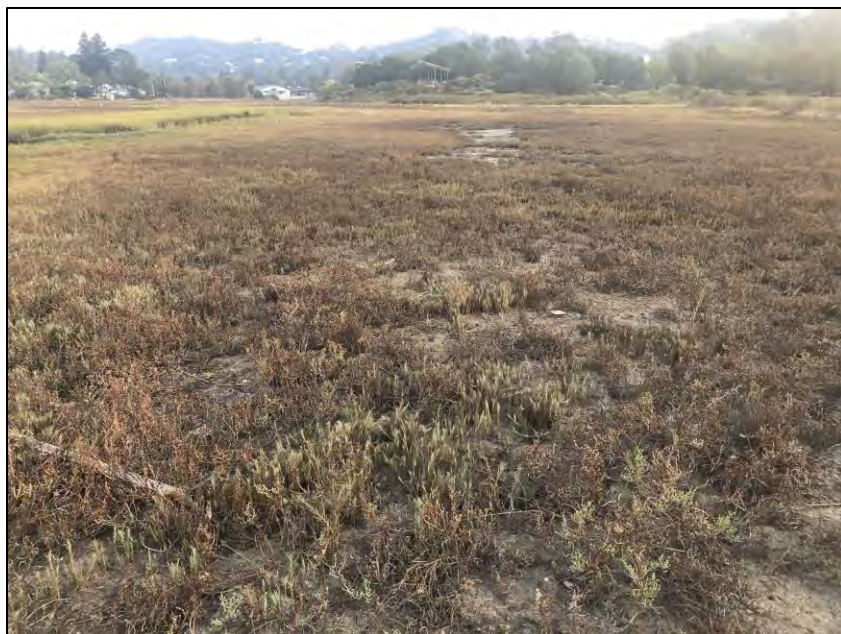
P-5. Project Site: Soil Replacement Site

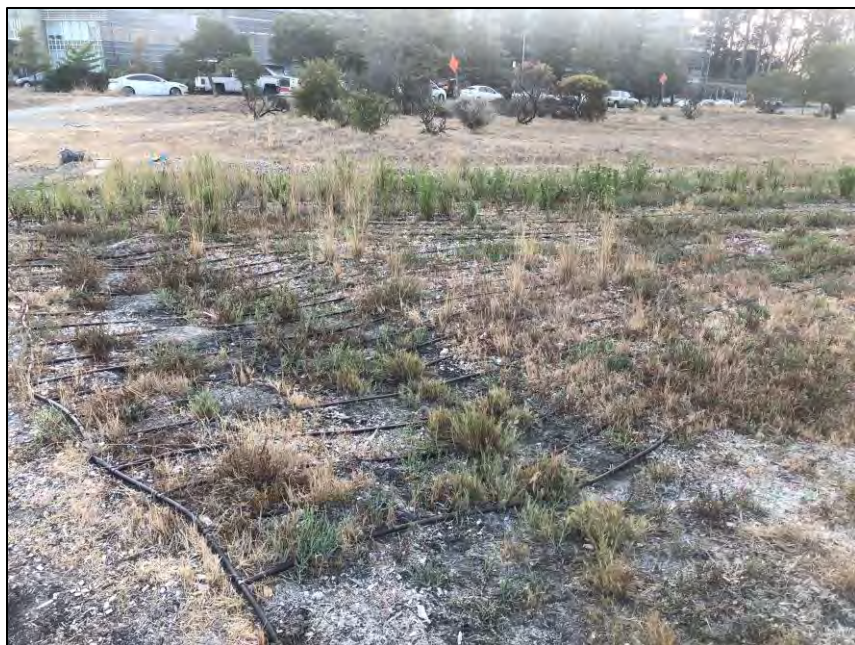
P-7. Project Site: Soil Amendment Site

OEI recommends hand removal of all *Plantago lanceolata* found in the soil amendment site. Removal will take place this fall by Friends of Corte Madera Creek Watershed.
