Annual Revegetation Monitoring Report for the Southeastern Creekside Marsh Culvert Replacement and Habitat Enhancement Project

2022 (YEAR 6)

Marin County Parks
February 2023

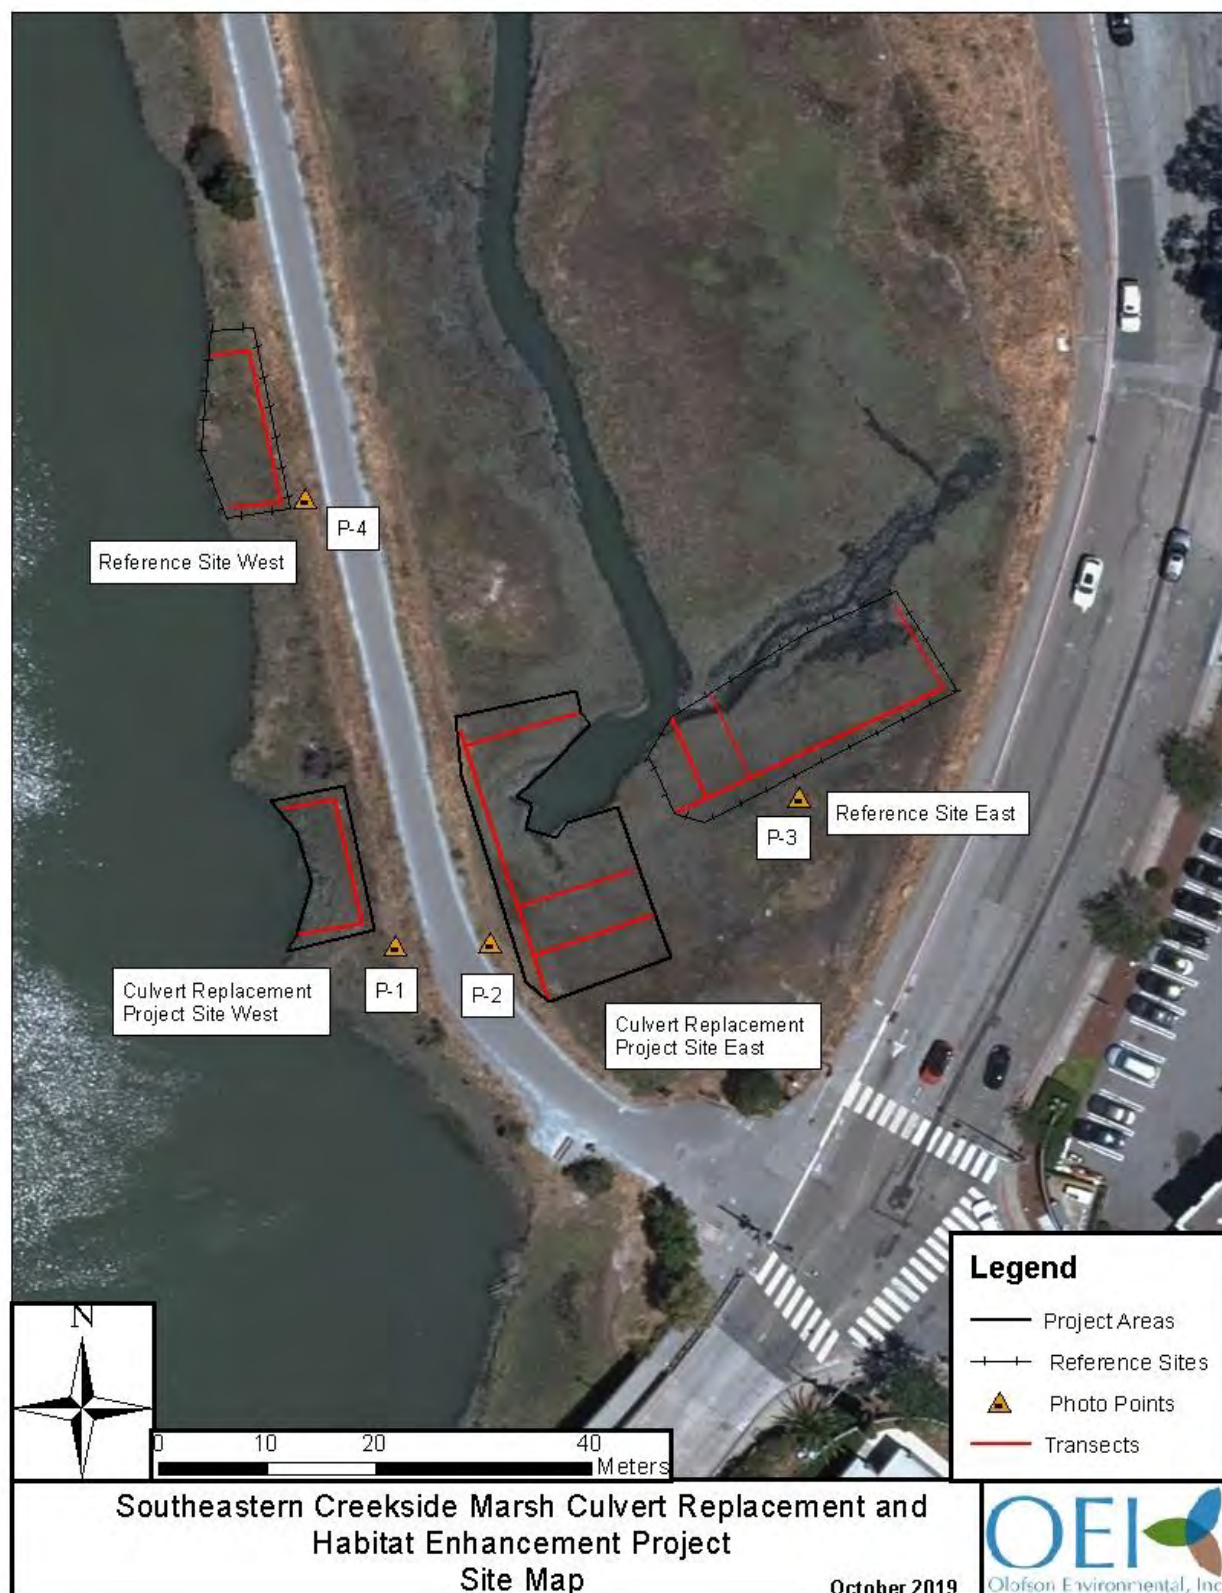
Figure 2. Culvert Replacement Project Site Map

A single bore culvert connecting Corte Madera Creek to the southern end of Creekside Marsh was removed and replaced with three new culvert pipes in 2016 (**Figure 2**). Construction included removing and storing the top layer of marsh vegetation within the construction area, placing coffer dams and relocating fish, excavating the berm between the creek and the marsh to remove the existing culvert, and placing three new 60-inch culverts in its place. In addition, the project closed a path north of the project area by placing soil in these areas as well as signs and fencing to discourage people from using the path.

The culvert replacement project area encompassed salt marsh habitats on both sides of the berm where construction occurred. Temporary impacts, including removal of salt marsh vegetation, occurred in 0.14 acre of estuarine wetland in Creekside Marsh and Corte Madera Creek.

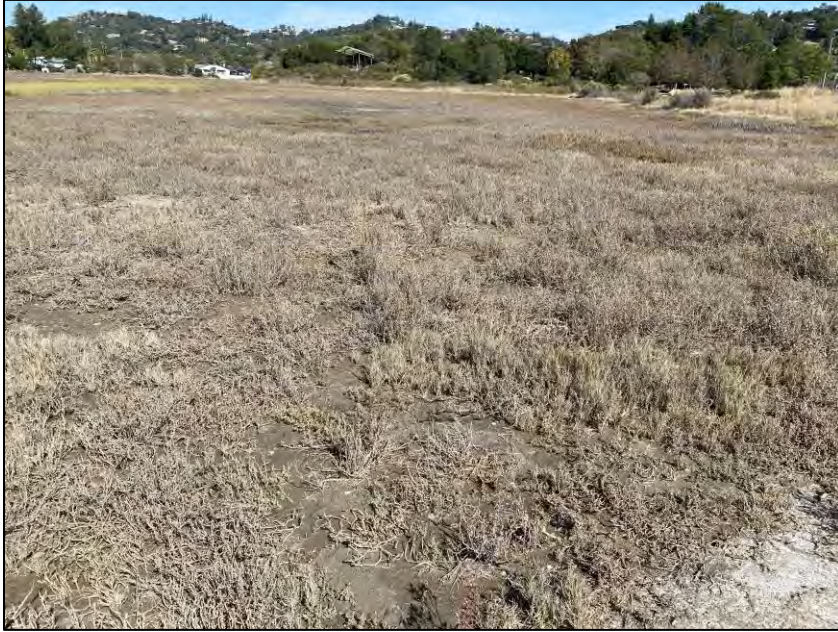
P-5. Project Site: Soil Replacement Site

Year 5 success criteria were achieved in Year 4 as shown below (**Table 2**). Percent cover compared to an adjacent reference site was not evaluated this year. The site was visually assessed to ensure that no major plant mortality occurred since success criteria were achieved. The soil replacement area appears to have plant cover equal to the surrounding marsh.

Plant survivorship was visually estimated where active plantings had taken place. Plant survivorship at the soil replacement site was above 90%. The soil replacement site is a mix of planted pickleweed and passive recruitment. These areas have intermixed with the surrounding marsh.

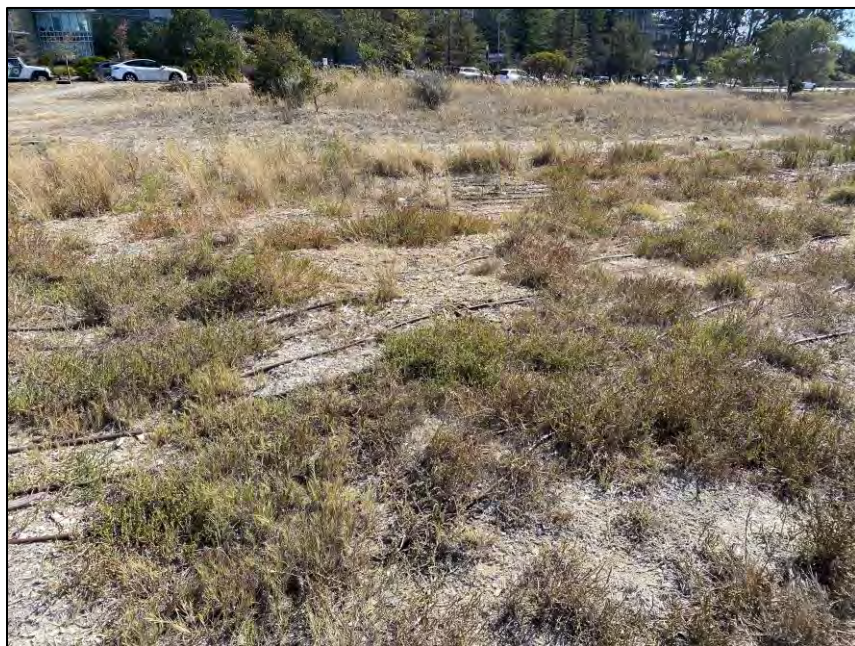
P-7. Project Site: Soil Amendment Site

Plant survivorship was visually estimated where active plantings had taken place. Plant survivorship at the soil amendment site was 70-80%.

Invasive species cover was greater than 5% in the soil amendment site. Invasive *Plantago lanceolata* was found invading the planted area. *Plantago lanceolata* had a percent cover of 8.3, down from 18.5 when compared to 2021. This species is found throughout the upland areas surrounding the site and grows well in disturbed soils.

OEI recommends a combination of hand removal and mulching to manage *Plantago lanceolata* within the soil amendment site. Removal will take place by Friends of Corte Madera Creek Watershed.
