FRIENDS OF
CORTE MADERA CREEK
WATERSHED

2017 and 2018 Water Quality Report

Corte Madera Creek Watershed

**Prepared by
Sandy Guldman
April 22, 2019**

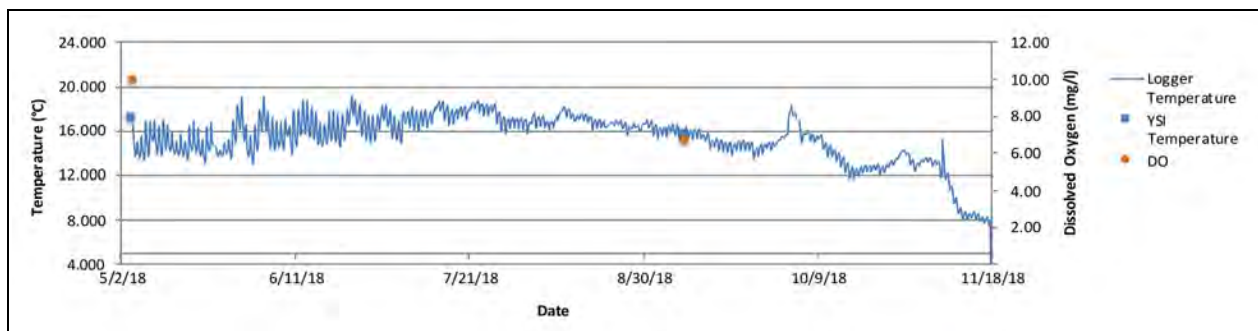
**Figure 17:** Temperature and DO in Fairfax Creek at Logger FX20 near Merwin Avenue in 2018

Fairfax Creek: At both logger locations (FX10 [Figure 13 and Figure 14] and FX20 [Figure 15 and Figure 16]), temperatures tended to be high for salmonids. Fairfax Creek has a culvert at its mouth that is a total barrier to salmonid passage. The barrier also causes major flooding in downtown Fairfax; treating both problems was identified in the Capital Improvement Program for the Ross Valley Watershed Program. Because the culvert is on Town of Fairfax property, treating the undersized culvert will depend on the Town of Fairfax initiating major efforts to obtain funding. There is a second dam, just downstream of 300 Olema Road. If both barriers to salmonid passage could be treated, then it would be prudent to work on adding riparian vegetation and structure to improve salmonid habitat.

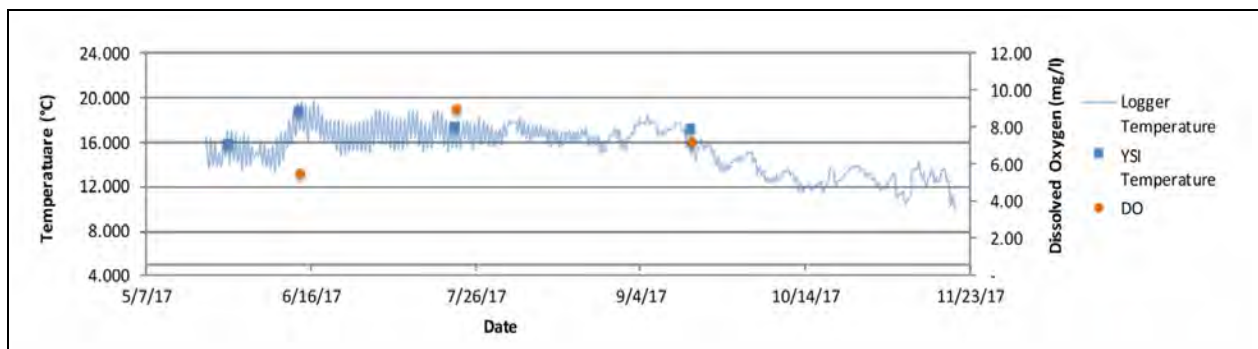
**Figure 18:** Temperature and DO in San Anselmo Creek near Deer Park Creek in 2017

Logger SA10 (Figure 16), located upstream of the confluence with Fairfax Creek, typically records fairly warm temperatures, but nighttime cooling provided some respite and the DO levels were adequate. At Lansdale (Figure 17 and Figure 18) there are significant groundwater inputs, demonstrated during construction of the pool-and-drop structure during summer 2012, when water poured into the excavated work area and a major dewatering effort was needed to complete construction.

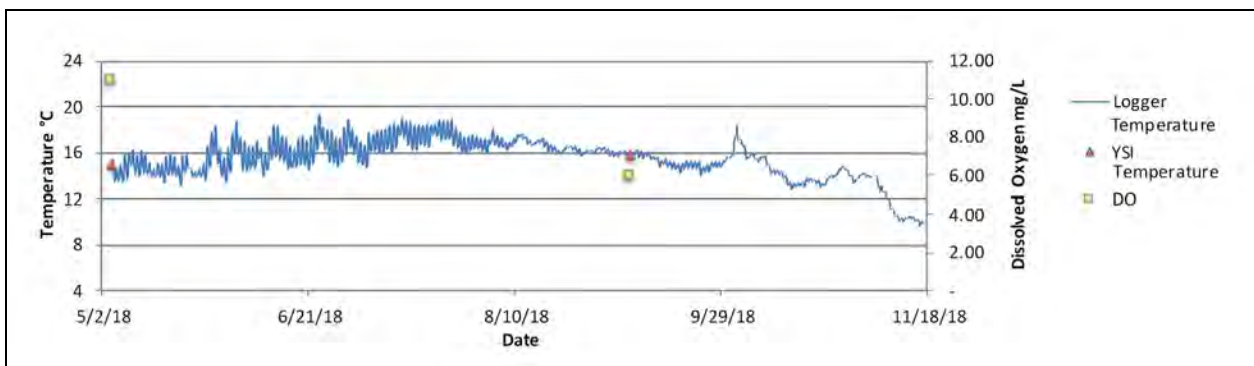
Figure 20: Temperature and DO in San Anselmo Creek near Lansdale in 2018

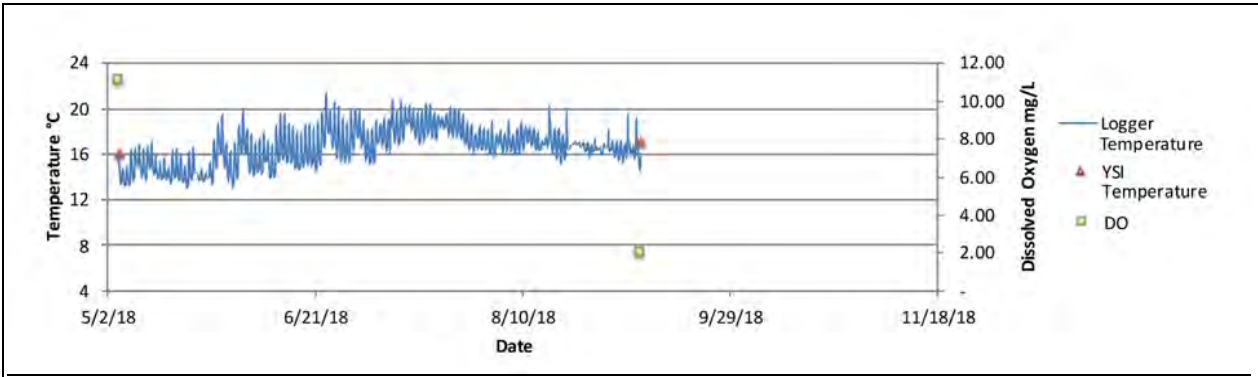
Figure 24: Temperature and DO in Sleepy Hollow Creek at Fire House in 2018

Sleepy Hollow Creek: Loggers in Sleepy Hollow Creek (SH10 [Figure 20 and Figure 21]) and SH20 at the Firehouse [Figure 22 and Figure 23]) show temperatures similar to those in Fairfax Creek. AAR also measured temperature in Sleepy Hollow Creek in 1999. The report (AAR 2000) states:
