2017 (YEAR 1)

# Annual Revegetation Monitoring Report for the Southeastern Creekside Marsh Culvert Replacement and Habitat Enhancement Project

Prepared by:  
Olofson Environmental Inc.

Submitted by:  
Marin County Parks  
December 2017

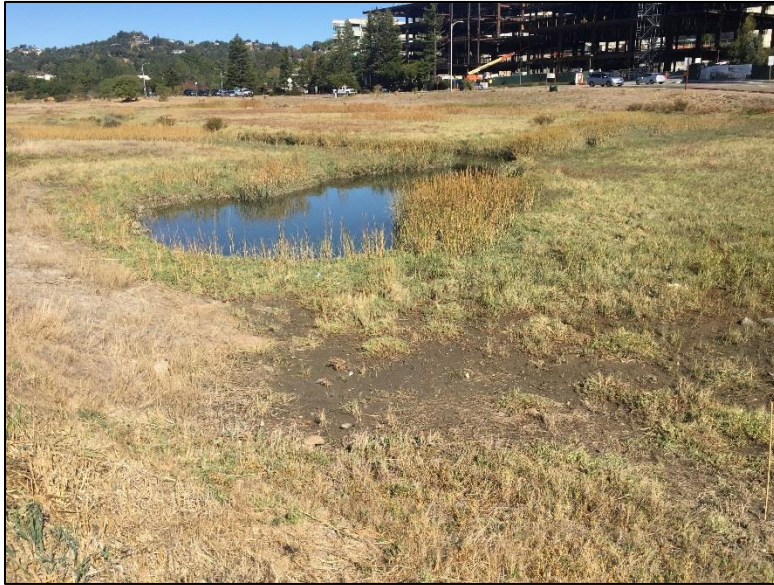
**P-1.** Project Site: Eastern Sampling Area

The Eastern Sampling Area had very high percent cover in a majority of the area, but had one patch of bare ground where passive recruitment is slow. This area was sparsely revegetated compared to the rest of the sampling site. Recruits are present here, but they are small and will require more time to achieve a high cover class.

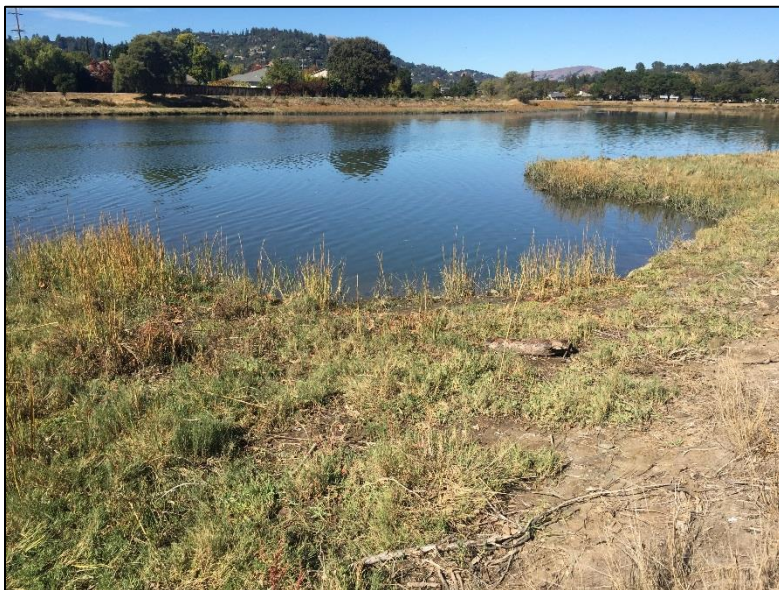
**P-2.** Project site: Western Sampling Area

The first-year success criterion of  $\geq 5\%$  native vegetation cover was met at both Western and Eastern Sampling Areas. The Western Sampling Area had a cover of 82%, meeting the Year 5 success criteria. The Eastern Sampling Area had a native species cover of 72.2%, meeting the Year 4 success criteria.
