Annual Revegetation Monitoring Report

for the Southeastern Creekside Marsh Culvert Replacement and
Habitat Enhancement Project

2020 (YEAR 4)

Marin County Parks
December 2020

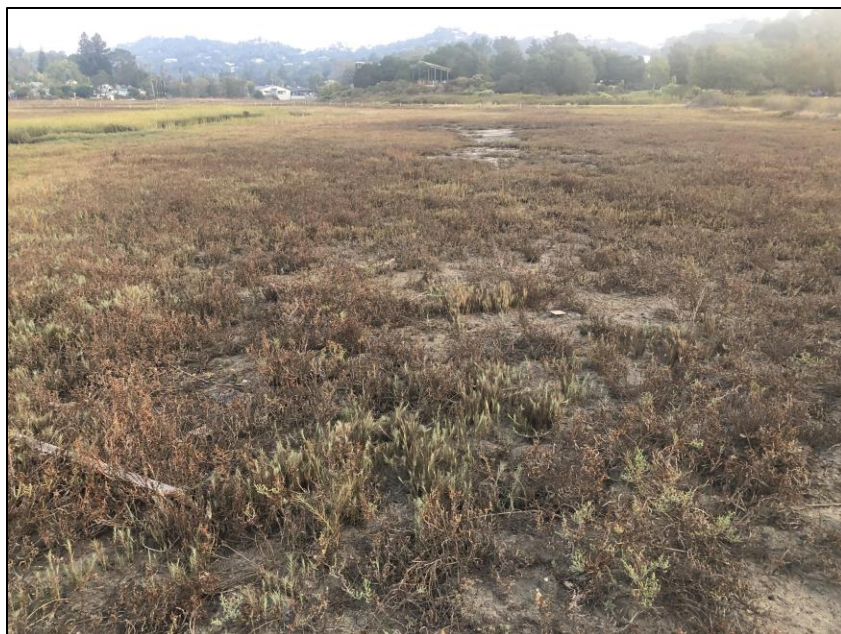
P-5. Project Site: Soil Replacement Site

Plant survivorship was visually estimated where active plantings had taken place. Plant survivorship at the soil replacement site was 80-90% The soil replacement site is a mix of planted pickleweed and passive recruitment. These areas have intermixed, and plant survival is high.

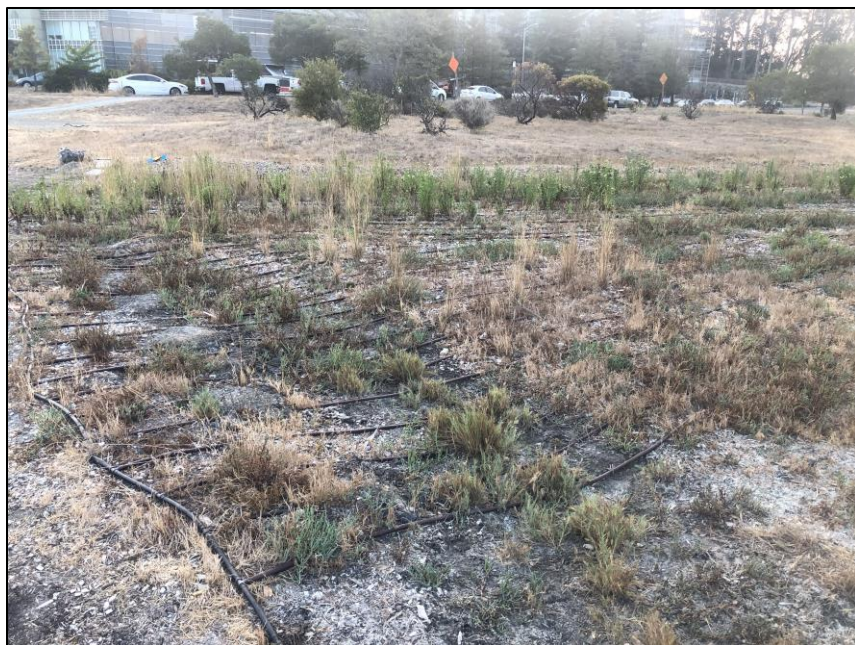
P-7. Project Site: Soil Amendment Site

Plantago lanceolata was found above the acceptable percent cover at the soil amendment site (**Table 10**). This species is found in areas adjacent to the restoration site and easily invades disturbed areas. This will be hand removed and monitored for treatment efficacy.

Plant survivorship was visually estimated where active plantings had taken place. Plant survivorship at the soil amendment site was 60-70%.

OEI recommends hand removal of all *Plantago lanceolata* found in the soil amendment site. Removal will take place this fall by Friends of Corte Madera Creek Watershed.
