# Annual Revegetation Monitoring Report

for the Southeastern Creekside Marsh Culvert Replacement and  
Habitat Enhancement Project

2021 (YEAR 5)

Marin County Parks  
December 2021

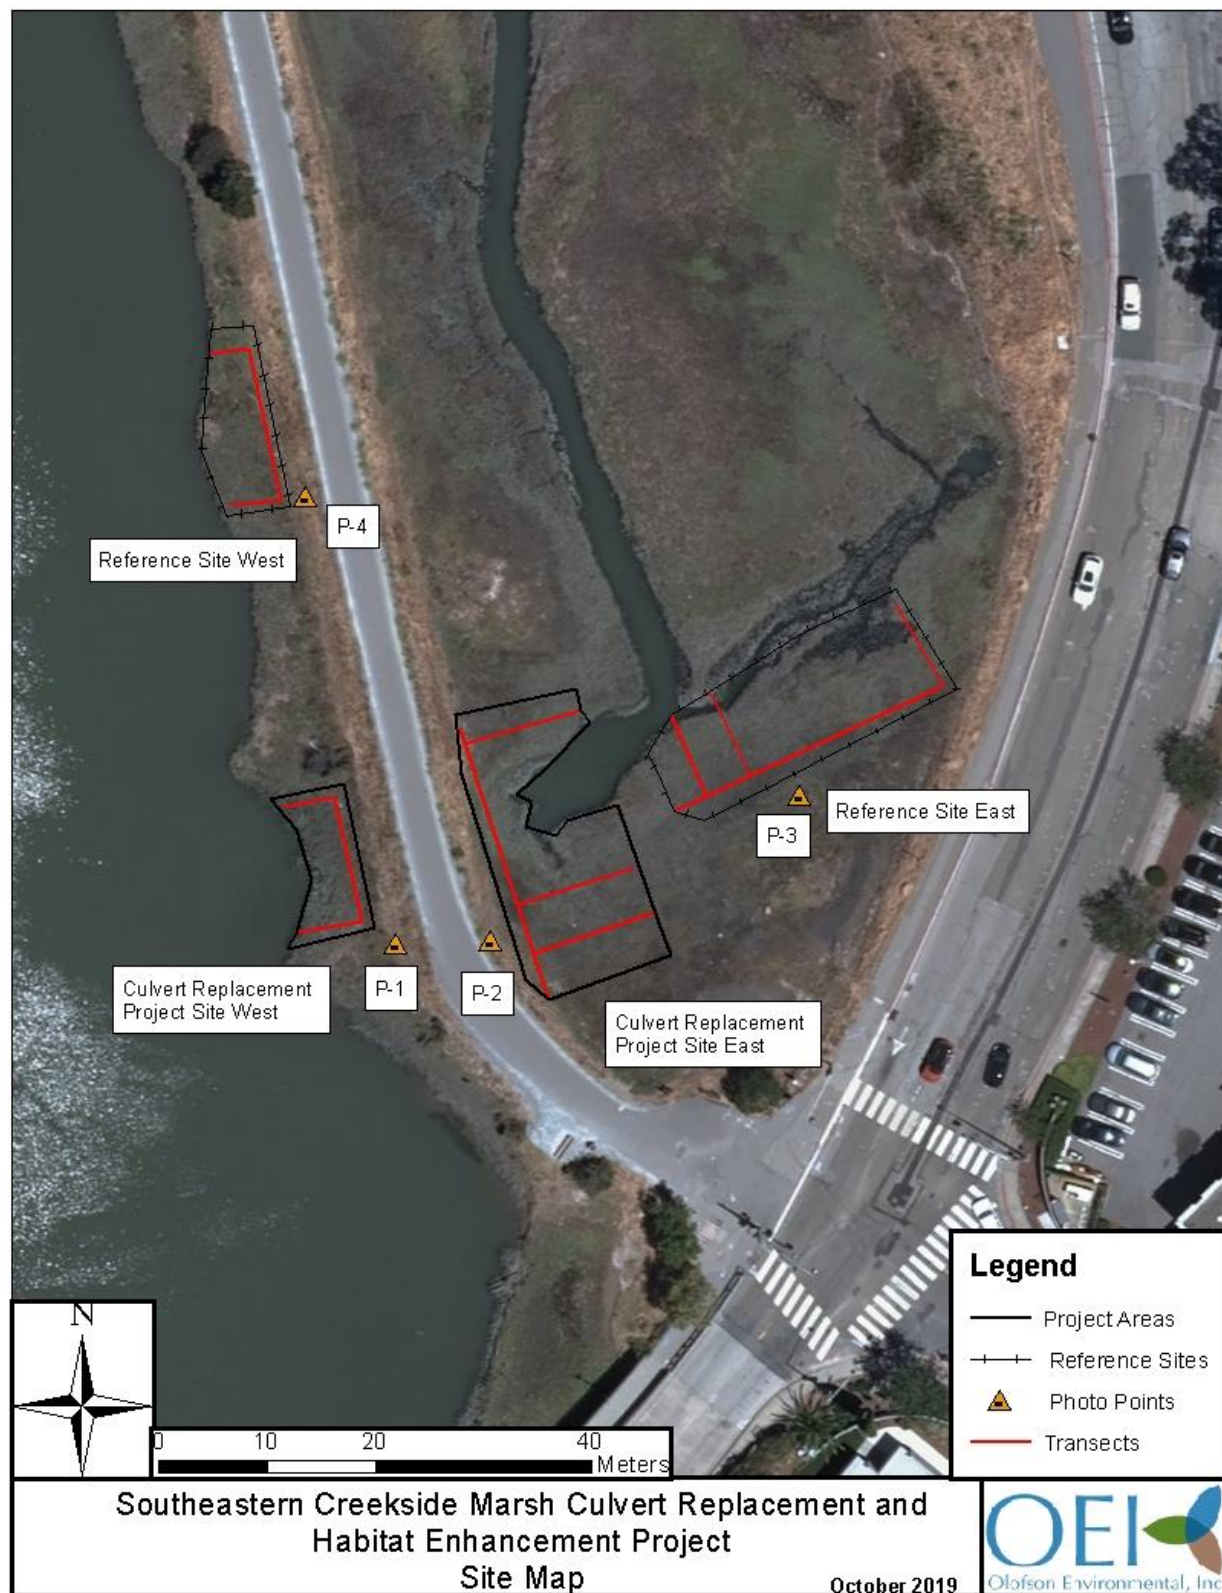
**Figure 2. Culvert Replacement Project Site Map**

A single bore culvert connecting Corte Madera Creek to the southern end of Creekside Marsh was removed and replaced with three new culvert pipes in 2016 (**Figure 2**). Construction included removing and storing the top layer of marsh vegetation within the construction area, placing coffer dams and relocating fish, excavating the berm between the creek and the marsh to remove the existing culvert, and placing three new 60-inch culverts in its place. In addition, the project closed a path north of the project area by placing soil in these areas as well as signs and fencing to discourage people from using the path.

The culvert replacement project area encompassed salt marsh habitats on both sides of the berm where construction occurred. Temporary impacts, including removal of salt marsh vegetation, occurred in 0.14 acre of estuarine wetland in Creekside Marsh and Corte Madera Creek.

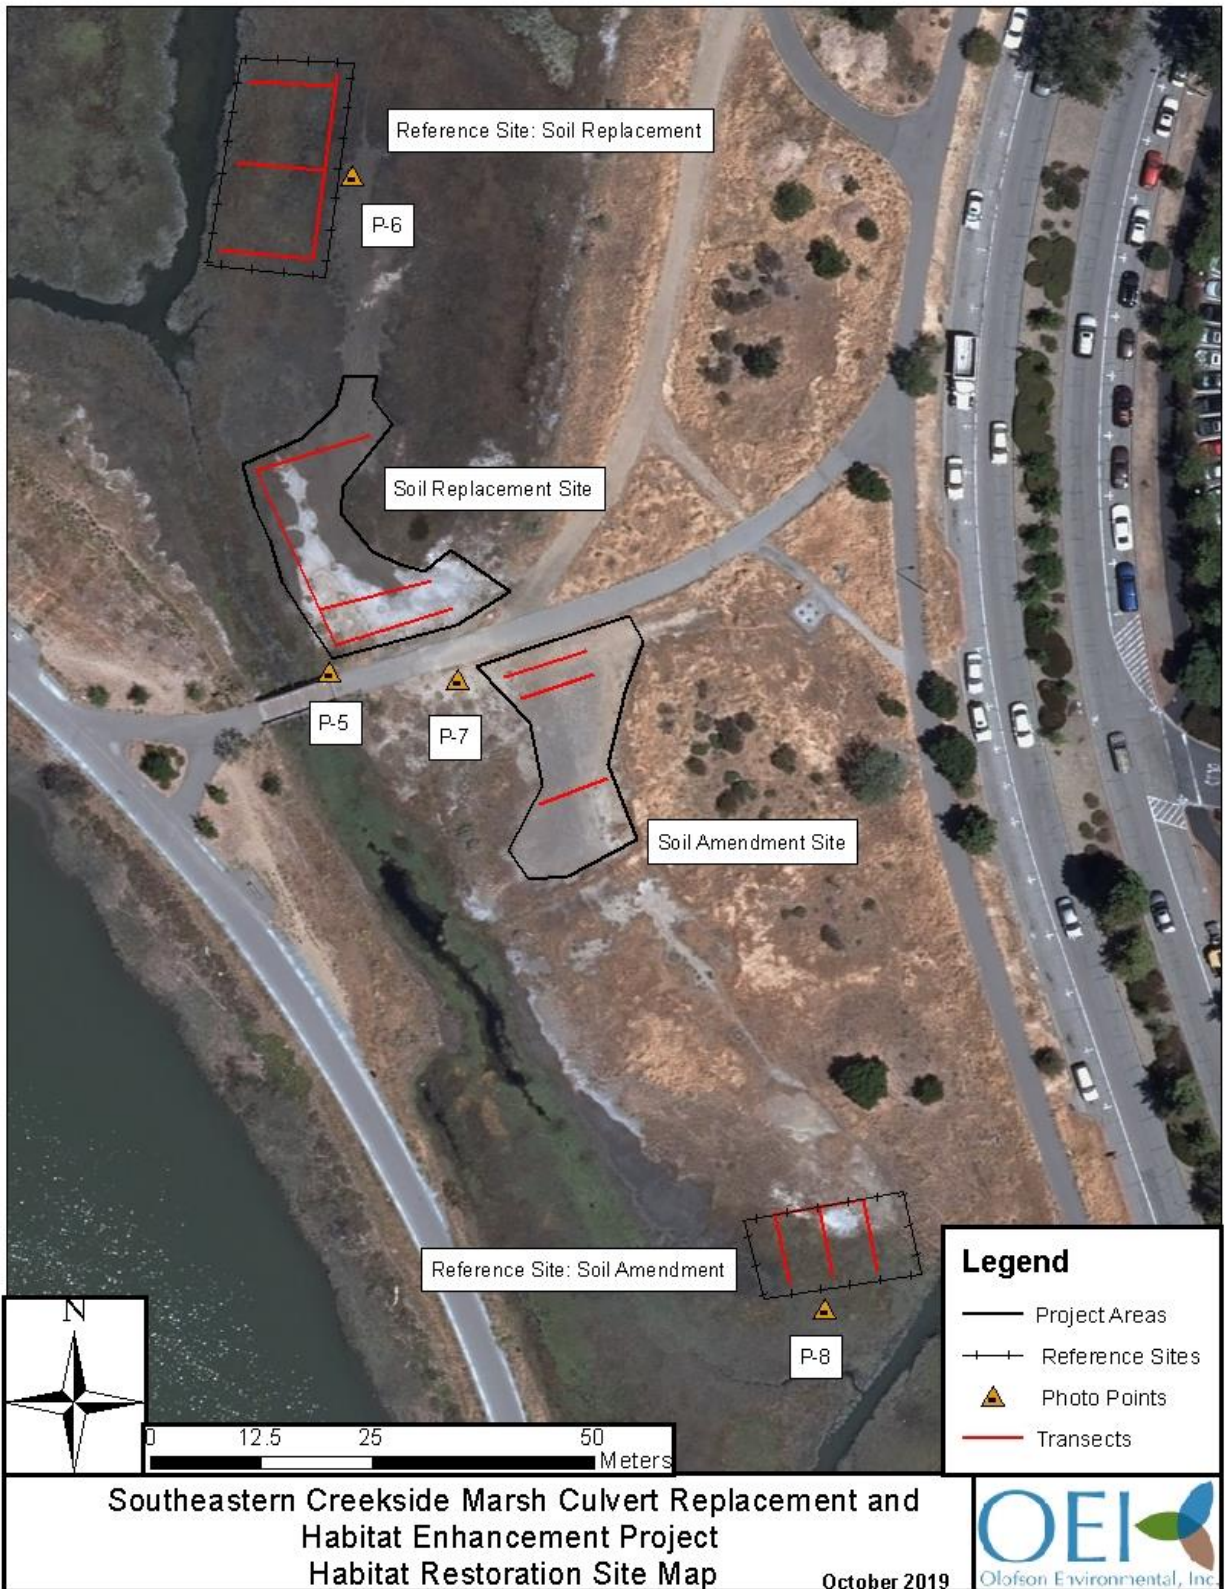
**Figure 3. Habitat Restoration Site Map**

Due to the shortage of Young Bay Mud for soil replacement, the specified habitat restoration area could not be achieved. To meet the area requirement, the soil at the remaining 0.1 acre was enhanced with soil amendments to support active planting. First, large rocks were removed from the existing soil. Then, gypsum and composted green waste were added to the soil and native plants were planted in January 2019 (**Figure 3**).

The soil replacement habitat restoration was evaluated using the point line intercept method (**Figure 3**). A primary transect of 30m was established and 3 secondary transects of 9m each were placed perpendicularly to it. The three 9m transects were sampled every half meter yielding 54 data points. A reference site was established north of the area at similar elevation to compare the percent cover of the restoration site.

The soil amendment habitat restoration was evaluated using the point line intercept method (**Figure 3**). Three 9m transects were established from low to high elevations and were sampled every half meter. A reference site was established south of the restoration area at a similar elevation.

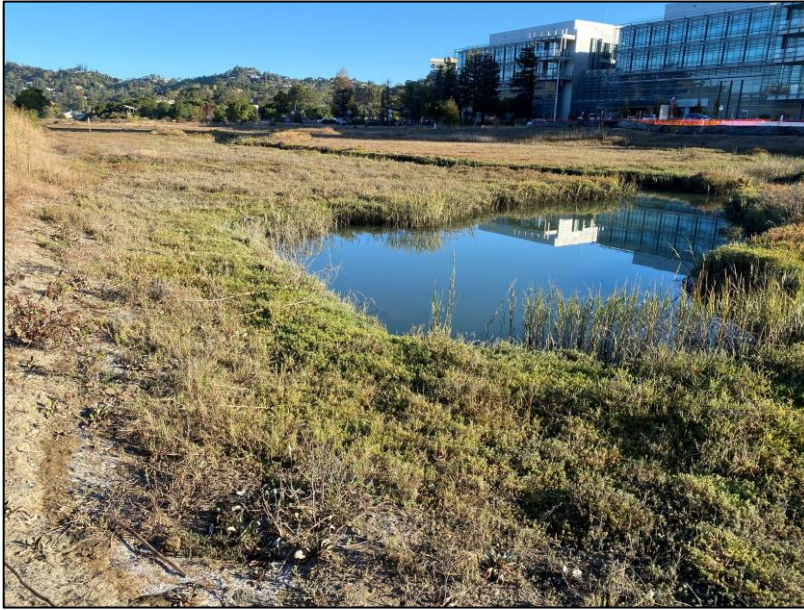
**P-1.** Project Site: Eastern Sampling Area

Plant survivorship was visually monitored at the culvert replacement site. Plant survivorship was above 90%, and the plantings have completely intermixed with the surrounding marsh.

Photo points were recorded at the culvert replacement project site to monitor the success of the plantings (**Appendix A**).

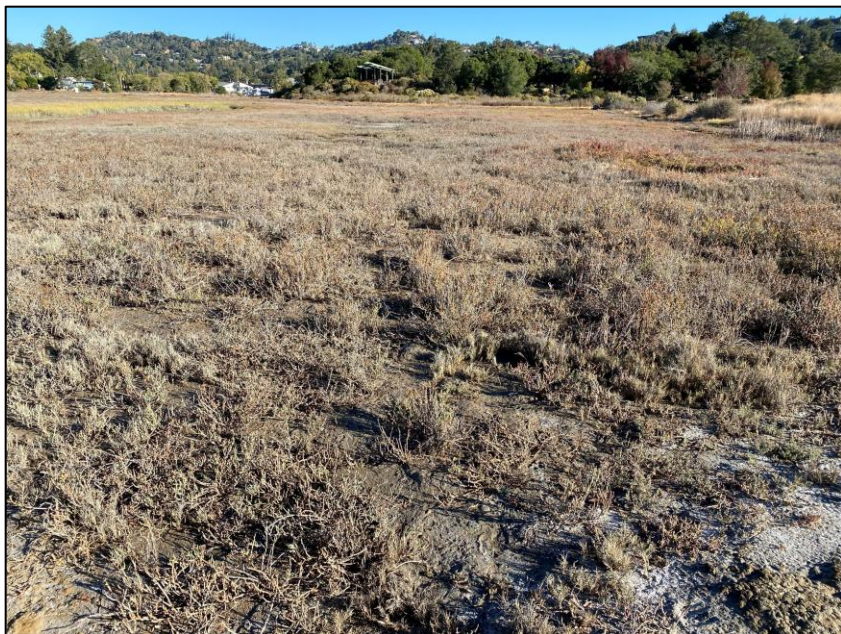
**P-5.** Project Site: Soil Replacement Site

Plant survivorship was visually estimated where active plantings had taken place. Plant survivorship at the soil replacement site was 80-90% The soil replacement site is a mix of planted pickleweed and passive recruitment. These areas have intermixed, and plant survival is high.

Photo points were recorded at the soil replacement project area to monitor the success of the plantings (**Appendix A**).

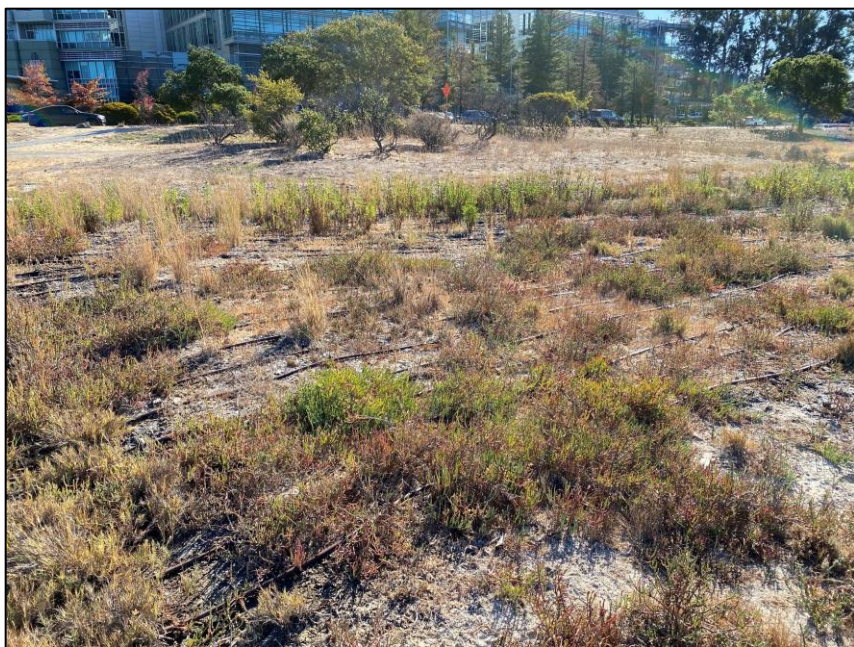
**P-7.** Project Site: Soil Amendment Site

*Plantago lanceolata* was found above the acceptable percent cover at the soil amendment site (**Table 10**). This species is found in areas adjacent to the restoration site and easily invades disturbed areas. The absolute cover of this species increased by 1.5% compared to 2020.

Invasive species cover was greater than 5% in the soil amendment site. Invasive *Plantago lanceolata* was found invading the planted area. This species is found throughout the upland areas surrounding the site and grows well in disturbed soils. The University of California Cooperative Extension's Weed Research & Information Center suggests hand pulling as an effective method for controlling this species. Removal of this species is recommended immediately as well as follow up monitoring that will be conducted quarterly by OEI biologists.

OEI recommends hand removal of all *Plantago lanceolata* found in the soil amendment site. Removal will take place by Friends of Corte Madera Creek Watershed.
