Annual Revegetation Monitoring Report

for the Southeastern Creekside Marsh Culvert Replacement and
Habitat Enhancement Project

2022 (YEAR 6)

Marin County Parks
February 2023

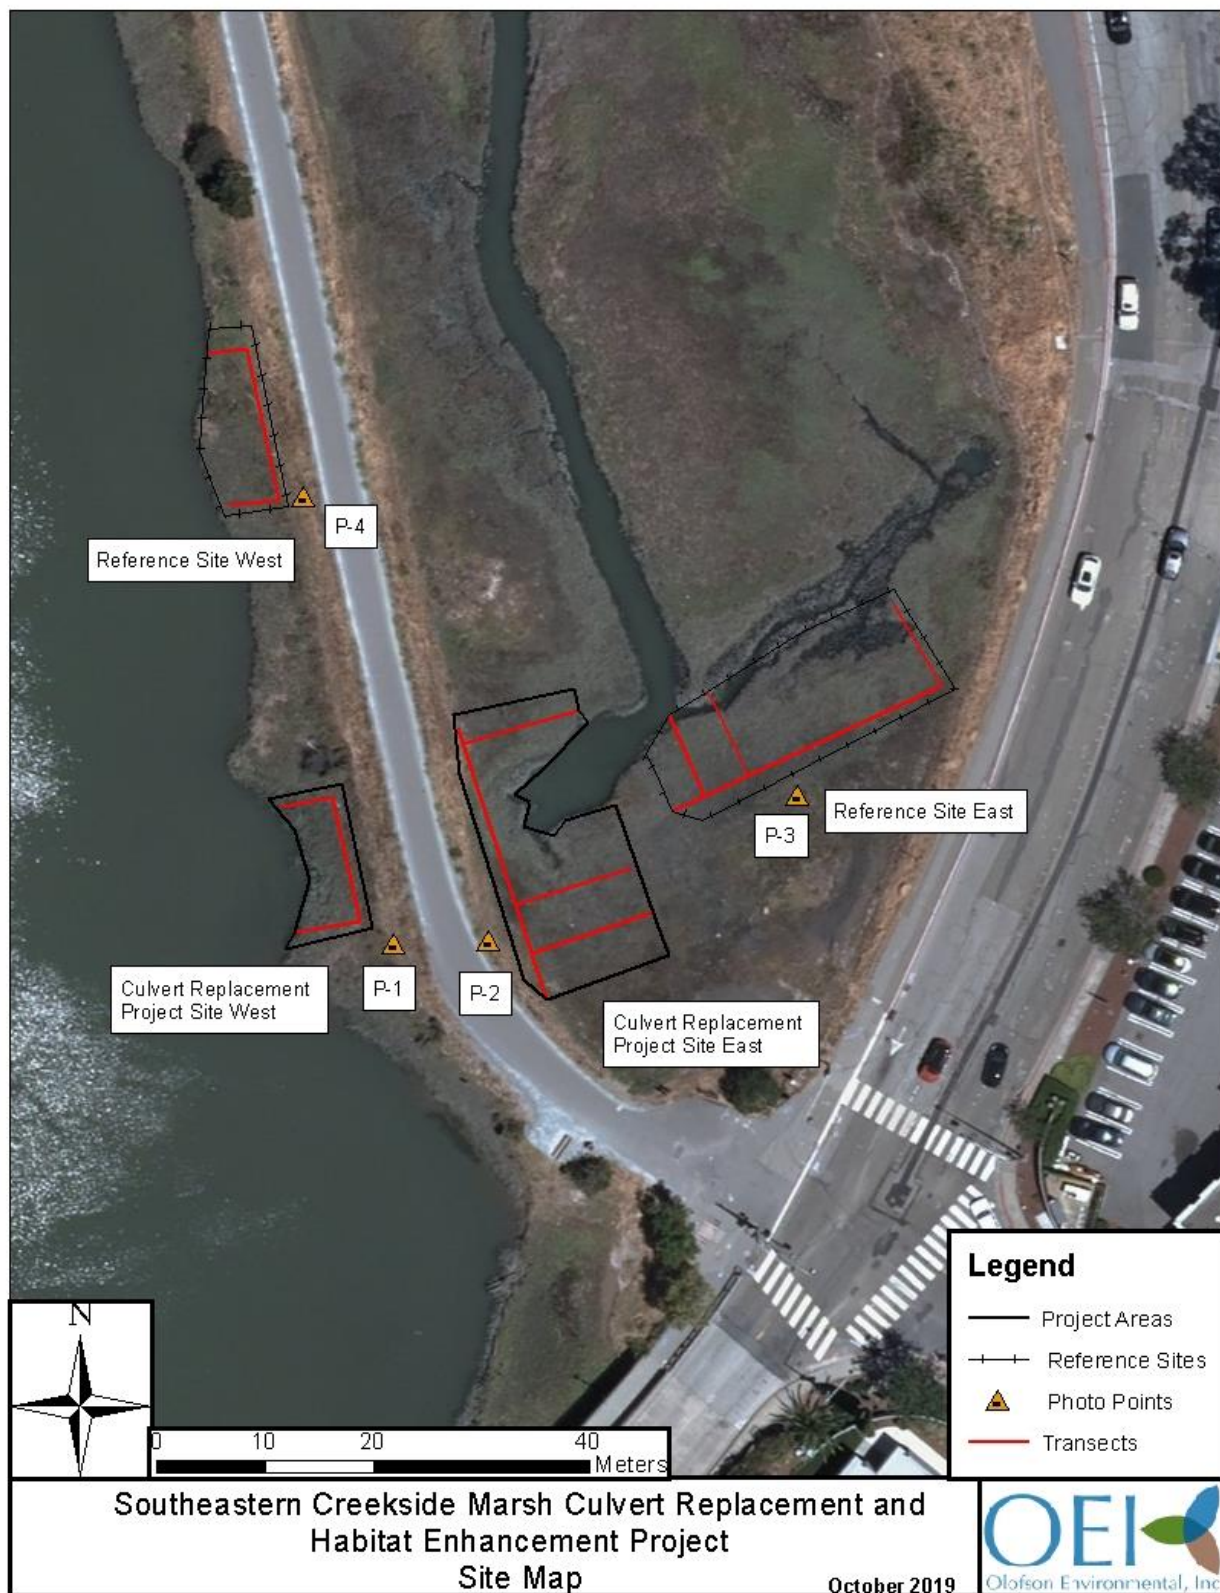
Figure 2. Culvert Replacement Project Site Map

A single bore culvert connecting Corte Madera Creek to the southern end of Creekside Marsh was removed and replaced with three new culvert pipes in 2016 (**Figure 2**). Construction included removing and storing the top layer of marsh vegetation within the construction area, placing coffer dams and relocating fish, excavating the berm between the creek and the marsh to remove the existing culvert, and placing three new 60-inch culverts in its place. In addition, the project closed a path north of the project area by placing soil in these areas as well as signs and fencing to discourage people from using the path.

The culvert replacement project area encompassed salt marsh habitats on both sides of the berm where construction occurred. Temporary impacts, including removal of salt marsh vegetation, occurred in 0.14 acre of estuarine wetland in Creekside Marsh and Corte Madera Creek.

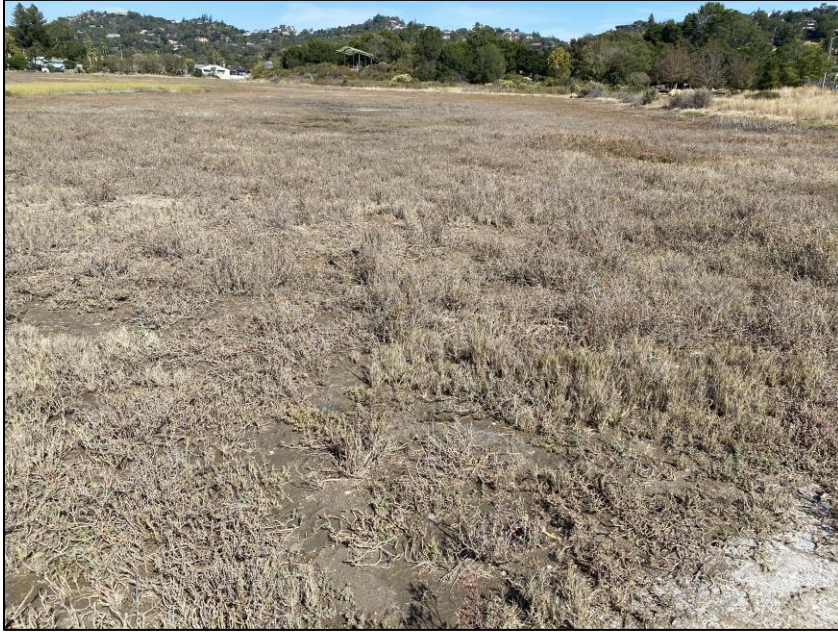
P-5. Project Site: Soil Replacement Site

Plant survivorship was visually estimated where active plantings had taken place. Plant survivorship at the soil replacement site was above 90%. The soil replacement site is a mix of planted pickleweed and passive recruitment. These areas have intermixed with the surrounding marsh.

The soil replacement area (**Figure 3**) was visually monitored to ensure that the percent cover of salt marsh species still met the Year 5 success criteria. The plantings continue to be successful and net cover appeared similar to the surrounding marsh. This concludes the fifth year of monitoring for this site.

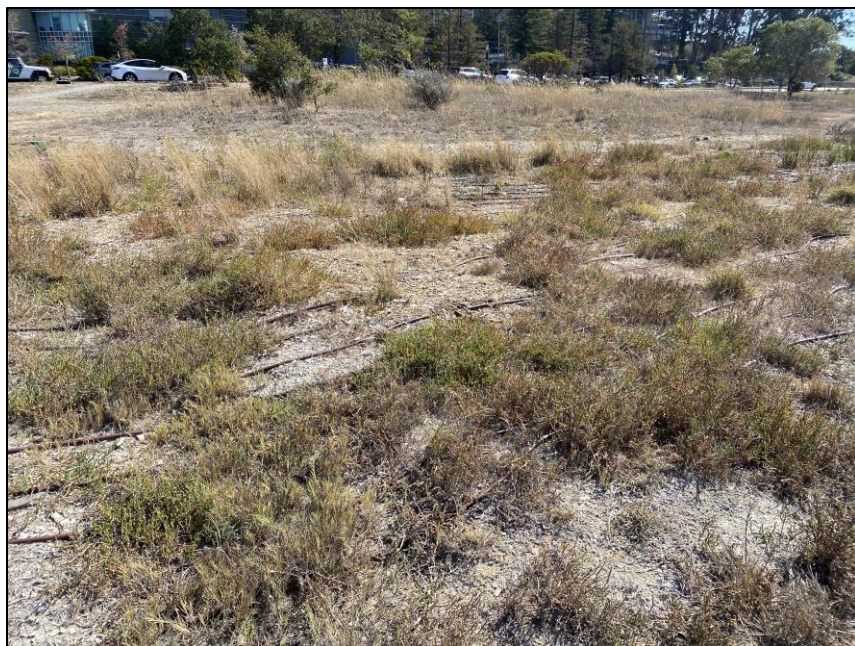
P-7. Project Site: Soil Amendment Site

Plant survivorship was visually estimated where active plantings had taken place. Plant survivorship at the soil amendment site was 70-80%.

Invasive species cover was greater than 5% in the soil amendment site. Invasive *Plantago lanceolata* was found invading the planted area. *Plantago lanceolata* had a percent cover of 8.3, down from 18.5 when compared to 2021. This species is found throughout the upland areas surrounding the site and grows well in disturbed soils.

OEI recommends a combination of hand removal and mulching to manage *Plantago lanceolata* within the soil amendment site. Removal will take place by Friends of Corte Madera Creek Watershed.
