**CATALOG OF STREAM CROSSINGS WITH CULVERTS AND
OTHER MANMADE IMPEDIMENTS TO FISH PASSAGE
LOCATED ON ANADROMOUS STREAM REACHES WITHIN
ROSS CREEK, CORTE MADERA CREEK WATERSHED,
MARIN COUNTY, CA.**

Prepared for Friends of the Corte Madera Creek Watershed

**By
Ross Taylor and Associates**

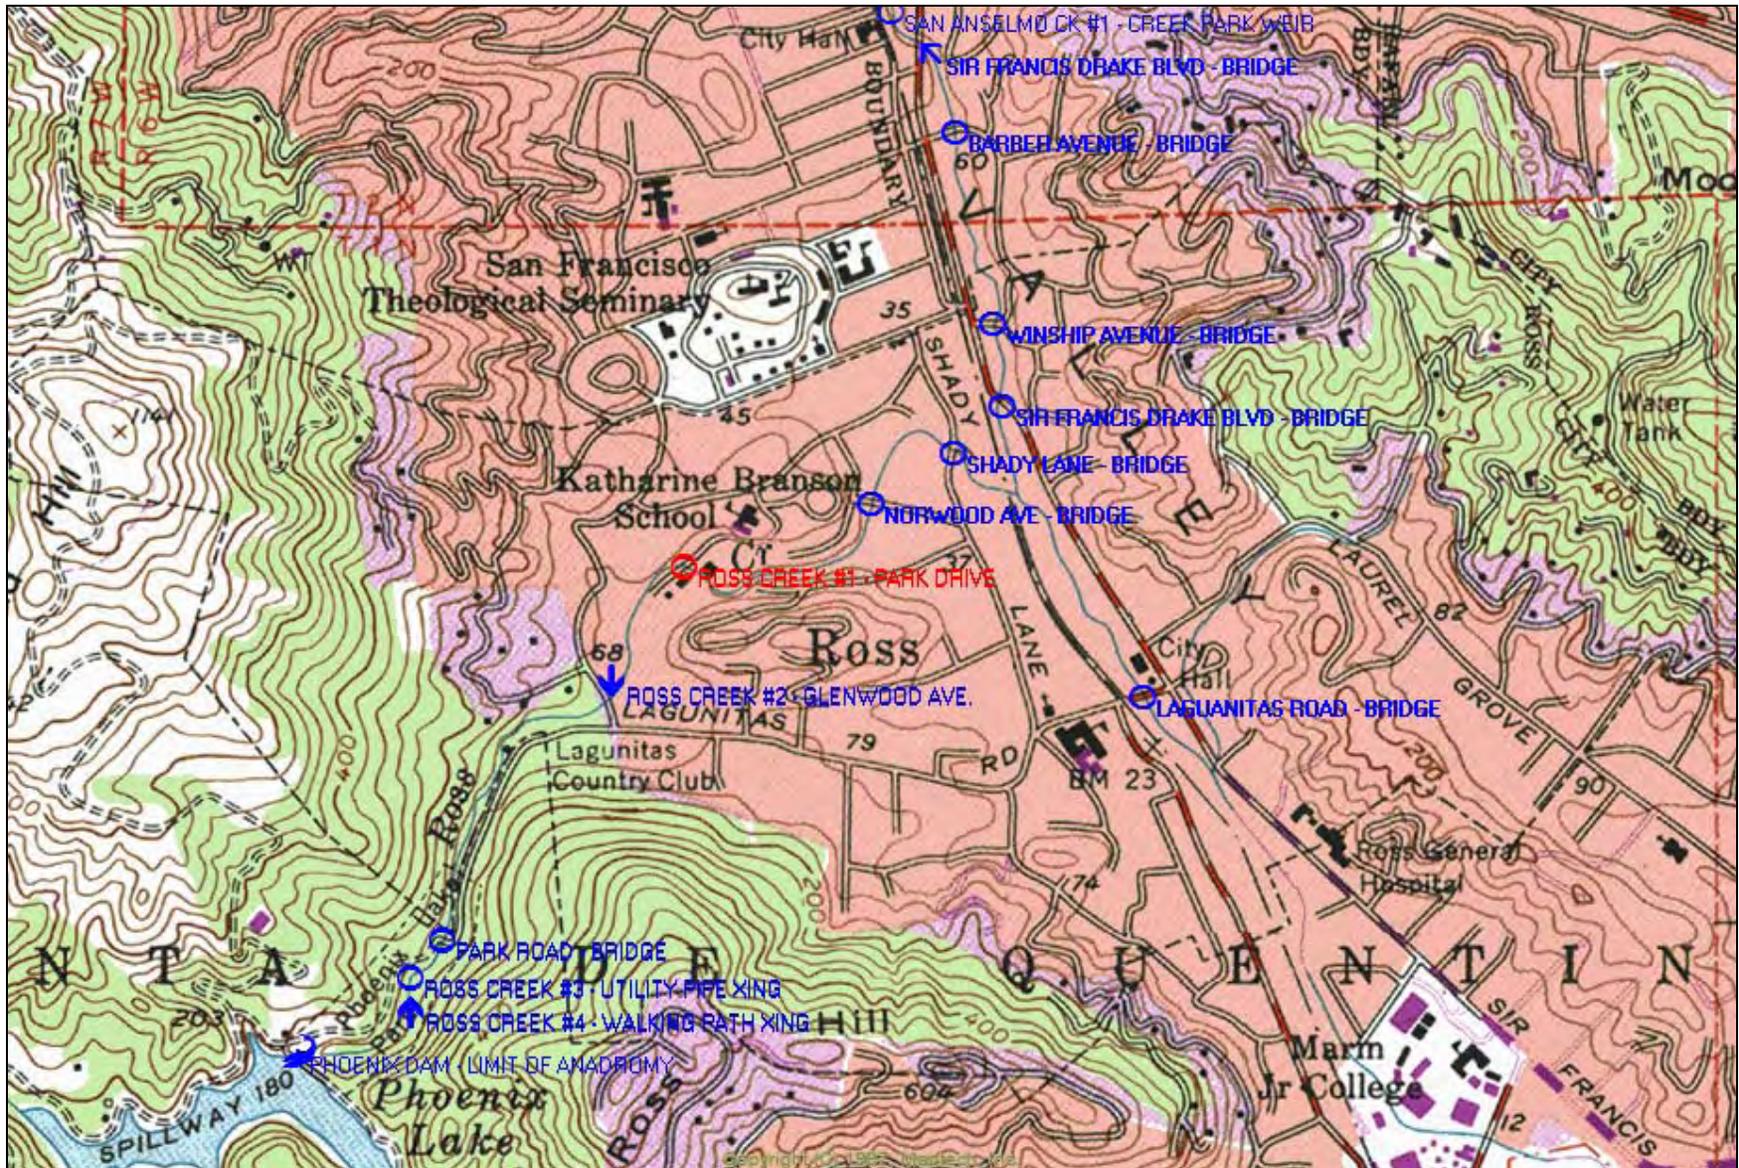
Site ID# R-01: Ross Creek #1/Park Drive; Corte Madera Creek

Dimensions: 14.0' rise x 16.2' span **Length:** Culvert = 18.0'; Inlet apron = 21.3'; Outlet apron = 6.3'. **Slope:** inlet apron = 4.37%; inlet to outlet = -0.33%; outlet apron = 31.58%.

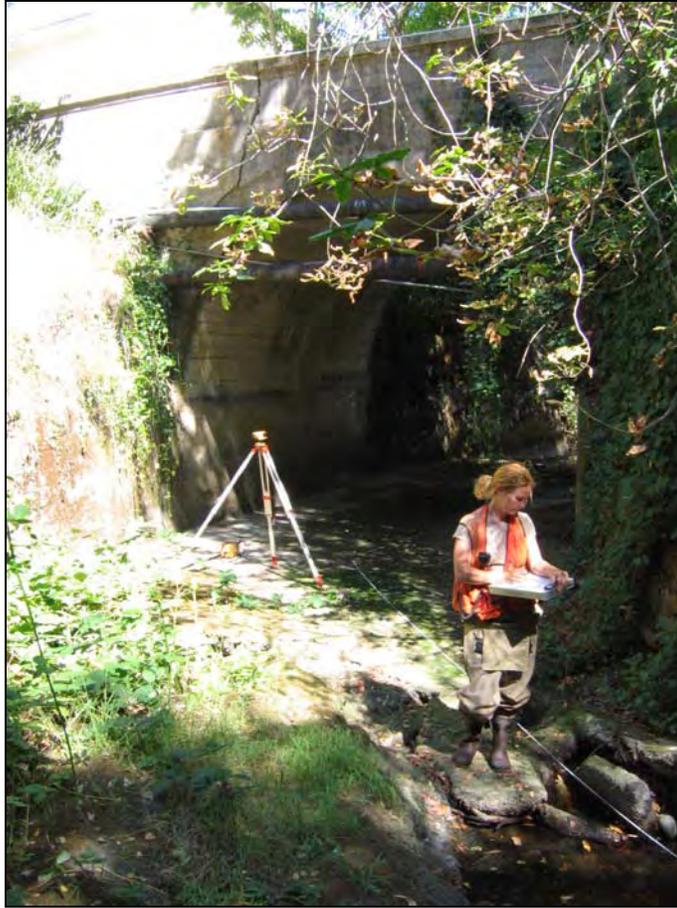
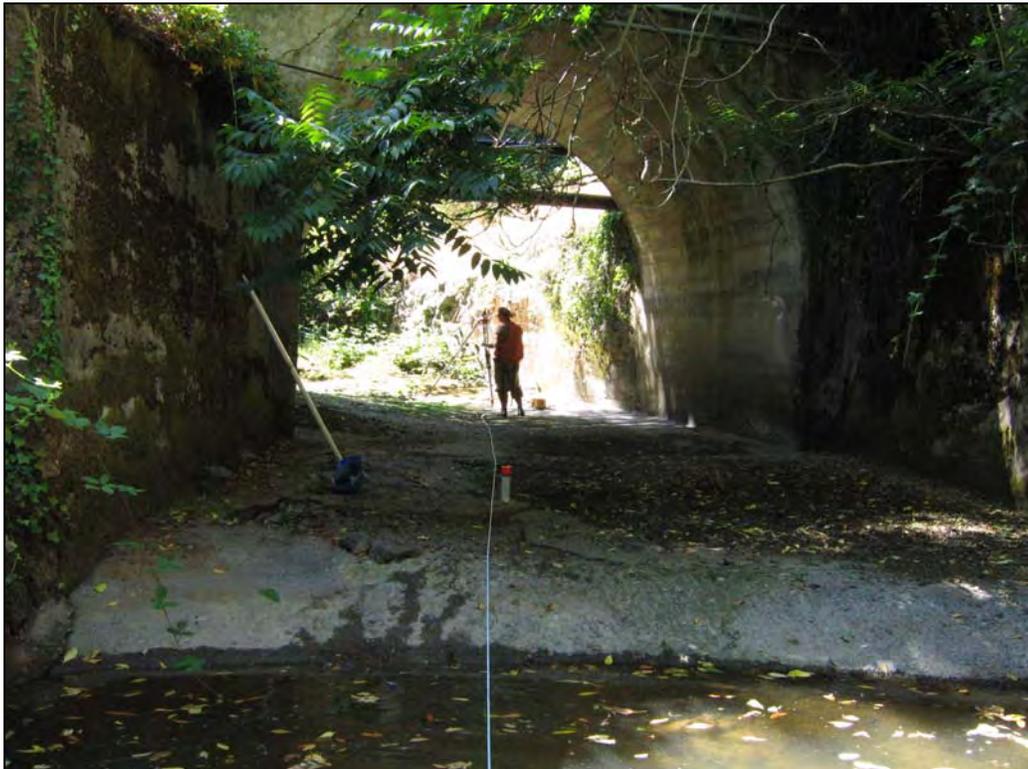
Site ID# R-01: Ross Creek #1/Park Drive; Corte Madera Creek

Crossing Type: Arch culvert w/inlet and outlet aprons, Concrete. **Corrugations:** None.

Fill Estimate: Not estimated because of bridge-like construction of crossing. **Overall Condition:** Extremely poor – extensive cracks in concrete throughout crossing. **Sizing:** Properly Sized; HW/D = 1 on a storm flow with more than a 100-year recurrence interval.

Drainage Area Upstream of Crossing: 2.81 square miles. **Estimated Migration Flows:** adults = 3.0–78.3 c.f.s., resident/2+ = 2.0–20.3 c.f.s., 1+/y-o-y = 1.0–8.8 c.f.s. **Passage Evaluation:** **RED:** as determined by the first-phase filter due to slope >3%; however FishXing was run for adult anadromous salmonids and the model suggested the crossing met the 8-16-16 ft/sec and 0.5ft minimum depth criteria for 10% of the range of estimated migration flow (71.0 – 78.0 c.f.s.). Main violation was lack-of-depth; however the steep break-in-slope over the outlet apron was not modeled in FishXing.

Preferred Treatment: Recommend having a qualified engineer assess the structural condition of the crossing. Recommend replacement with a properly sized open-bottom arch or a bridge.

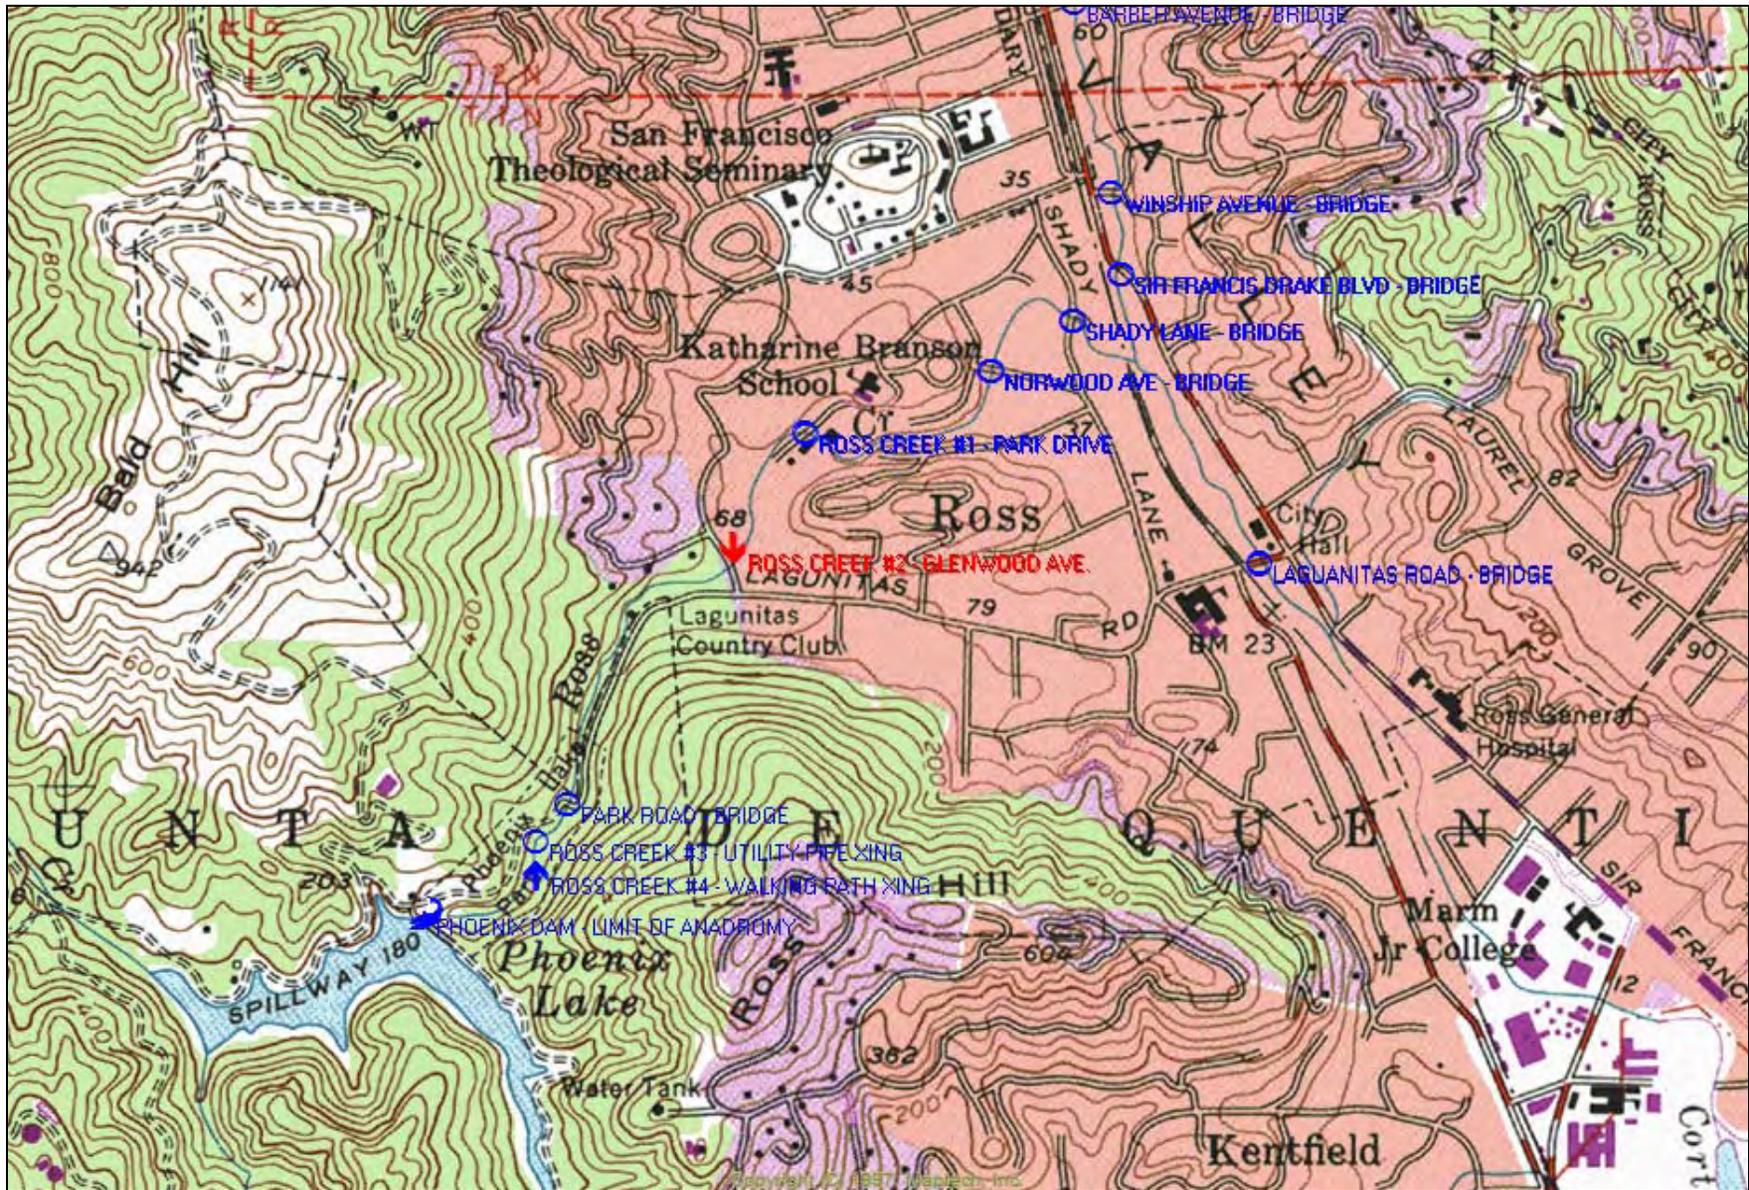
Site ID# R-02: Ross Creek #2/Glenwood Avenue; Corte Madera Creek

Crossing Type: Box culvert, Concrete. **Corrugations:** None; however invert was partially embedded with sand, gravel, small cobbles. **Dimensions:** 14.0' H x 20.0' W.
Length: 19.5'. **Slope:** 0.01%. **Modifications:** None. **Rustline Height:** N/A **Average Active Channel Width:** 17.5'. However, channel upstream and downstream was constricted by retaining walls. **Fill Estimate:** Not estimated because of bridge-like construction of crossing. **Overall Condition:** Good. **Sizing:** Properly Sized; HW/D = 1 on a storm flow with more than a 100-year recurrence interval.

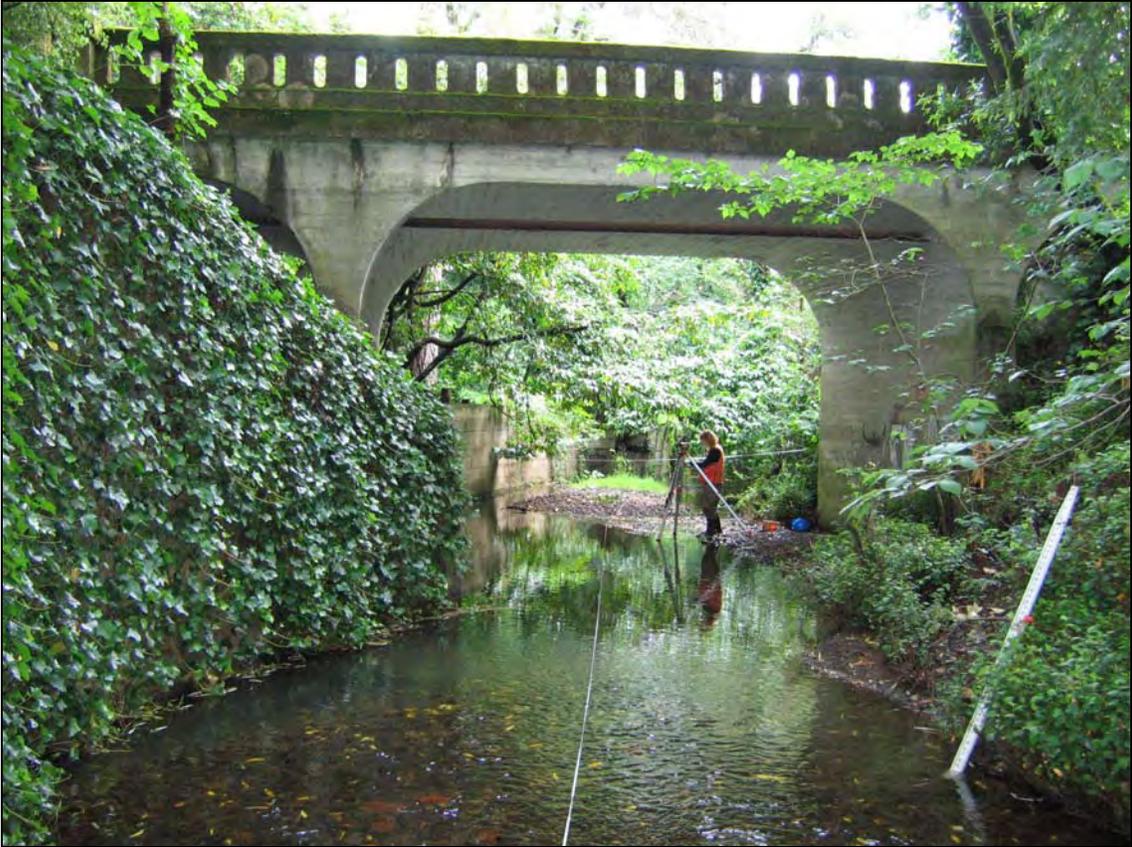
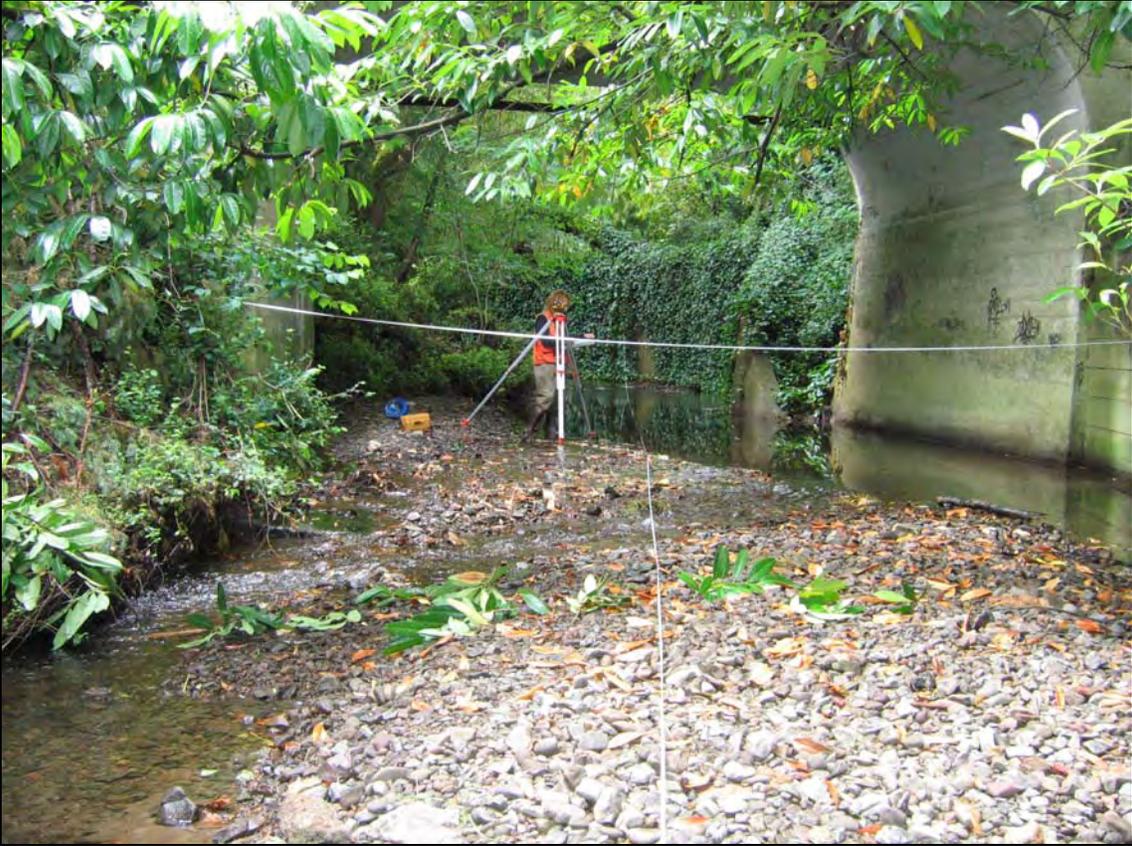
Site ID# R-02: Ross Creek #2/Glenwood Avenue; Corte Madera Creek

Drainage Area Upstream of Crossing: 2.78 square miles. **Estimated Migration Flows:** adults = 3.0–77.4 c.f.s.; resident/2+ = 2.0–20.0 c.f.s.; 1+/y-o-y = 1.0–8.7 c.f.s. **Passage Evaluation:** **GRAY:** as determined by the first-phase filter. FishXing was run for all age classes of salmonids and the model suggested that the crossing met passage requirements at all flows for all fish. When surveyed (summer low-flow conditions) the crossing was back-watered 0.26' at the outlet and 0.44' at the inlet.

Preferred Treatment: No treatment is recommended since the current crossing provides unimpeded passage, is in good condition, and is properly sized for storm flow conveyance. Recommend periodic inspection to monitor potential changes in elevation of the downstream channel and that the crossing remains back-watered.

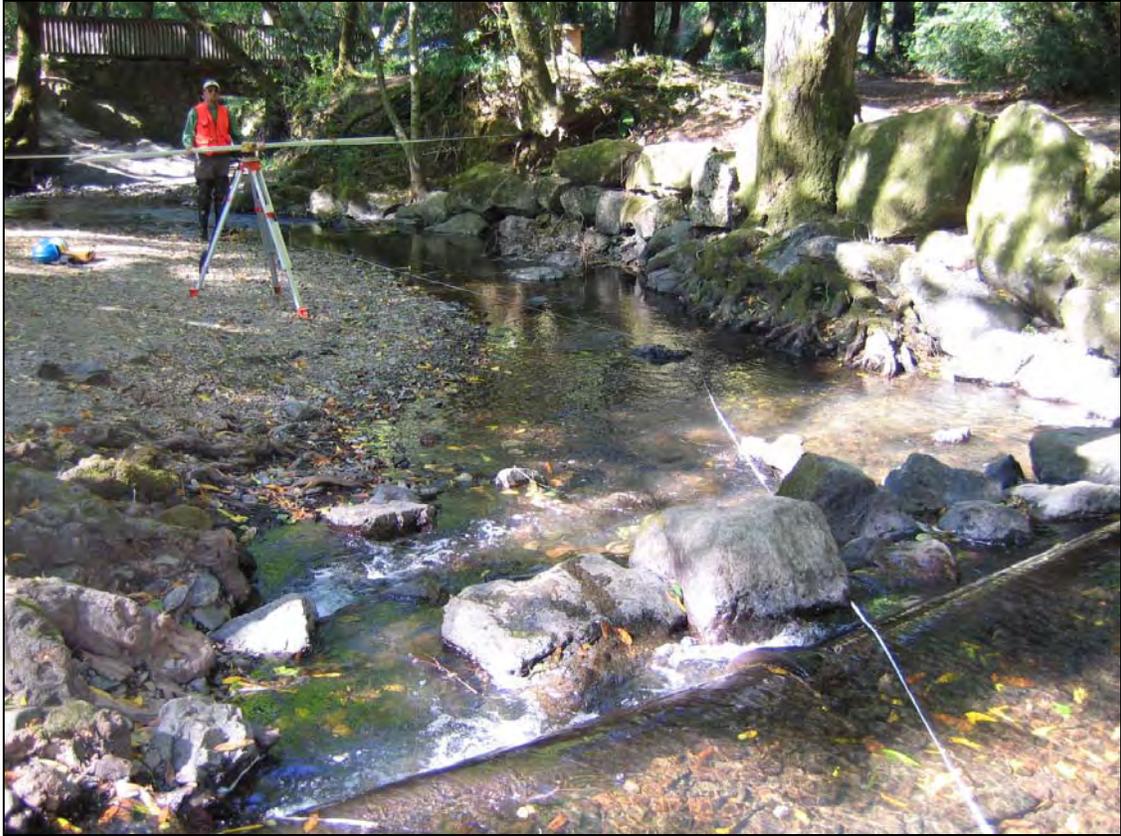
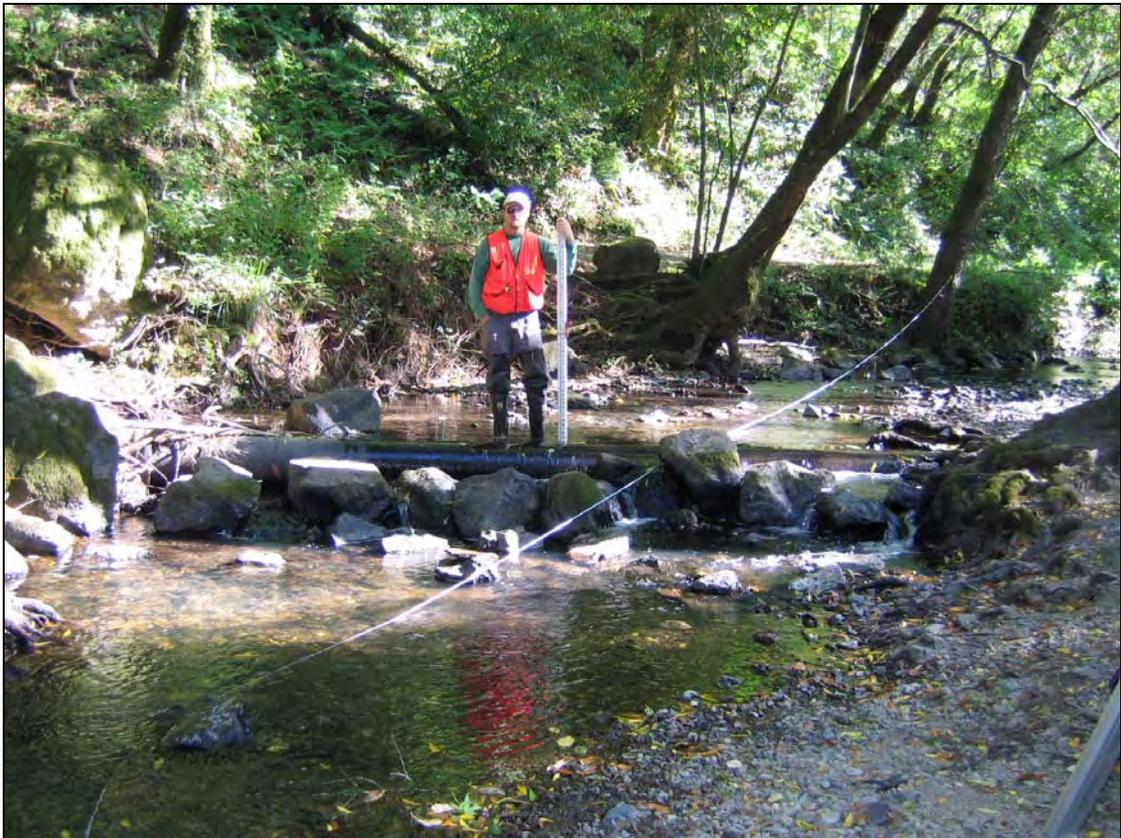
Site ID# R-03: Ross Creek #3/Natalie Coffin Park; Corte Madera Creek

Crossing Type: Utility pipe that perpendicularly crosses the stream channel.

Corrugations: None. **Dimensions:** Pipe is 18" in diameter **Length:** N/A since pipe is perpendicular to channel **Slope:** N/A. **Modifications:** None. **Rustline Height:** N/A

Average Active Channel Width: 22.6' **Fill Estimate:** Not estimated because of bridge-like construction of crossing. **Overall Condition:** Good. **Sizing:** Not applicable because crossing has no boundaries to limit capacity.

Drainage Area Upstream of Crossing: 2.69 square miles. **Estimated Migration Flows:** adults = 3.0–74.9 c.f.s.; resident/2+ = 2.0–19.4 c.f.s.; 1+/y-o-y = 1.0–8.4 c.f.s. **Passage Evaluation:** **GRAY:** as determined by the first-phase filter due to the drop over the pipe. FishXing estimated the crossing met the 8-16-16 ft/sec and 0.5ft minimum depth passage criteria for adult anadromous salmonids for the entire range of migration flows, met the resident trout/2+ passage criteria for 50% of the migration flows, and failed to meet passage criteria for 1+/y-o-y juveniles.

Preferred Treatment: No treatment recommended other than periodic inspection to assess changes in channel grade and height of drop over the utility pipe.

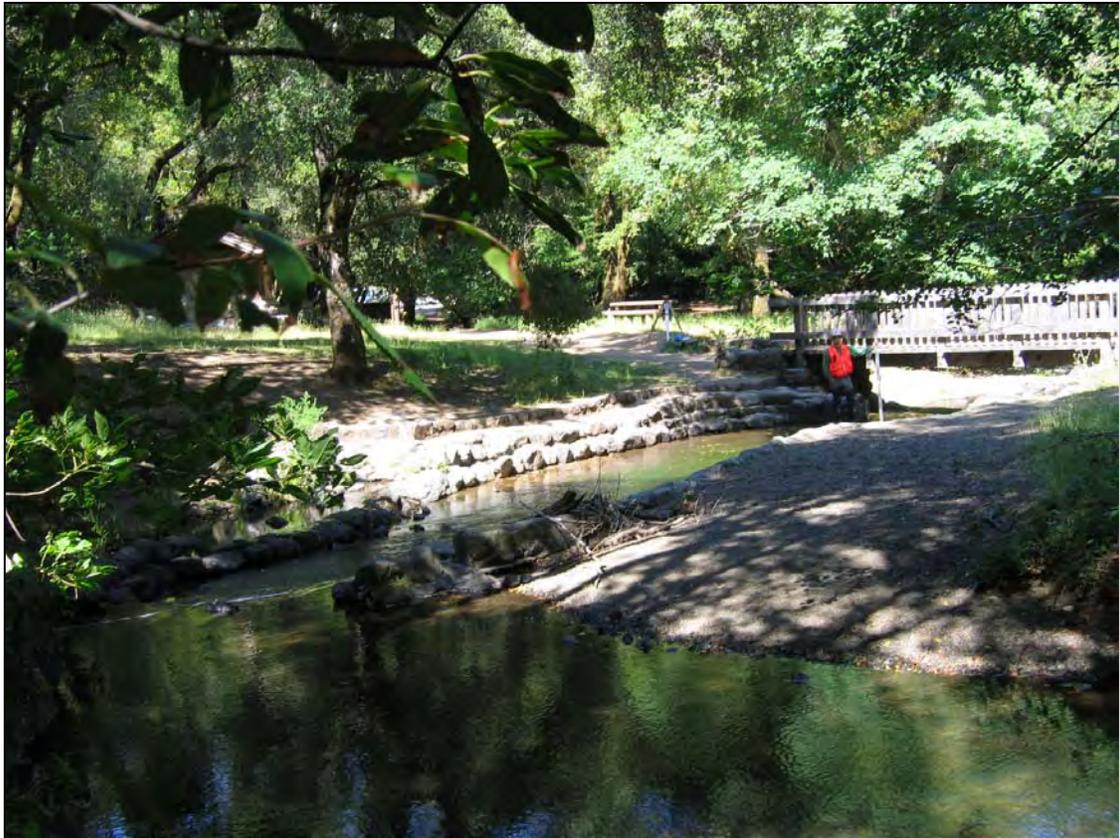
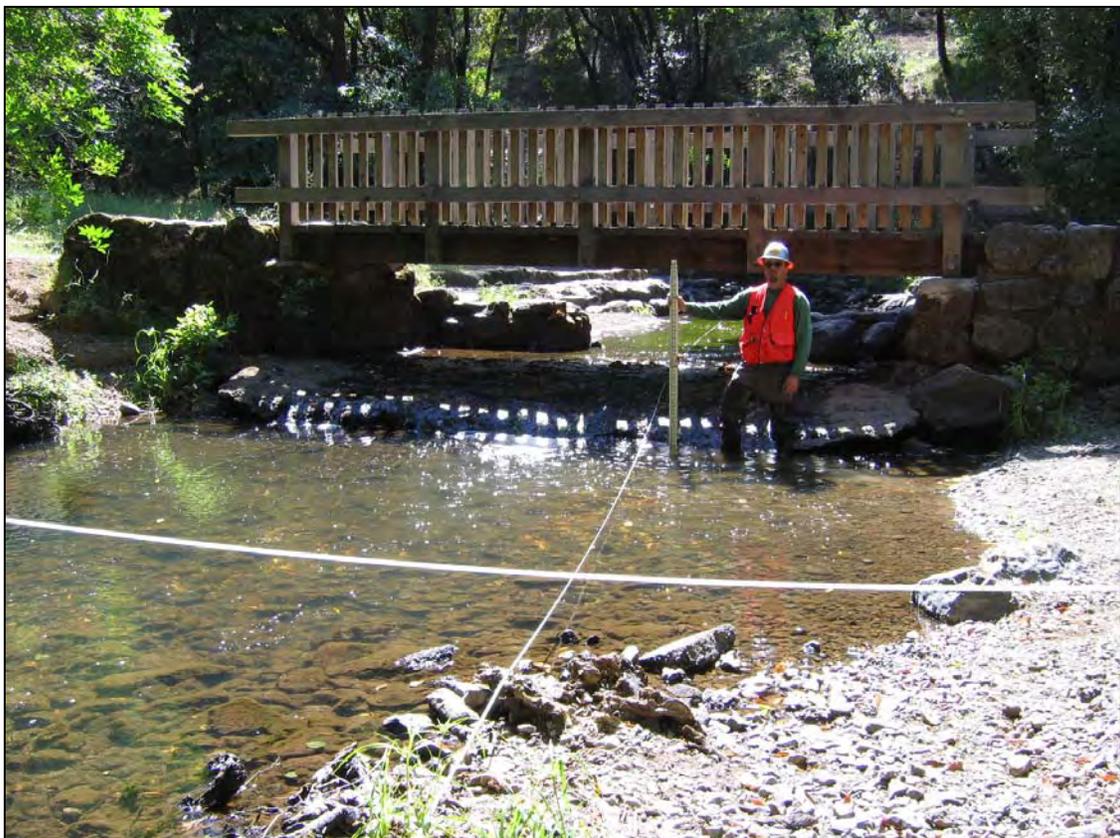
Site ID# R-04: Ross Creek #4/Natalie Coffin Park; Corte Madera Creek

Crossing Type: Bridge that serves as a walking path in park, with an extensive upstream apron and rock walls that form summertime wading pool area. **Corrugations:** None. **Dimensions:** 3.6'H x 24.4 W. **Length:** 72.5' for entire length of concrete invert. **Slope:** 0.2%.
Modifications: None. **Rustline Height:** N/A **Average Active Channel Width:** 22.6' **Fill Estimate:** Not estimated because of bridge-like construction of crossing. **Overall Condition:** Good. **Sizing:** Properly sized to pass more than the 100-year storm flow.

Drainage Area Upstream of Crossing: 2.67 square miles. **Estimated Migration Flows:** adults = 3.0–74.4 c.f.s.; resident/2+ = 2.0-19.3 c.f.s.; 1+/y-o-y = 1.0-8.4 c.f.s. **Passage Evaluation:** **RED:** as determined by the first-phase filter due to slope >3% through the crossing (4.09%) and over the length of the outlet apron (8.75%).

Preferred Treatment: Although this crossing is a serious impediment to upstream migration, the relative lack of available upstream habitat renders this site a fairly low priority to restoration of anadromous salmonid habitat. However, if passage were restored at Phoenix Dam then this crossing would be of importance to fix. In addition to preventing steelhead from utilizing a significant reach of habitat (≈1.4 miles above upper end of reservoir), the dam cuts-off surface flow to the downstream channel during drier summer months and creates habitat (the reservoir) for non-native fishes that may predate juvenile steelhead when they spill over the dam (note fish observations at this site and R-01).
