CATALOG OF STREAM CROSSINGS WITH CULVERTS AND OTHER MANMADE IMPEDIMENTS TO FISH PASSAGE LOCATED ON ANADROMOUS STREAM REACHES WITHIN SAN ANSELMO CREEK, CORTE MADERA CREEK WATERSHED, MARIN COUNTY, CA.

Prepared for Friends of the Corte Madera Creek Watershed

By
Ross Taylor and Associates

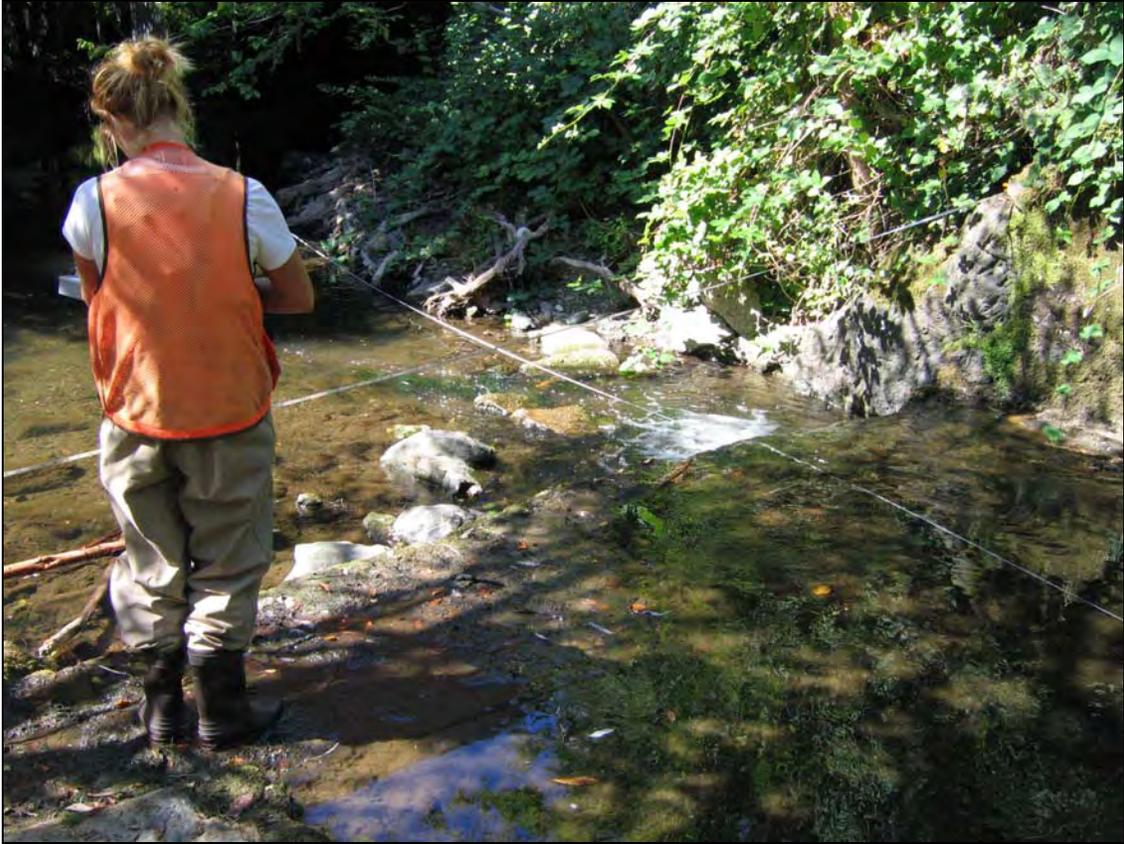
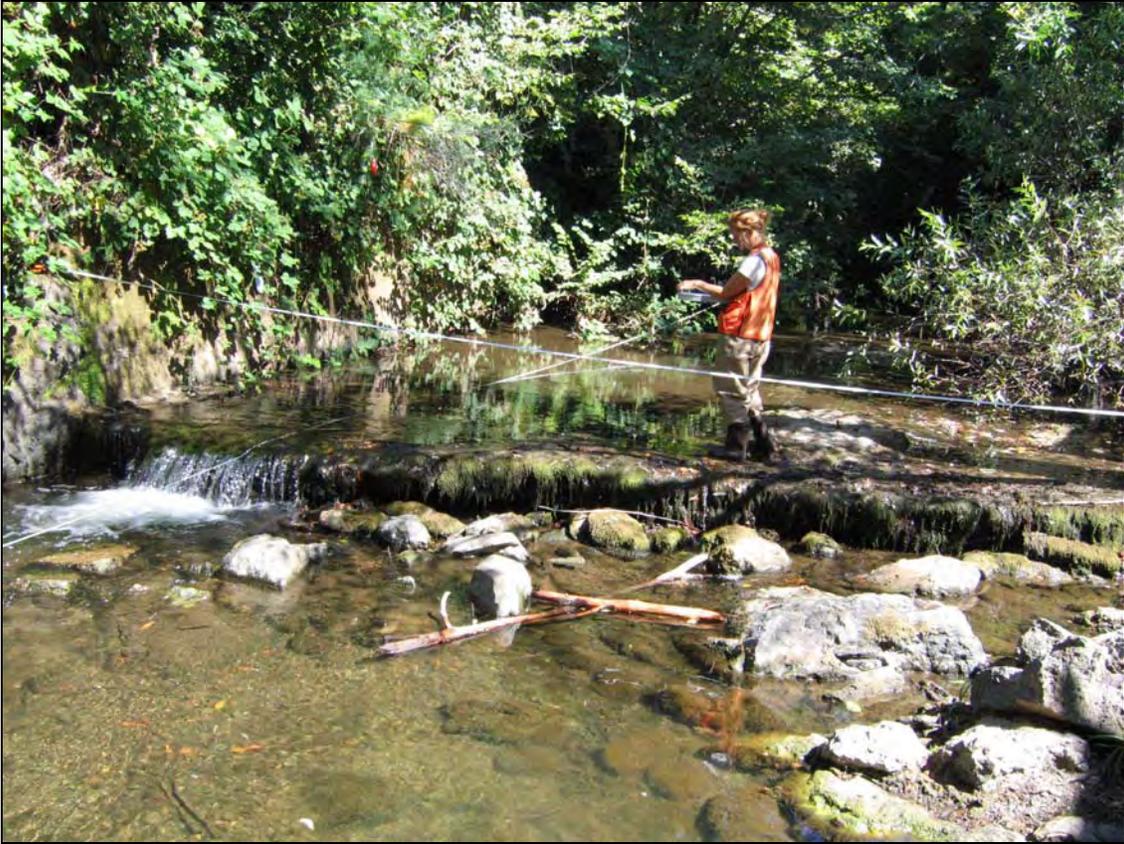
Site ID# SA-01: San Anselmo Creek #1/Creek Park; Corte Madera Creek

Crossing Type: Concrete weir with upstream apron. **Corrugations:** None. **Dimensions:** the weir spans 27.8'. **Length:** 39.2' of concrete apron upstream of weir. **Slope:** for length of apron = 0.31%. **Modifications:** None. **Rustline Height:** N/A **Average Active Channel Width:** 22.6'
Fill Estimate: Not applicable. **Overall Condition:** Good. **Sizing:** Not applicable.

Drainage Area Upstream of Crossing: 13.10 square miles. **Estimated Migration Flows:** adults = 3.0–364.8 c.f.s.; resident/2+ = 2.0-94.5 c.f.s.; 1+/y-o-y = 1.0-41.1 c.f.s. **Passage Evaluation:** **GRAY:** as determined by the first-phase filter due to the slightly perched outlet. FishXing estimated that the crossing met the passage criteria for adult anadromous salmonids for the entire range of estimated migration flows, met passage criteria for resident trout/2+ salmonids for the entire range of estimated migration flows, and met passage criteria for 1+/y-o-y salmonids for 80% of the range of estimated migration flows (>8.0 c.f.s.).

Habitat: Quantity = approximately 63,600' of potential fish-bearing habitat upstream of Site ID# SA-01, which includes habitat within Sleepy Hollow and Fairfax creeks. Quality = in the vicinity of the crossing, rated as “poor” for the ranking matrix based on Taylor and Associates survey crew’s field notes and interpretation of previous habitat assessment (Rich, 2000). This lower reach of San Anselmo Creek is within downtown San Anselmo and has been subjected to extensive urban development, including sections of channel running underneath buildings. The crossing was surveyed by Taylor and Associates on 7/08/05 and there was continuous flow in the channel. At 10:30 AM the air temp = 17°C and the water temp = 16°C. The survey crew noted few pools, minimal in-stream cover, a moderately dense riparian zone of hardwoods, and high amounts of sand, mud, and fines. There were also extensive amounts of trash within the stream channel. Most of the stream channel was constricted by armored banks and retaining walls. The crew noted extremely abundant numbers (50-100 fish) of roach both downstream and upstream of Site ID# SA-01.

Preferred Treatment: No treatment recommended since a high level of fish passage probably occurs at this site. Recommend periodic inspection of the crossing to assess any changes to the channel elevation of the downstream side of the weir.

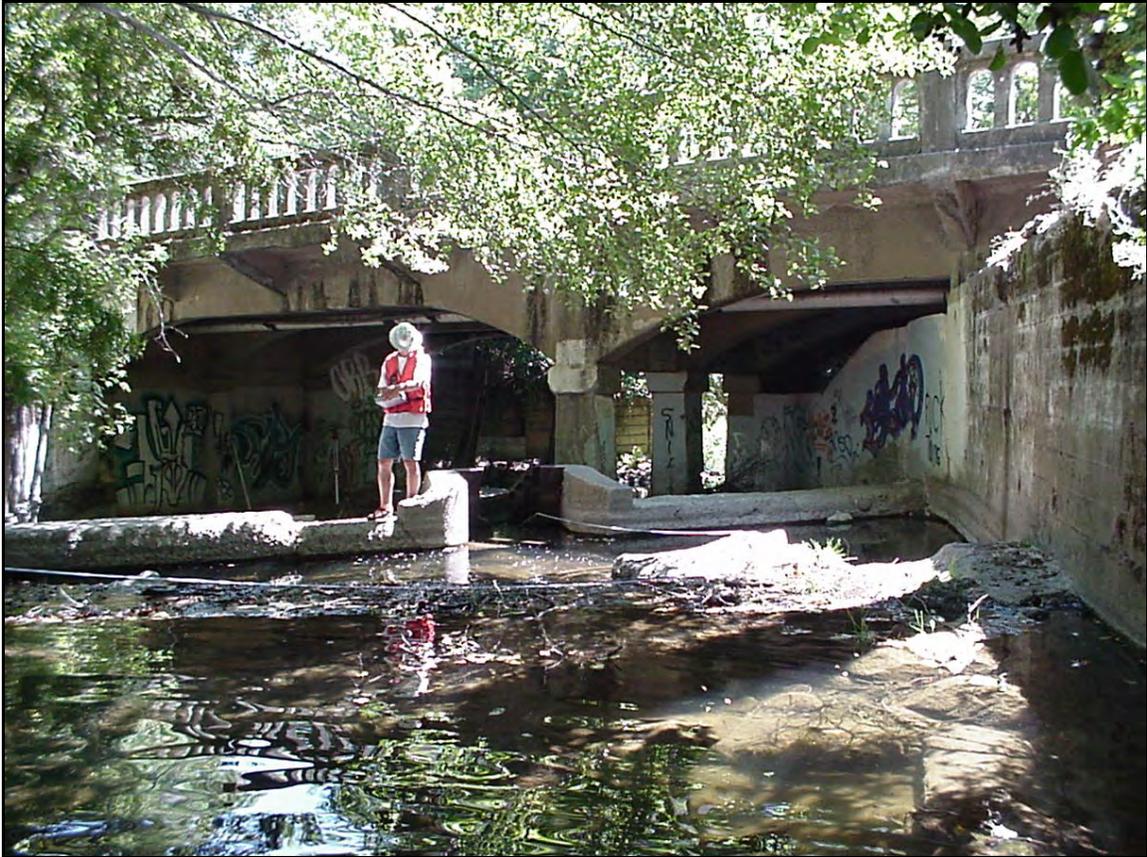
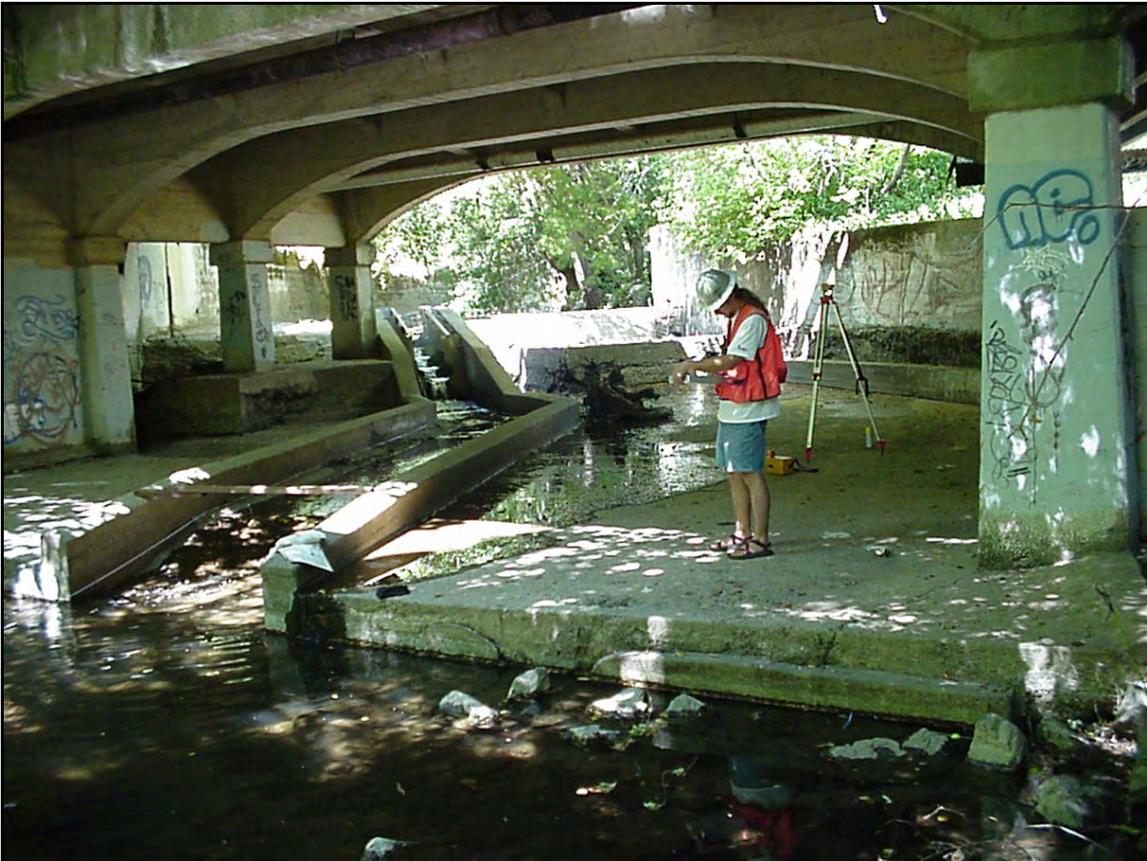
Site ID# SA-02 aka MR-078: San Anselmo Creek #2/Saunders Avenue; Corte Madera Creek

Crossing Type: Box w/ Fish Ladder, Concrete. **Corrugations:** None. **Dimensions:** 15.0' height x 37.0' width **Length:** Fish Ladder = 17.6'; Box = 42.0' **Slope:** Fish Ladder = 12.26%; Box = 0.44% **Modifications:** Denil Fish Ladder. **Rustline Height:** N/A **Average Active Channel Width:** 23.8' **Fill Estimate:** 147 Cubic Yards. **Overall Condition:** Good. **Sizing:** Properly Sized; HW/D = 1 on a storm flow with more than a 250-year recurrence interval.

Drainage Area Upstream of Crossing: 9.48 square miles. **Estimated Migration Flows:** adults = 3.0–264.0 c.f.s.; resident/2+ = 2.0-68.4 c.f.s.; 1+/y-o-y = 1.0-29.8 c.f.s. **Passage Evaluation: RED:** Although FishXing was unable to accurately model hydraulics through the fish ladder, a literature review confirmed that the current structure fails to meet Denil fish ladder construction criteria (Rajaratnam and Katopodis 1991). The narrow 42-foot long concrete flume-like channel below the ladder probably impedes passage too. Observations of adult steelhead have been made upstream of this crossing, thus some fish do pass through this crossing (Guldman, pers. comm).

Habitat: Quantity = approximately 33,200' of potential fish-bearing habitat upstream of Site ID# SA-02. Quality = rated as “fair” for the ranking matrix based on Taylor and Associates survey crew’s field notes. Habitat and fisheries information available from a 2002 proposal developed by the Friends of the Corte Madera Creek Watershed indicate that upper reaches of San Anselmo Creek provides the widest range of habitat types and areas in upper Sleepy Hollow Creek and Cascade Creek provide the best remaining spawning and over-summer rearing habitat. The crossing was surveyed by Taylor and Associates on 7/24/02 and there was continuous flow in the channel. At 11:30AM the air temp = 20.5°C and the water temp = 17°C. The survey crew noted a channel confined by concrete walls in a residential area, few pools, and a moderately dense riparian zone of hardwoods. The crew noted extremely abundant numbers (>100 fish) of juvenile salmonids and other unknown fish species both downstream and upstream of Site ID# SA-02. Most of the salmonids were observed in the outlet pool.

Preferred Treatment: This crossing was originally surveyed in 2003 as part of Ross Taylor and Associates’ assessment of County of Marin-maintained crossings. In 2003 the recommendation was to re-design the fish ladder and downstream concrete chute to improve conditions for fish passage. Currently, Stetson Engineering and Michael Love and Associates are developing a design for SA-02 as another Phase of the NOAA-funded Corte Madera Creek Fish Passage Program.

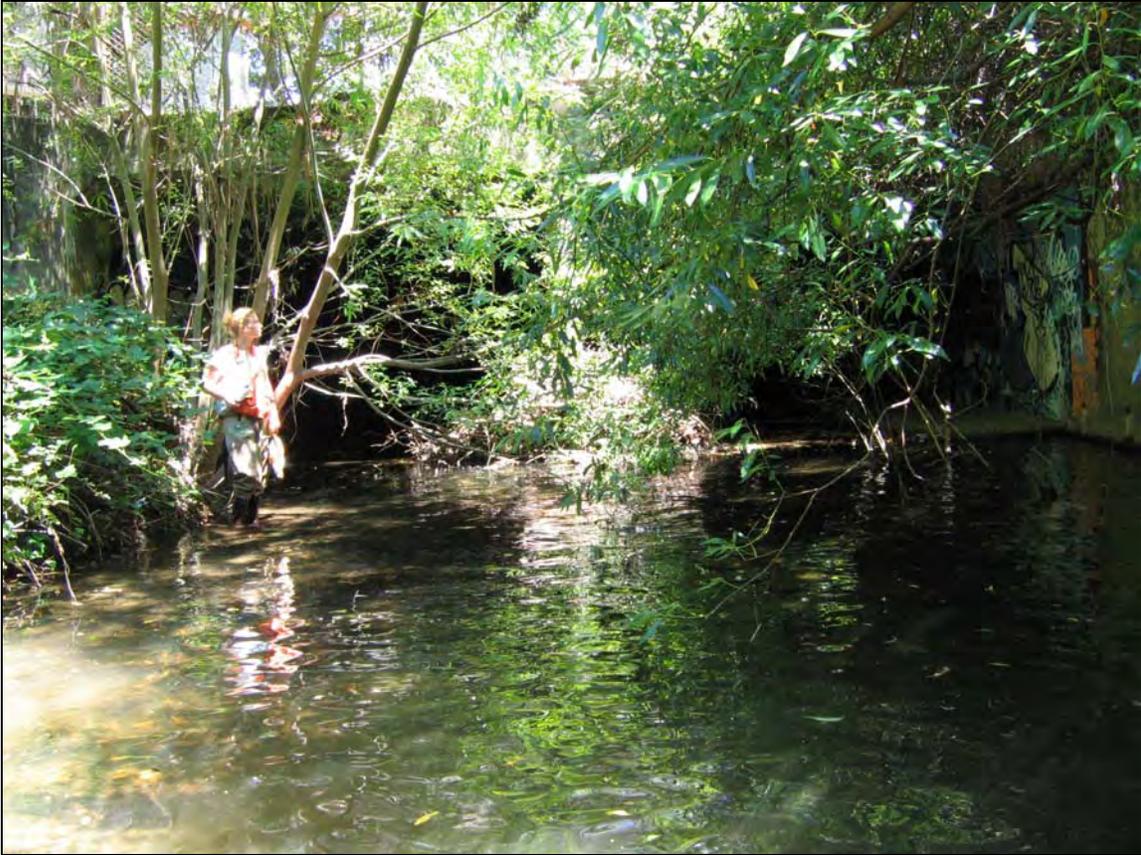
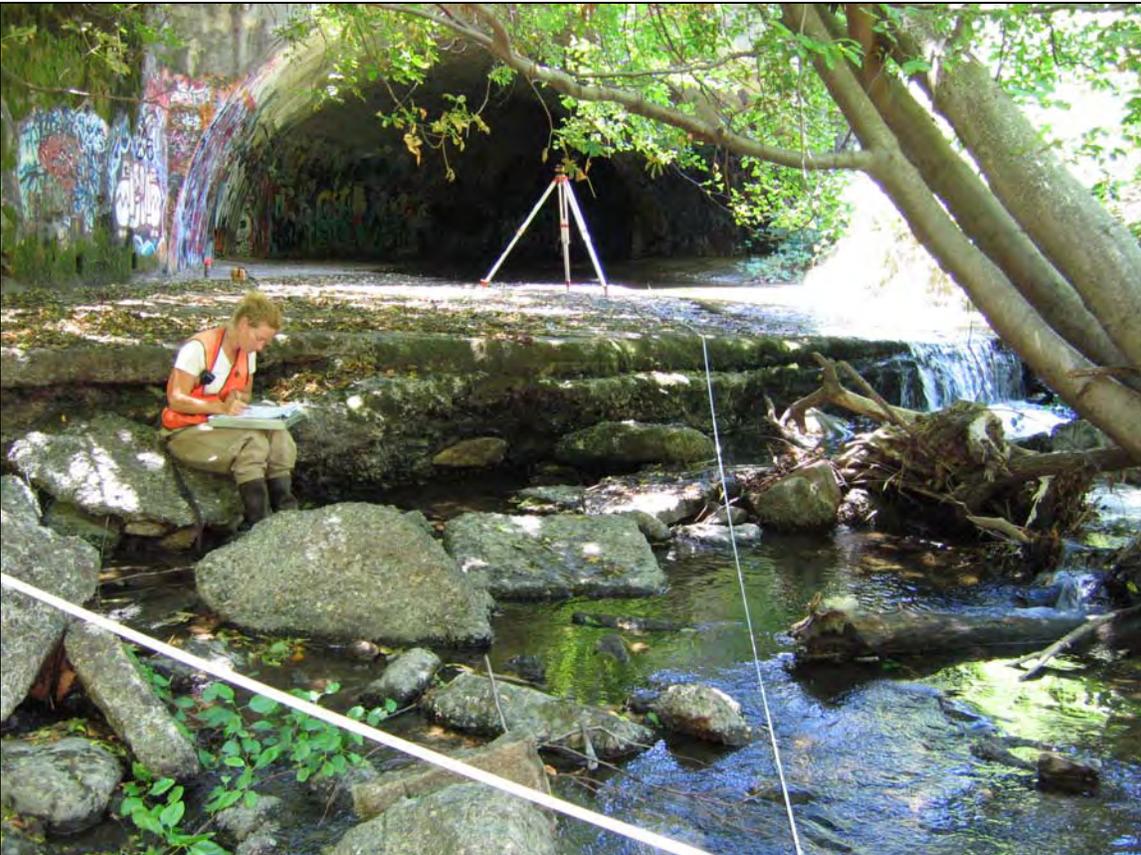
Site ID# SA-03: San Anselmo Creek #3/Center Blvd./Lansdale Avenue; Corte Madera Creek

Crossing Type: Composite: upper end = two-bay box culvert; lower end = arch culvert w/flat floor. Both sections constructed of concrete. **Corrugations:** None. **Dimensions:** box culvert LB-bay = 10.2'H x 15.4'W; RB-bay = 10.2'H x 14.7'W; arch = 15.9' rise x 32.0' span.

Length: Box culvert LB-bay = 152.0'; RB-bay = 147.7' arch section = 130.2'.

Slope: Box LB-bay = 0.53%; Box RB-bay = 0.58%; arch section = 0.23%. **Modifications:** None. **Rustline Height:** N/A **Average Active Channel Width:** 27.1' **Fill Estimate:** Not measured due to safety issues on road surface. **Overall Condition:** Good. **Sizing:** Properly Sized; HW/D = 1 on a storm flow with more than a 100-year recurrence interval.

Drainage Area Upstream of Crossing: 9.34 square miles. **Estimated Migration Flows:** adults = 3.0–260.1 c.f.s.; resident/2+ = 2.0–67.3 c.f.s.; 1+/y-o-y = 1.0–29.3 c.f.s. **Passage Evaluation:** **RED:** as determined by the first-phase filter due to the nearly three-foot drop at the outlet. Observations of adult steelhead have been made upstream of this crossing, thus some fish do pass through this crossing (Guldman, pers. comm.). However due to the perched outlet and excessive length of flat/wide concrete invert these successful fish are probably the “exception, not the rule” in migrating through this significant impediment.

Preferred Treatment: The only feasible means to improve fish passage would be a retrofit consisting of a series of downstream weirs to decrease the leap into the culvert and a series of either corner baffles or weirs within the crossing to increase water depths. Consider treatment of this site prior to treatment of Site ID# SA-04.

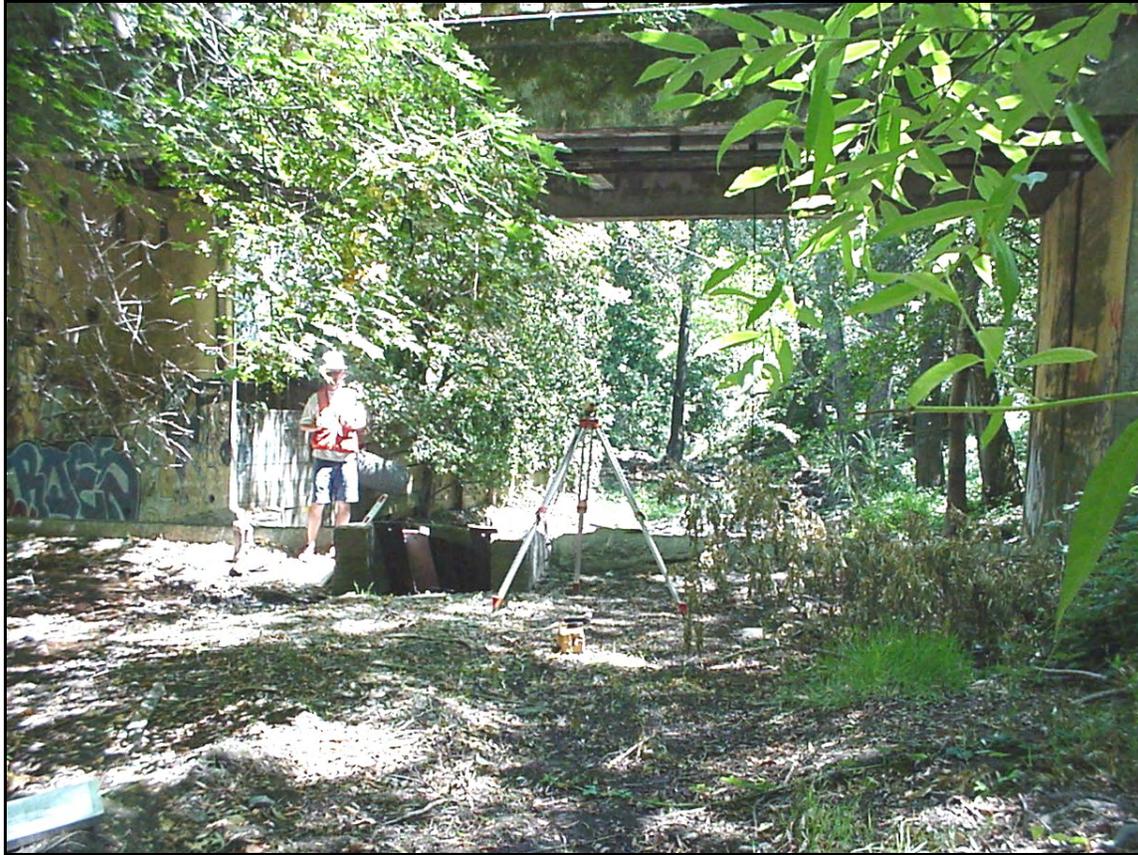
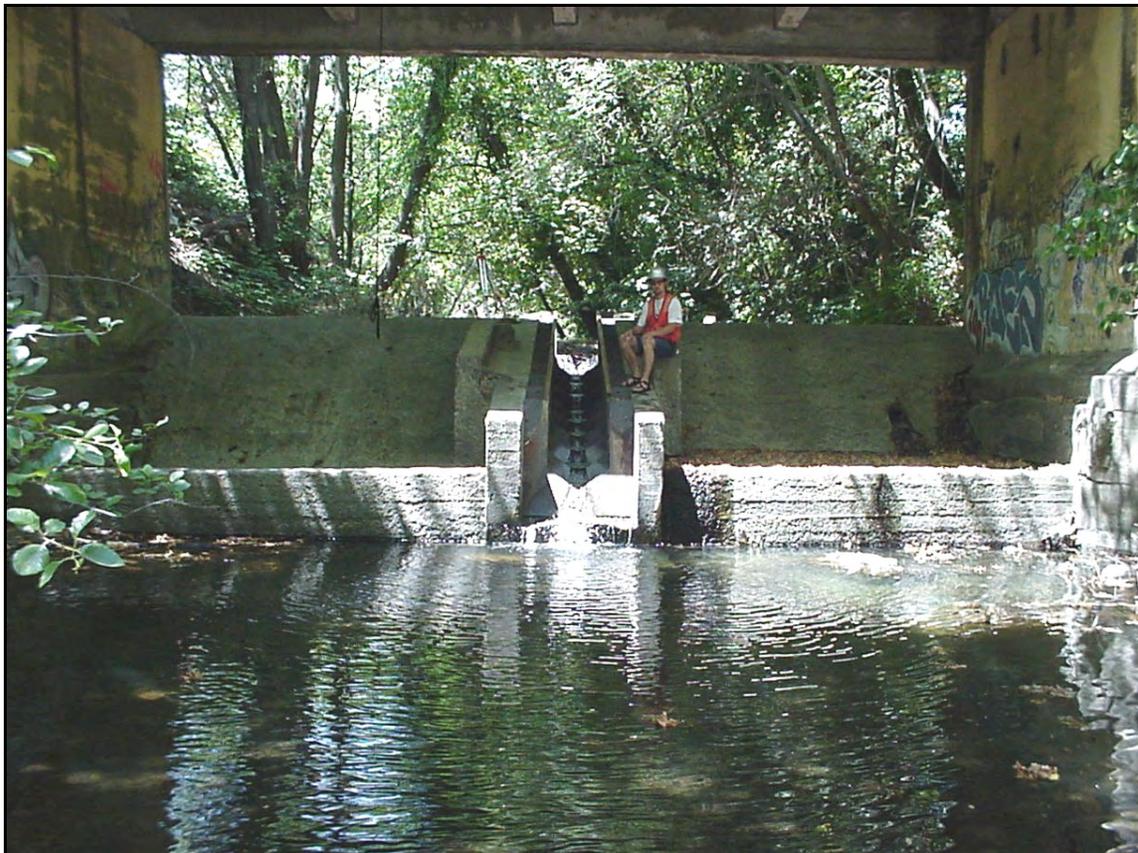
Site ID# SA-04: San Anselmo Creek #4/Pastori Avenue; Corte Madera Creek

Crossing Type: Fish Ladder, Concrete. **Corrugations:** None. **Dimensions:** 12.0' height x 37.0' width **Length:** 25.3' **Slope:** 20.40% **Modifications:** Denil Fish Ladder. **Rustline Height:** N/A **Average Active Channel Width:** 23.1' **Fill Estimate:** 1,125 Cubic Yards. **Overall Condition:** Good. **Sizing:** Properly Sized; HW/D = 1 on a storm flow with more than a 250-year recurrence interval. Pastori Avenue is overtopped on more than a 250-year storm flow.

Drainage Area Upstream of Crossing: 8.70 square miles. **Estimated Migration Flows:** adults = 3.0–242.3 c.f.s.; resident/2+ = 2.0–62.7 c.f.s.; 1+/y-o-y = 1.0–27.3 c.f.s. **Passage Evaluation: GRAY:** Fish ladder slope (20%) is upper limit for adult passage and assumed to be insufficient for resident and juvenile passage. Low flow walls breach at 24 c.f.s. Velocity issues occur around 20 c.f.s. when Manning's n = 0.08. FishXing can not model fish ladders therefore adult passage was assessed using research by Rajaratnam and Katopodis (1991).

Habitat: Quantity = approximately 28,900' of potential fish-bearing habitat upstream of Site ID# SA-04. Quality = in the vicinity of the crossing, rated as "poor" for the ranking matrix based on Taylor and Associates survey crew's field notes and interpretation of previous habitat assessment (Rich, 2000). However, habitat conditions improve farther upstream. The crossing was surveyed by Taylor and Associates on 7/24/02 and there was continuous flow in the channel. At 2:30PM the air temp = 23°C and the water temp = 18°C. The survey crew noted a channel confined by concrete walls in a residential area, few pools, and a moderately dense riparian zone of hardwoods. The crew noted abundant numbers (50-100 fish) of juvenile salmonids and other unknown species both downstream and upstream of Site ID# SA-04.

Preferred Treatment: This crossing was originally surveyed in 2003 as part of Ross Taylor and Associates' assessment of County of Marin-maintained crossings. In 2003, the recommendation was to re-design fish ladder to improve conditions for fish passage and to consider the feasibility of two options: (1) gradual removal of concrete dam/weir over several seasons to achieve a natural stream channel under bridge or (2) construction of series of concrete weirs onto existing dam/weir to raise tail-water elevation. Currently, Stetson Engineering and Michael Love and Associates are developing a design for #SA-04 as another Phase of the NOAA-funded Corte Madera Creek Fish Passage Program.

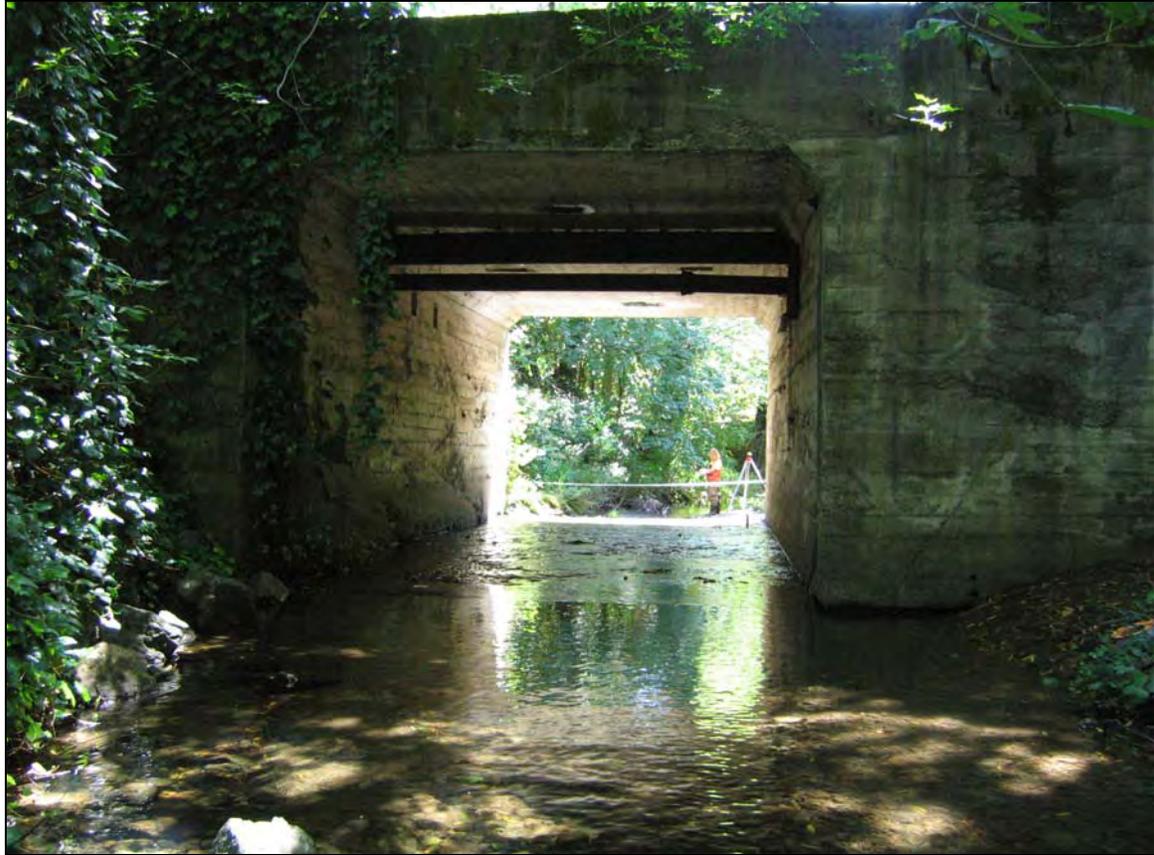
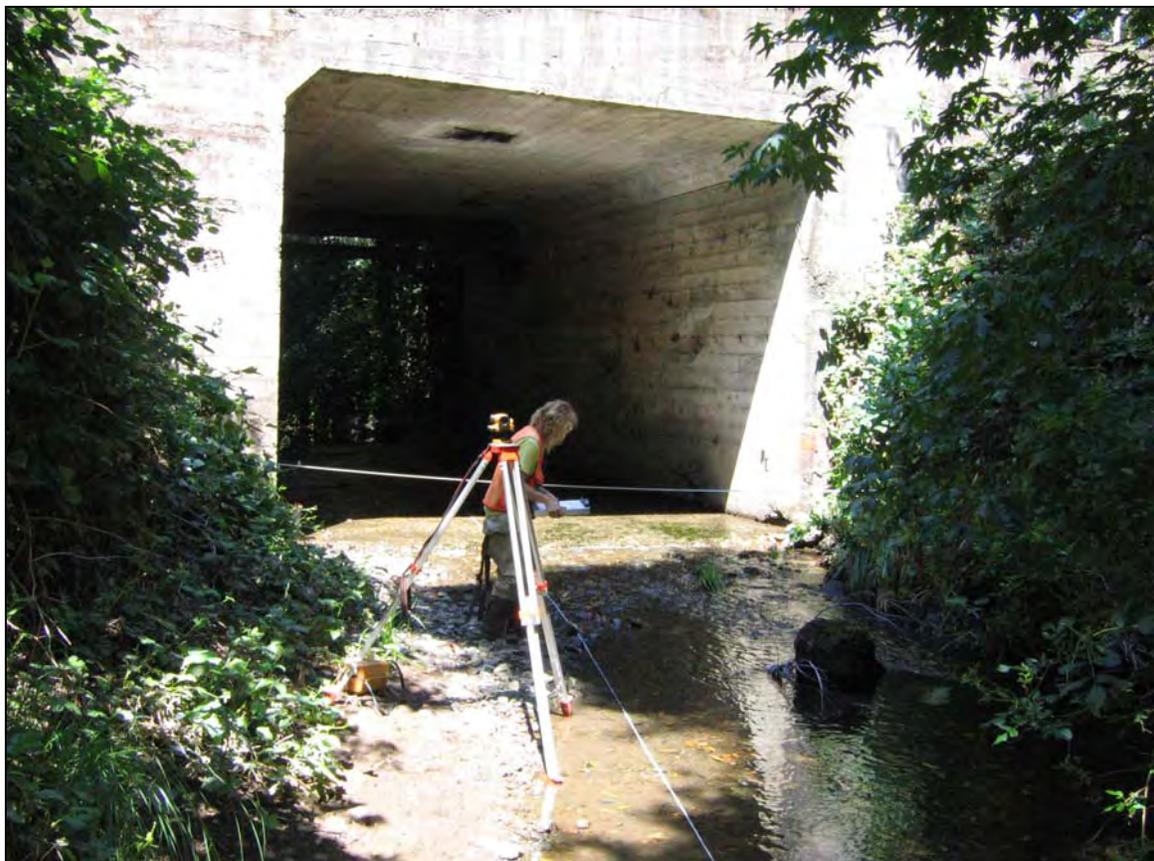
Site ID# SA-05: San Anselmo Creek #5/Fairfax-Bolinas Road; Corte Madera Creek

Crossing Type: Box culvert, Concrete. **Corrugations:** None. **Dimensions:** 14.0' H x 18.0' W
Length: 47.0' **Slope:** 0.85% **Modifications:** None. **Rustline Height:** N/A **Average Active Channel Width:** 21.2' **Fill Estimate:** 1,959 Cubic Yards. **Overall Condition:** Fair, excessive wear on invert – worn to exposed rebar in several locations. **Sizing:** Properly Sized; HW/D = 1 on a storm flow with more than a 100-year recurrence interval.

Drainage Area Upstream of Crossing: 4.41 square miles. **Estimated Migration Flows:** adults = 3.0–122.8 c.f.s.; resident/2+ = 2.0–31.8 c.f.s.; 1+/y-o-y = 1.0–13.8 c.f.s. **Passage Evaluation: GRAY:** As determined by the first-phase evaluation filter due to the slightly perched outlet (negative residual depths at both the inlet and outlet). FishXing estimated that this crossing met passage criteria for adult anadromous salmonids for 57% of the range of migration flows (between 55.0 – 122.8 c.f.s.) and failed to meet passage criteria for resident/2+ age and 1+/y-o-y age classes. Actual passage of adults may be higher and some resident/2+ passage may occur due to “lack-of-depth” being the primary criteria violation flagged by FishXing.

Preferred Treatment: Because the crossing allows a fairly high level of adult steelhead passage treatment of this site should be a medium to low priority to postpone until more severe impediments within Corte Madera Creek are addressed. However, if the Town of Fairfax determined that the failing invert needed repair, the feasibility of either partially removing the culvert floor or creating a low-flow channel within the culvert invert should be considered.

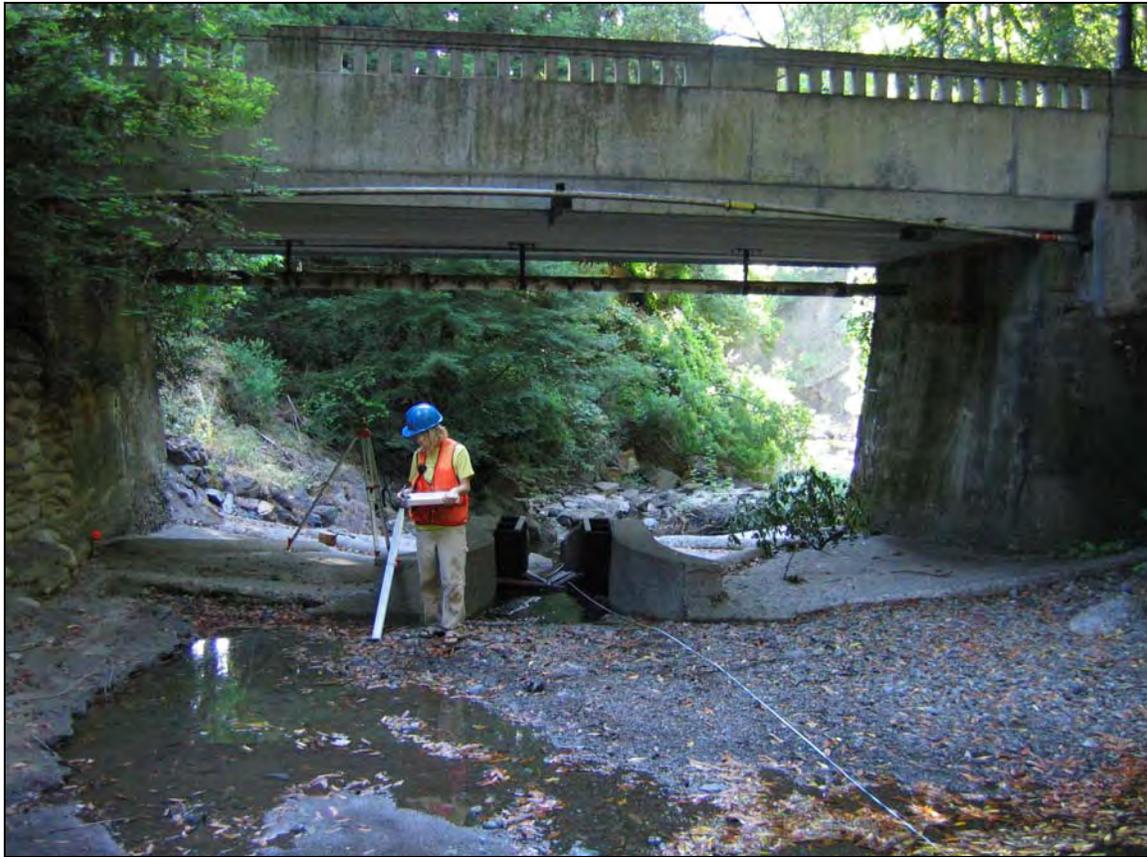
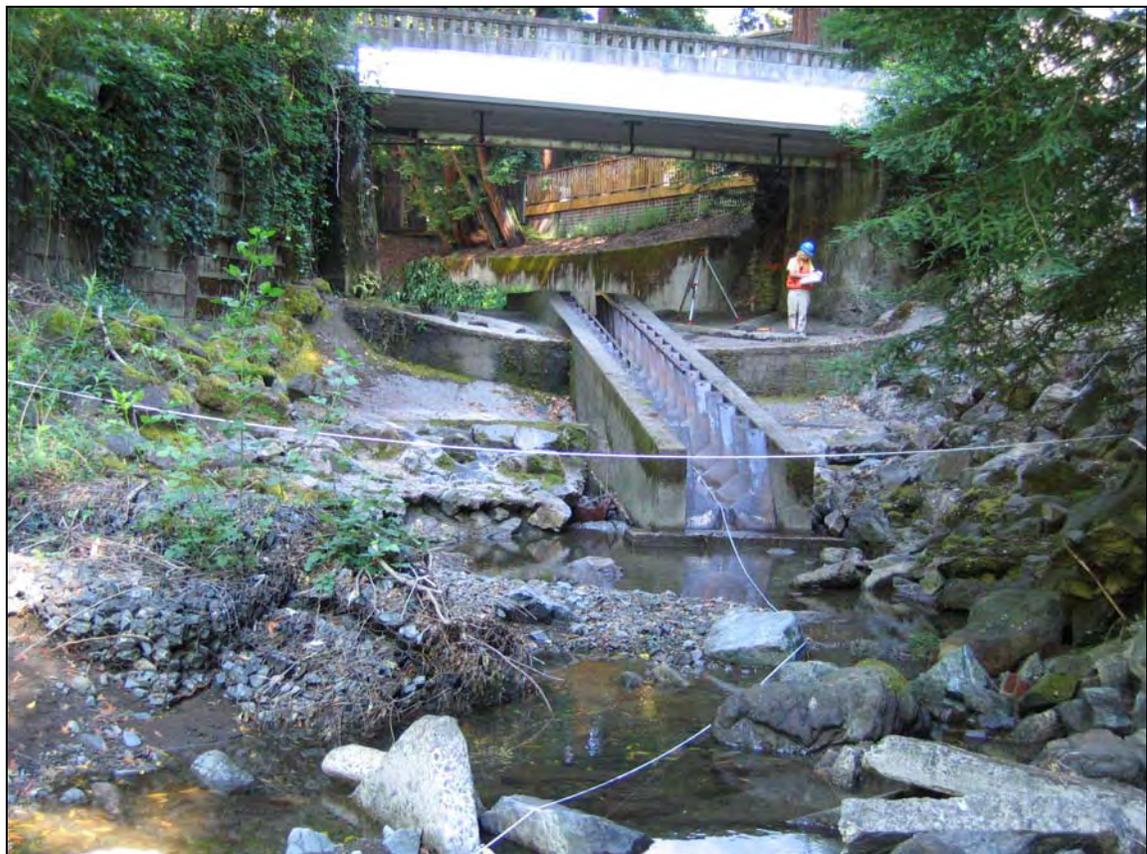
Site ID# SA-06: San Anselmo Creek #6/Canyon Road; Corte Madera Creek

Crossing Type: Concrete box culvert with fish ladder. **Corrugations:** None. **Dimensions:** 11.4' H x 28.0' W **Length:** through crossing and down fish ladder = 53.6'. **Slope:** from pool-tail of 1st upstream resting habitat to top of ladder = 0.38%; fish ladder = 17.53%. **Modifications:** Concrete and steel plate fish ladder. **Rustline Height:** N/A **Average Active Channel Width:** 27.9' **Fill Estimate:** not estimated due to the bridge-like construction of crossing. **Overall Condition:** Fair, some cracks in concrete invert at inlet. **Sizing:** Properly Sized; HW/D = 1 on a storm flow with more than a 100-year recurrence interval.

Drainage Area Upstream of Crossing: 3.38 square miles. **Estimated Migration Flows:** adult anadromous salmonids = 3.0–94.1 c.f.s.; resident/2+ = 2.0-24.4 c.f.s.; 1+/y-o-y = 1.0-10.6 c.f.s. **Passage Evaluation: GRAY:** As determined by the first-phase evaluation filter due to the slightly perched outlet (negative residual depths at both the inlet and outlet). FishXing is unable to accurately assess the hydraulics of varying flow through a Denil-style fish ladder. The slope of 17.53% is near the upper limit recommended for these types of ladders and no passage of resident and juvenile salmonids was assumed. Recommend making visits to site during winter storms to better assess hydraulics and flow conditions during migration-level discharges.

Preferred Treatment: Recommend conducting site visits during winter storms to better assess hydraulics and flow conditions during migration-level discharges. The ladder should also be inspected during and immediately after winter storms to make sure that woody debris is not clogging the ladder and causing passage problems.
