**CATALOG OF STREAM CROSSINGS WITH CULVERTS AND  
OTHER MANMADE IMPEDIMENTS TO FISH PASSAGE  
LOCATED ON ANADROMOUS STREAM REACHES WITHIN  
SLEEPY HOLLOW CREEK, CORTE MADERA CREEK  
WATERSHED, MARIN COUNTY, CA.**

**Prepared for Friends of the Corte Madera Creek Watershed**

**By  
Ross Taylor and Associates**

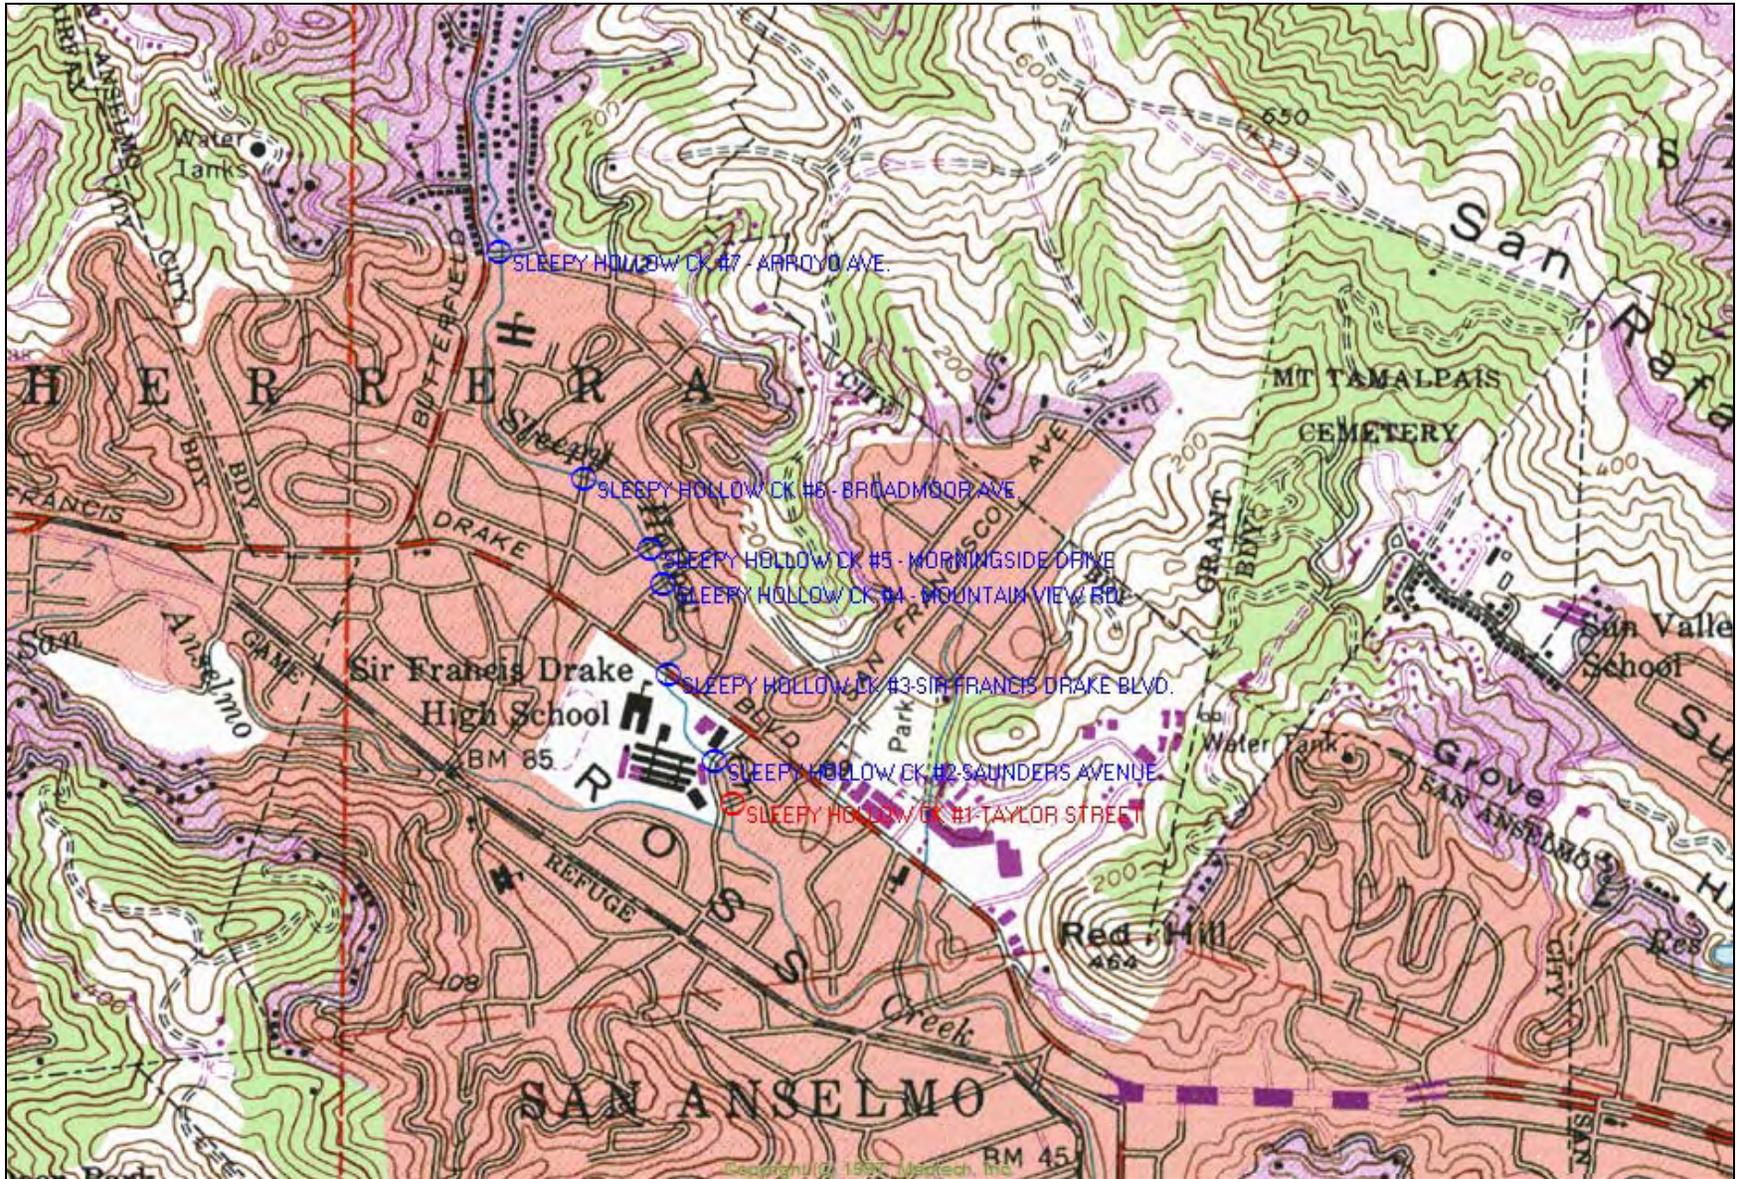
Site ID# SH-01: Sleepy Hollow Creek #1/Taylor Street; Corte Madera Creek

**Crossing Type:** Concrete arch culvert with flat floor. **Corrugations:** None. **Dimensions:** 10.4' Rise x 12.2' Span **Length:** 30.7' **Slope:** 4.36% **Modifications:** None. **Rustline Height:** N/A **Ave. Active Channel Width:** 18.6' **Fill Estimate:** 743 Cubic Yards. **Overall Condition:** Fair–floor worn to exposed rebar in several places, several cracks in walls, outlet is undercut. **Sizing:** Adequately-sized; HW/D = 1 on a flow between a 50 and 100-year recurrence interval.

**Drainage Area Upstream of Crossing:** 3.60 square miles. **Estimated Migration Flows:** anadromous adult salmonids = 3.0–100.3 c.f.s.; resident/2+ = 2.0–26.0 c.f.s.; 1+/y-o-y = 1.0–11.3 c.f.s. **Passage Evaluation: RED:** as determined by the first-phase filter due to slope >3%; however FishXing was run for adult anadromous salmonids and the model suggested the crossing met the 8-16-16 ft/sec and 0.5ft minimum depth criteria for 37% of the range of estimated migration flow (64.0 – 100.0 c.f.s.). Main violation was lack-of-depth; however the three-tiered drop at the outlet was not modeled in FishXing and probably creates unfavorable hydraulic conditions during migration-level flows.

**Preferred Treatment:** Because the current crossing is adequately sized, a retrofit is recommended to improve conditions for fish passage. A series of boulder or concrete weirs are required to sufficiently raise the tail-water elevation and corner baffles within the culvert will increase depths and decrease velocities. Recommend consulting with CDFG and NOAA hydraulic engineers for design assistance.

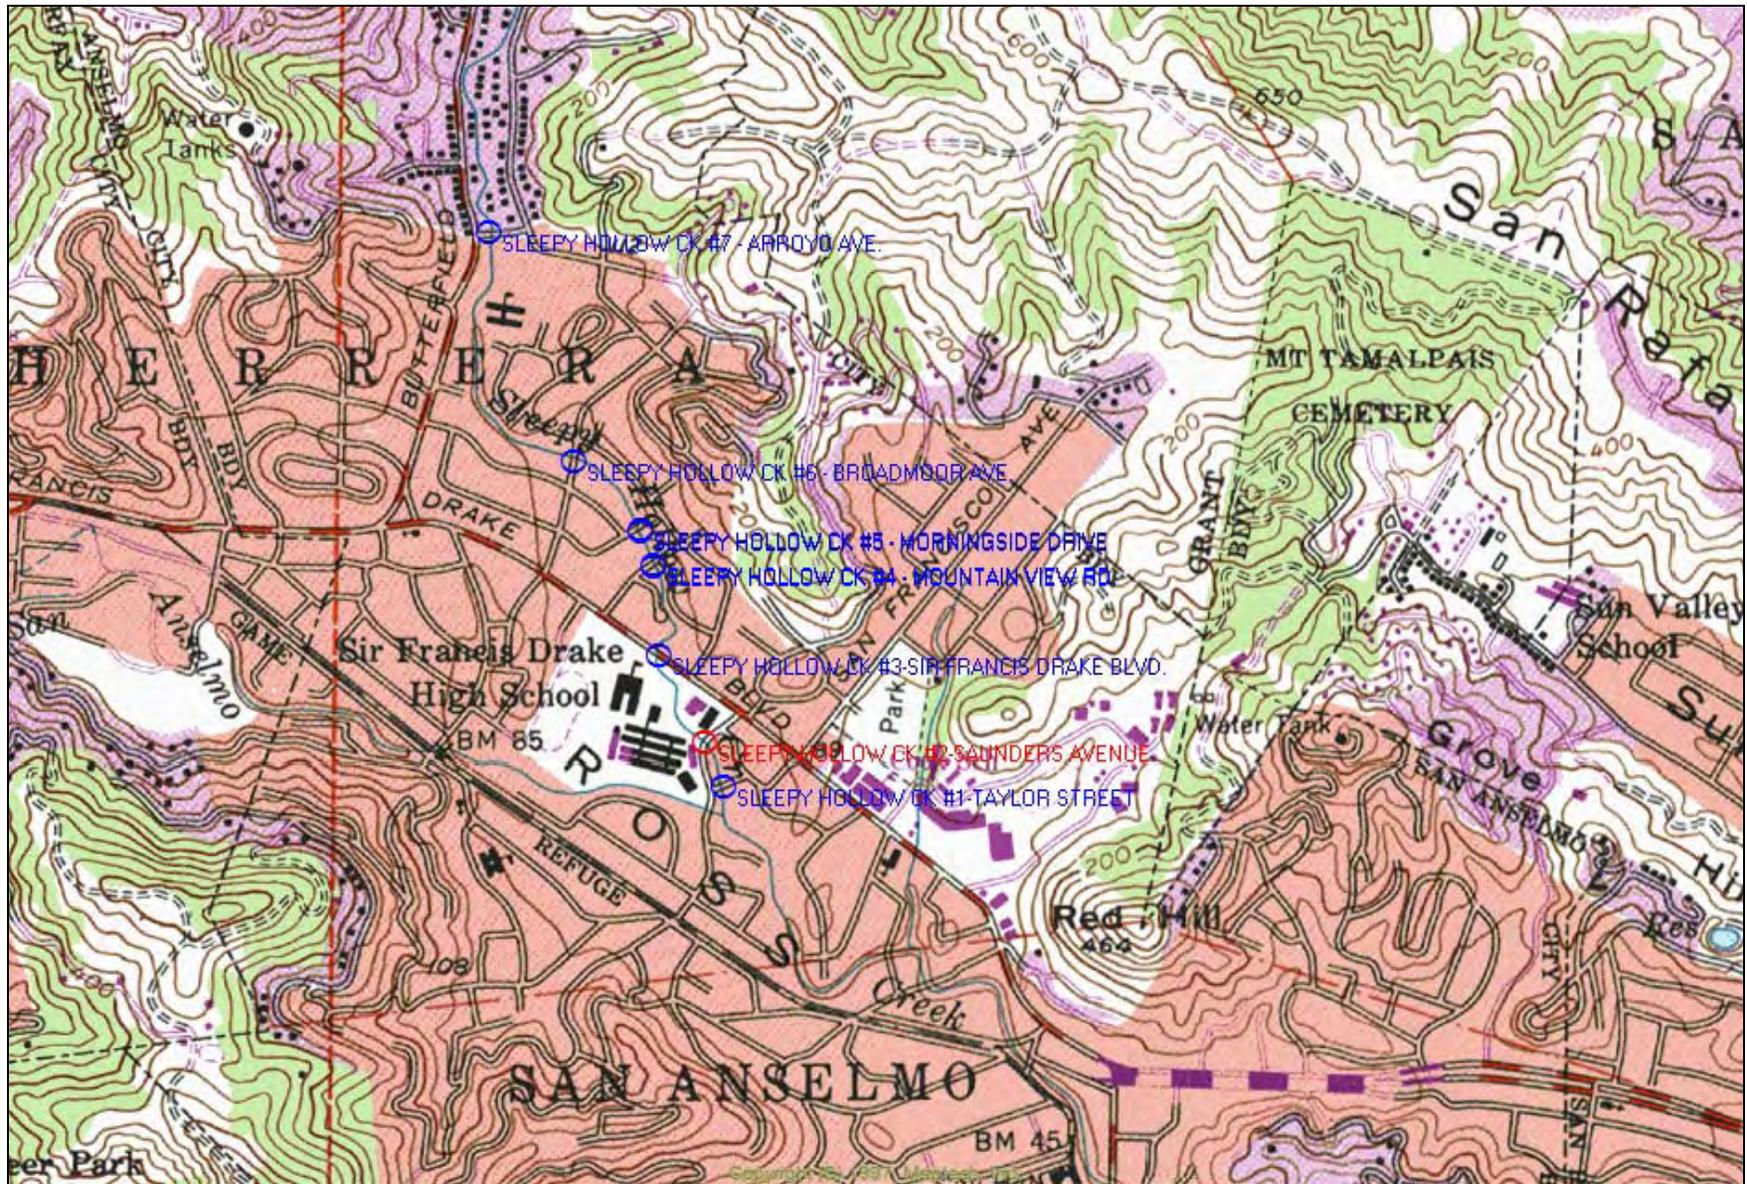
Site ID# SH-02: Sleepy Hollow Creek #2/Saunders Avenue; Corte Madera Creek

**CrossingType:** Concrete arch culvert. **Corrugations:** None. **Dimensions:** 12.0' Rise x 10.0' Span. **Length:** 42.7' **Slope:** 1.22% **Modifications:** None. **Rustline Height:** N/A  
**Ave. Active Channel Width:** 18.6' **Fill Estimate:** 973 Cubic Yards. **Overall Condition:** Good.  
**Sizing:** Properly-sized; HW/D = 1 on a storm flow with more than a 100-year recurrence interval.

**Drainage Area Upstream of Crossing:** 3.57 square miles. **Estimated Migration Flows:** anadromous adult salmonids = 3.0–99.4 c.f.s; resident/2+ = 2.0–25.7 c.f.s.; 1+/y-o-y = 1.0–11.2 c.f.s. **Passage Evaluation: GRAY:** as determined by the first-phase evaluation filter due to the constriction of the channel width through the crossing and insufficient residual depths at culvert inlet and outlet. FishXing estimated that the crossing met the 8-8-16ft/sec and 0.5 minimum depth passage criteria for adult anadromous salmonids for 66% of the range of migration flows (passable between 35.8–99.4 c.f.s.). FishXing estimated that the crossing failed to meet passage criteria for resident/2+ and 1+/y-o-y age classes. Actual passage of adults and older juveniles is probably higher due to “lack-of-depth” flagged as the primary criteria violation. Crossing was also assessed as having a flat/even invert when in actuality the invert was partially embedded and stream flow was concentrated to the right-bank side.

**Preferred Treatment:** Because the current crossing is properly sized and is fairly passable, no treatment is recommended at this point. Recommend periodic inspection to ensure that back-watering effect by tail-water control remains effective.

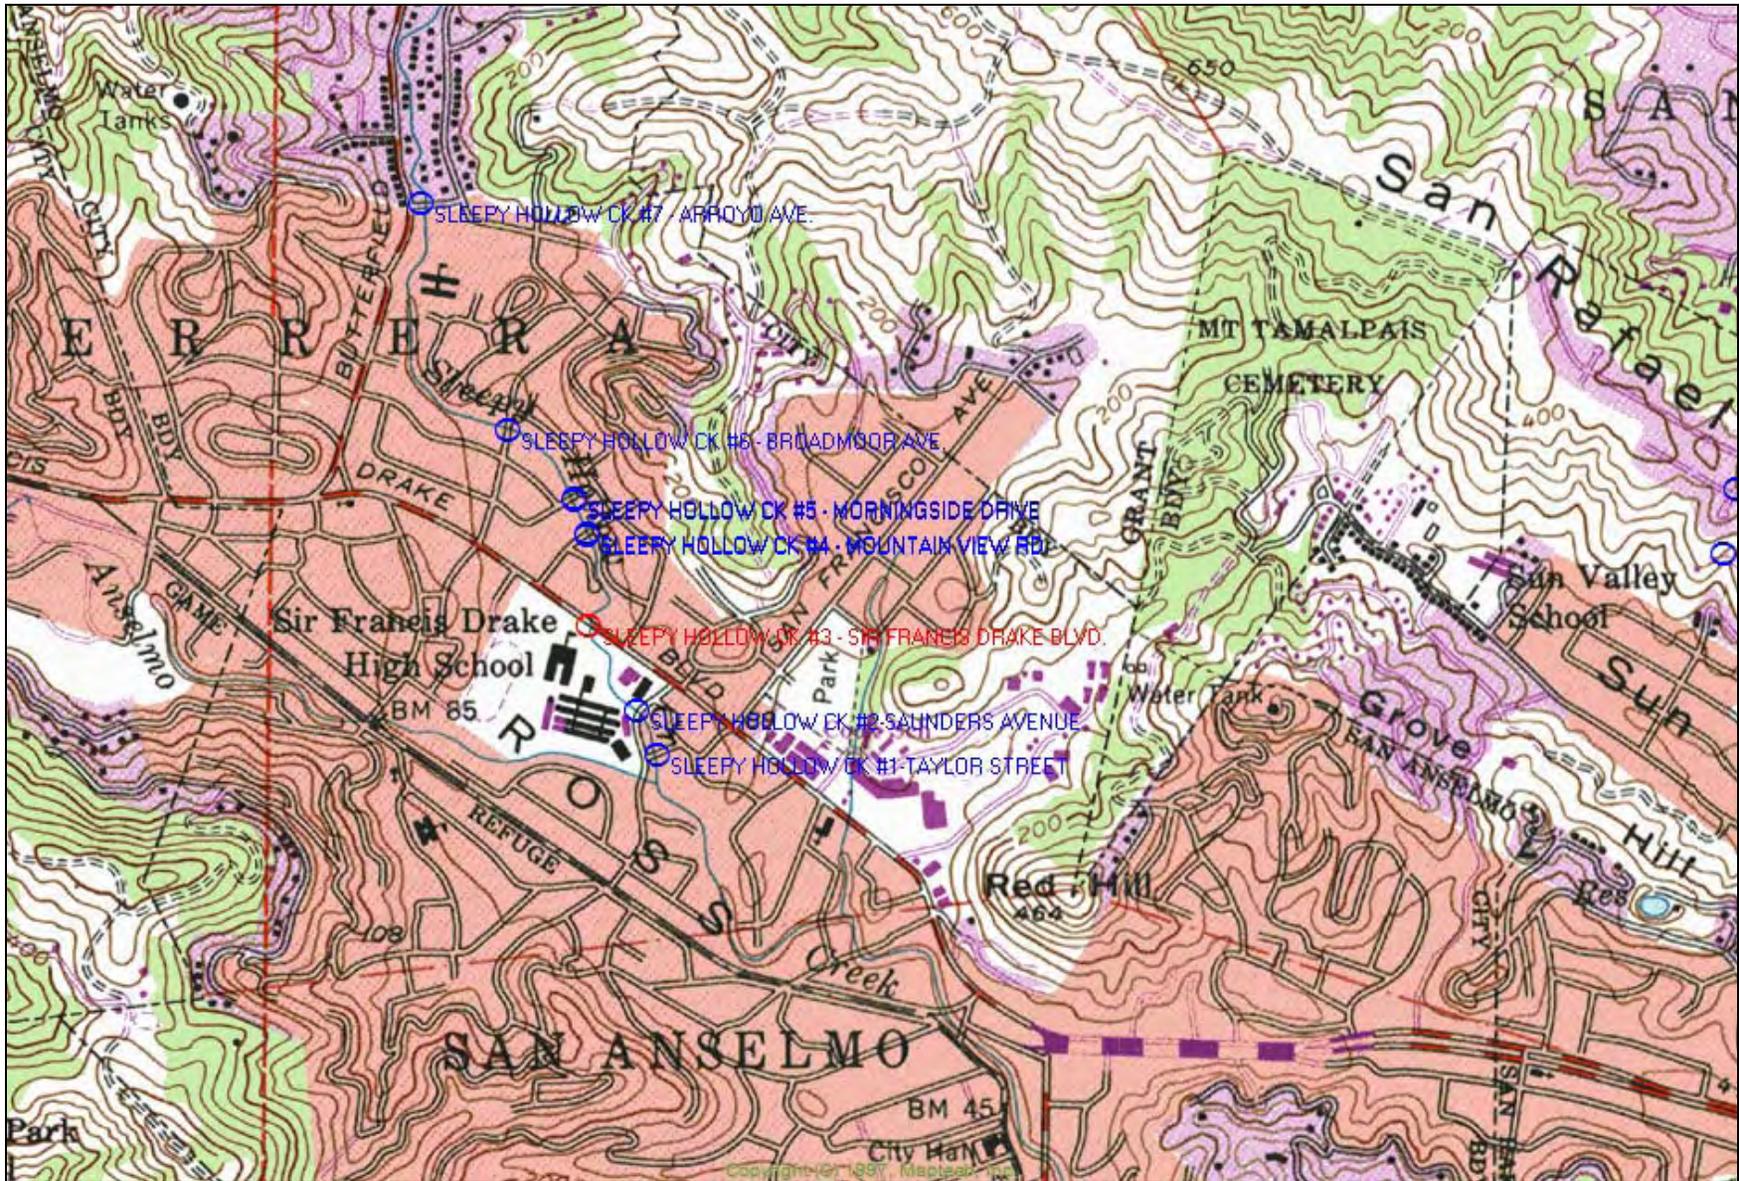
**Site ID# SH-03: Sleepy Hollow Creek #3/ Sir Francis Drake Blvd.; Corte Madera Creek**

**Crossing Type:** Concrete arch culvert with U-shaped invert. **Corrugations:** None.  
**Dimensions:** 9.9' Rise x 9.5' Span **Length:** 60.3' **Slope:** 1.91% **Modifications:** None.  
**Rustline Height:** N/A **Ave. Active Channel Width:** 18.6' **Fill Estimate:** 1,543 Cubic Yards.  
**Overall Condition:** Good. **Sizing:** Properly-sized; HW/D = 1 on a storm flow with more than a  
100-year recurrence interval.

**Drainage Area Upstream of Crossing:** 3.47 square miles. **Estimated Migration Flows:**  
anadromous adult salmonids = 3.0–96.6 c.f.s; resident/2+ = 2.0–25.0 c.f.s.; 1+/y-o-y = 1.0–10.9  
c.f.s. **Passage Evaluation:** **GRAY:** as determined by the first-phase evaluation filter due to the  
constriction of the channel width through the crossing and insufficient residual depths at culvert  
inlet and outlet. FishXing estimated that the crossing met the 8-8-16ft/sec and 0.5 minimum depth  
passage criteria for adult anadromous salmonids for 86% of the range of migration flows (9.7–94.3  
c.f.s.). Passage criteria for resident/2+ fish was met for 82% of the range of migration flows (3.1–

22.1 c.f.s.) and criteria for 1+/y-o-y fish was met for 67% of the range of migration flows (3.1–9.8  
c.f.s.). Actual passage of adults and older juveniles is probably higher because the crossing was  
assessed as having a flat/even invert when in actuality the invert was U-shaped that created an  
additional 1.8' of depth through much of the culvert.

**Preferred Treatment:** Because the current crossing is properly sized and fairly passable, no  
treatment is recommended at this point. Recommend periodic inspection to ensure that back-  
watering effect by tail-water control remains effective.

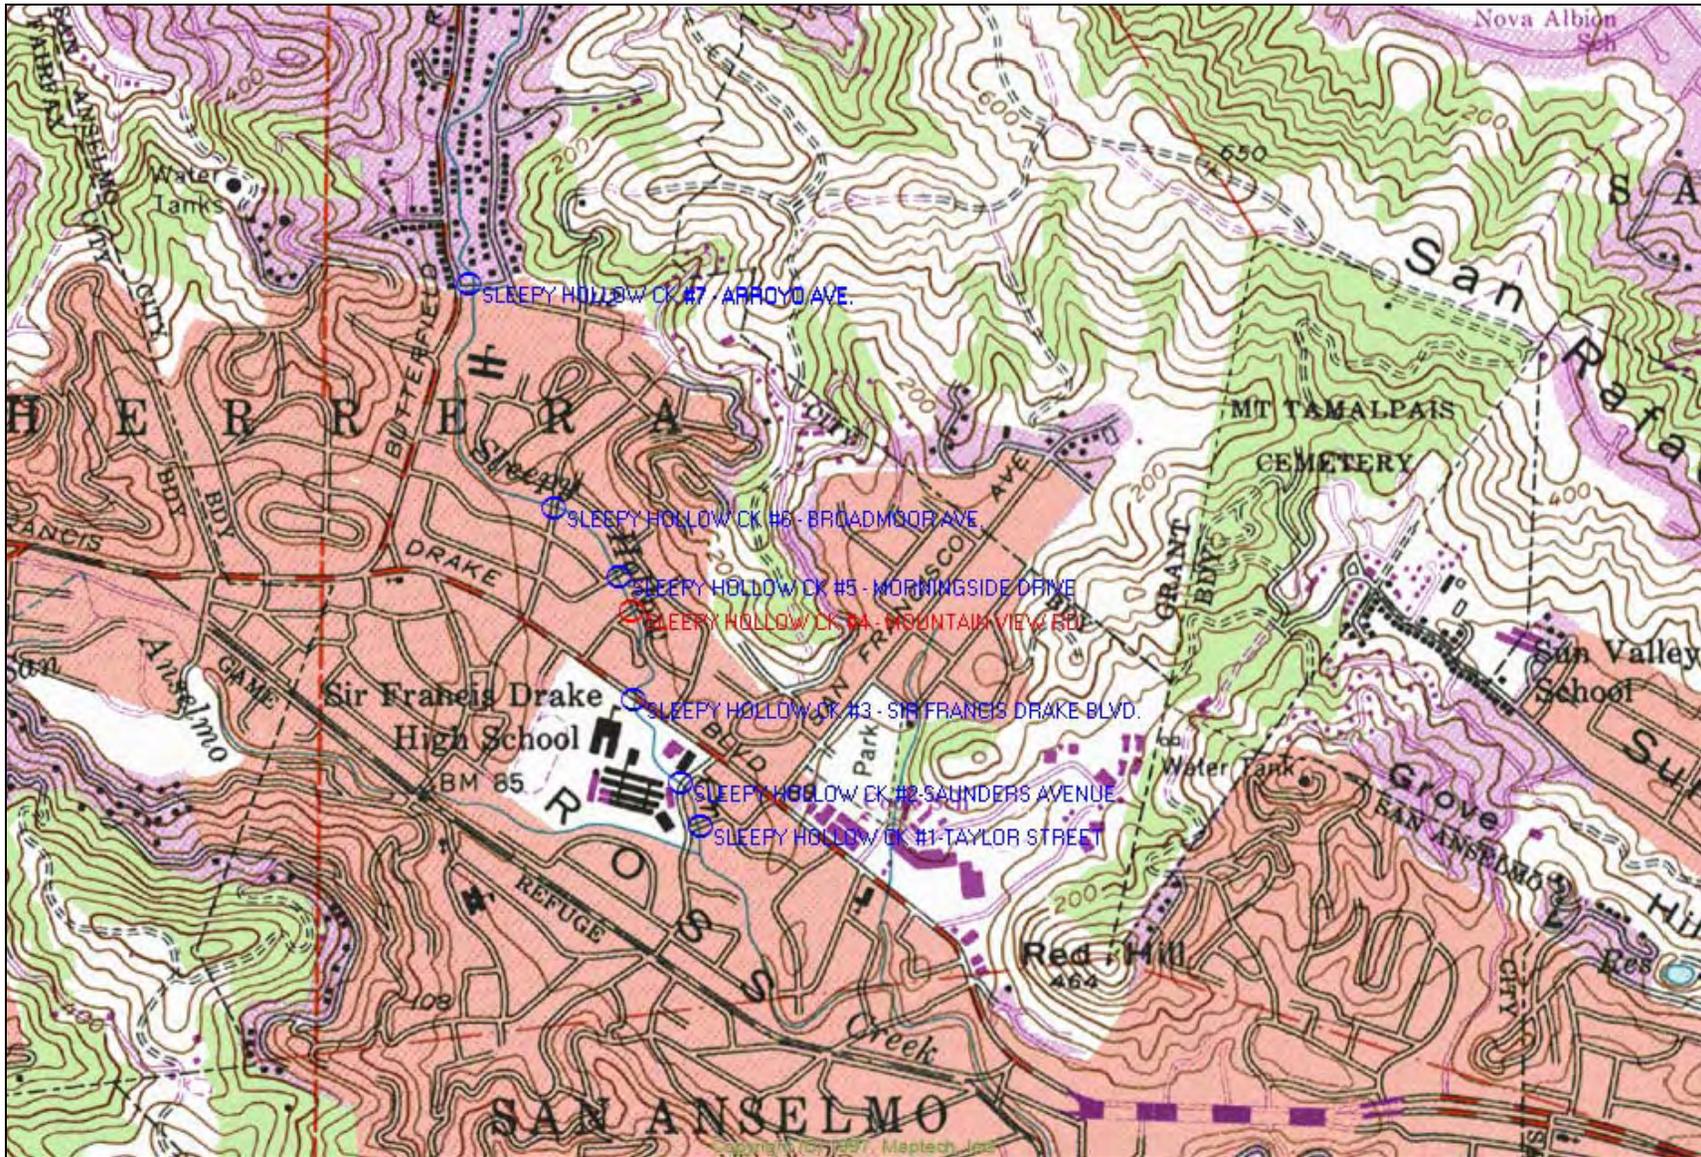
Site ID# SH-04: Sleepy Hollow Creek #4/Mountain View Avenue; Corte Madera Creek

**Crossing Type:** Concrete arch culvert with slight U-shaped invert. **Corrugations:** None.

**Ave. Active Channel Width:** 18.6' **Fill Estimate:** 349 Cubic Yards. **Overall Condition:** Good.

c.f.s. **Passage Evaluation: GRAY:** as determined by the first-phase evaluation filter due to the

constriction of the channel width through the crossing and insufficient residual depths at culvert

inlet and outlet. FishXing estimated that the crossing met the 8-8-16ft/sec and 0.5 minimum depth

passage criteria for adult anadromous salmonids for 47% of the range of migration flows (52.3-

95.8 c.f.s.). FishXing estimated that the crossing failed to meet passage criteria for all juvenile age

**Preferred Treatment:** Because the current crossing is properly sized and fairly passable, no treatment is recommended at this point. Recommend periodic inspection to monitor potential changes in elevation of the downstream channel bed.

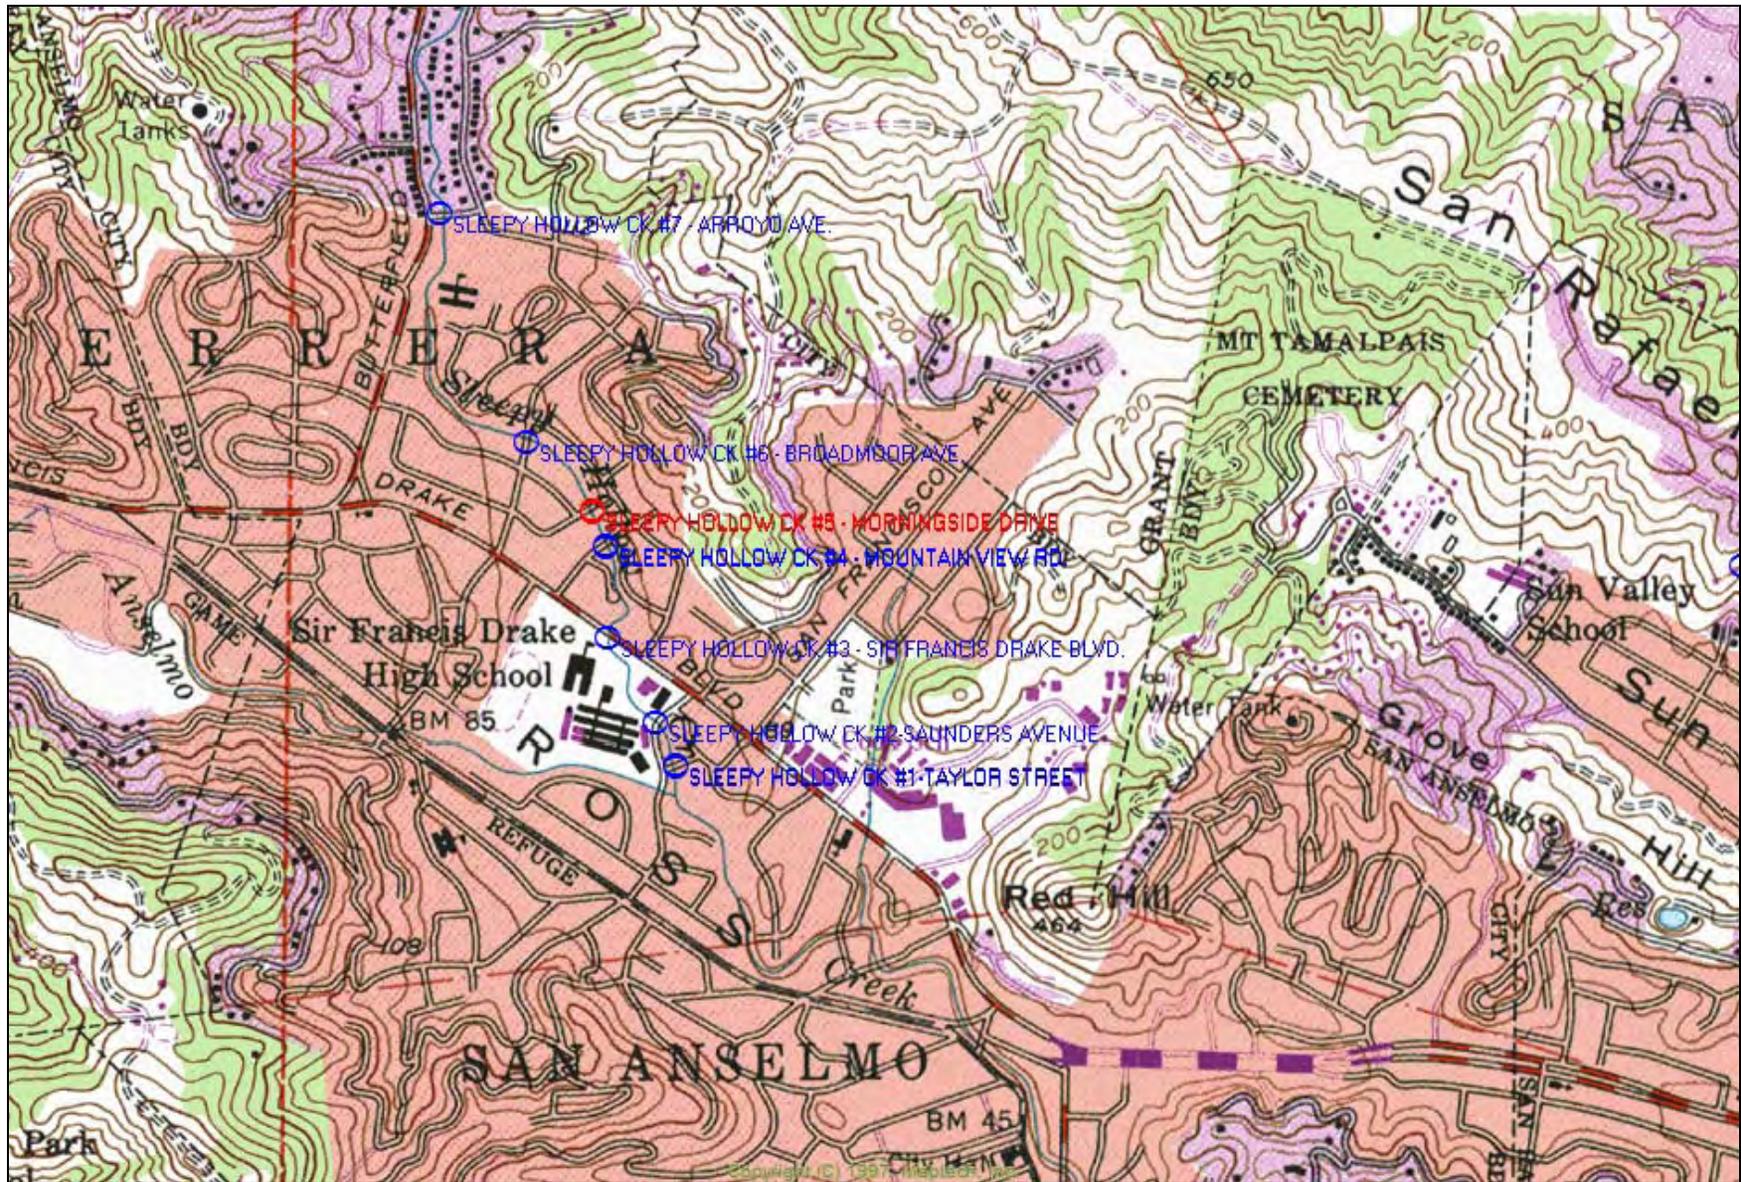
Site ID# SH-05: Sleepy Hollow Creek #5/Morningside Drive; Corte Madera Creek

**Crossing Type:** Concrete box culvert w/inlet apron. **Corrugations:** None. **Dimensions:** 7.7' H x 14.0' W **Length:** culvert = 40.0'; apron = 29.5' **Slope:** 0.78% **Modifications:** None.  
**Rustline Height:** N/A **Ave. Active Channel Width:** 18.6' **Fill Estimate:** 429 Cubic Yards.  
**Overall Condition:** Good. **Sizing:** Properly-sized; HW/D = 1 on a storm flow with more than a 100-year recurrence interval.

**Drainage Area Upstream of Crossing:** 3.40 square miles. **Estimated Migration Flows:** anadromous adult salmonids = 3.0–94.7 c.f.s.; resident/2+ = 2.0-24.5 c.f.s.; 1+/y-o-y = 1.0-10.7 c.f.s. **Passage Evaluation: GRAY:** as determined by the first-phase evaluation filter due to the constriction of the channel width through the crossing and insufficient residual depths at culvert inlet and outlet. FishXing estimated that the crossing met the 8-8-16ft/sec and 0.5 minimum depth passage criteria for adult anadromous salmonids for 75% of the range of migration flows (52.3-95.8 c.f.s.). The crossing met passage criteria of resident/2+ age class salmonids for 55% of the range of migration flows (12.1-24.5 c.f.s.) and failed to meet passage for 1+/y-o-y juveniles. Actual passage of adults and juveniles is probably higher because the crossing was assessed with a flat/even invert when in actuality the invert was slightly U-shaped which created additional depth.

**Preferred Treatment:** Because the current crossing is properly sized and fairly passable, no treatment is recommended at this point. Recommend periodic inspection to ensure that back-watering effect by tail-water control remains effective.

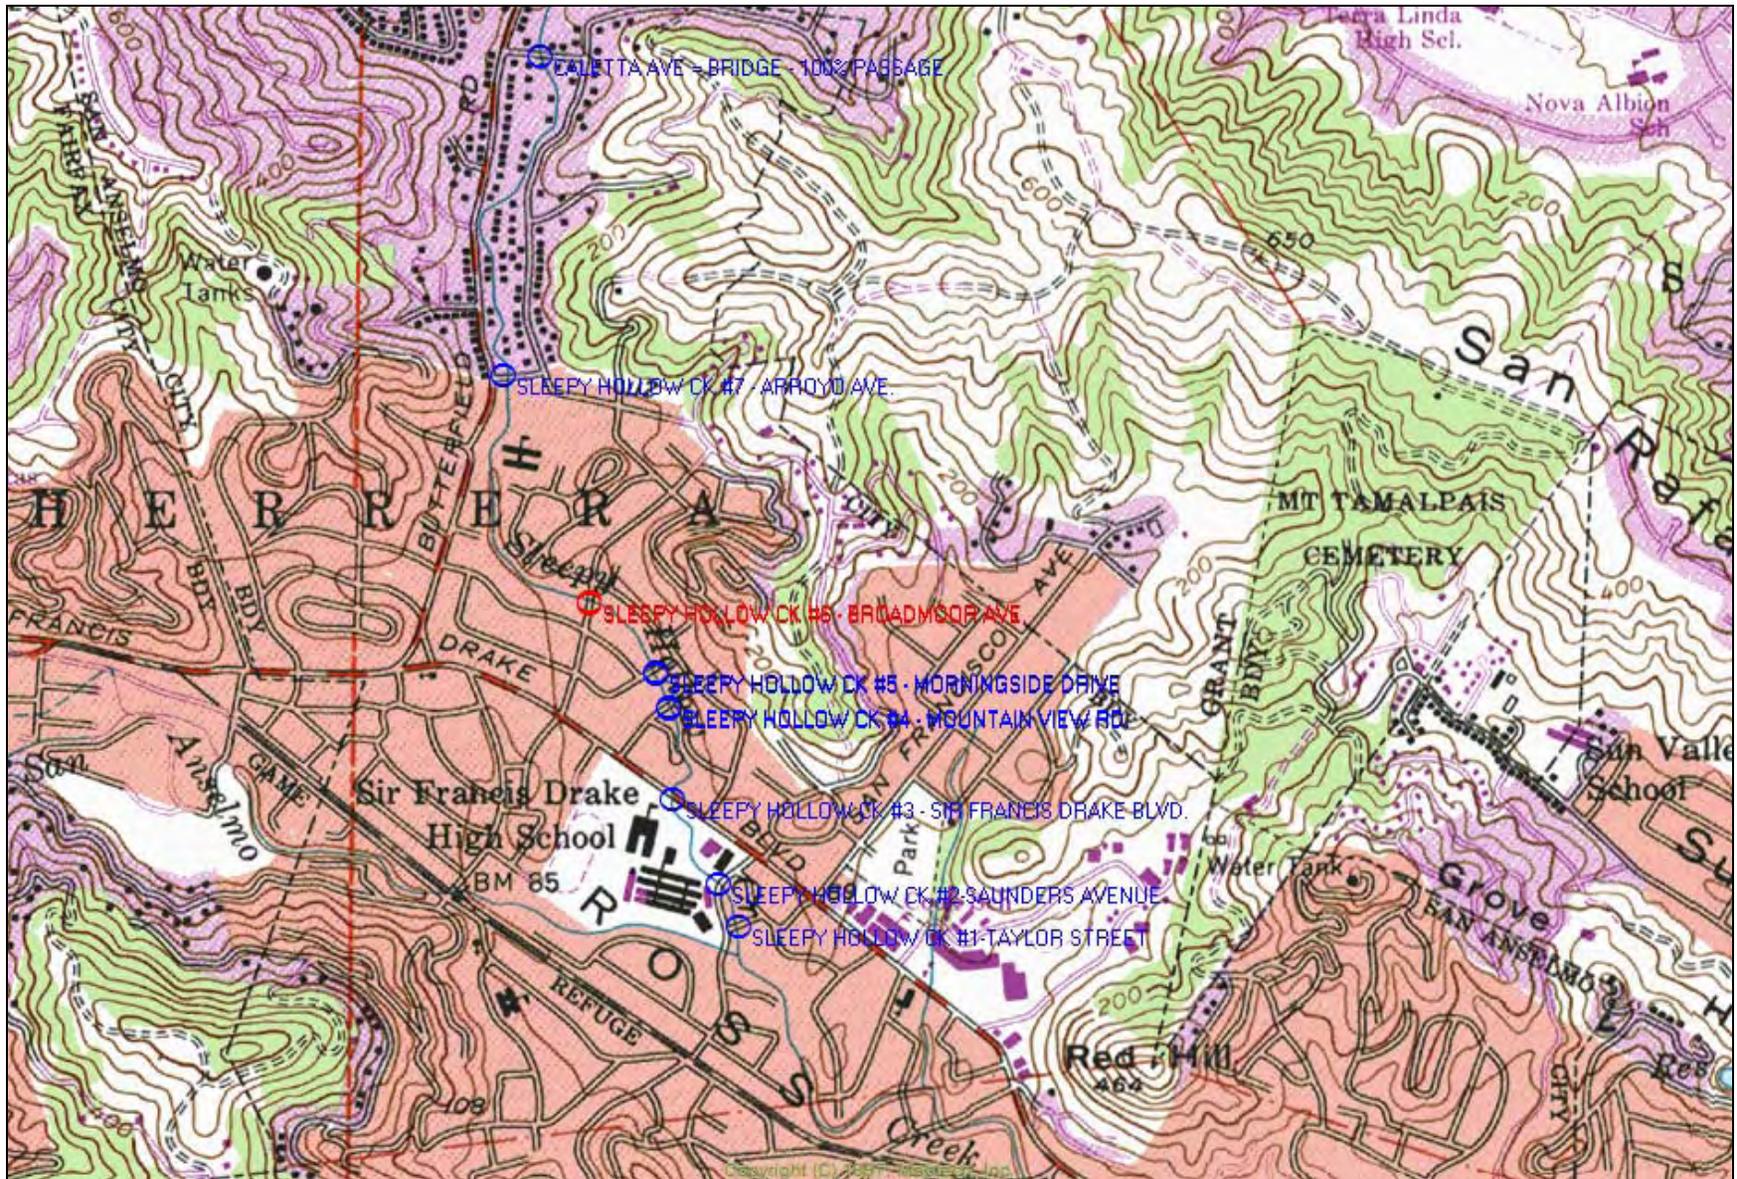
Site ID# SH-06: Sleepy Hollow Creek #6/Broadmoor Avenue; Corte Madera Creek

**Crossing Type:** Box culvert, concrete. **Corrugations:** None. **Dimensions:** 7.5' H x 14.0' W  
**Length:** 50.0' **Slope:** 0.58% **Modifications:** None. **Rustline Height:** N/A  
**Ave. Active Channel Width:** 18.6' **Fill Estimate:** 429 Cubic Yards. **Overall Condition:** Good.  
**Sizing:** Properly-sized; HW/D = 1 on a storm flow with more than a 100-year recurrence interval.

**Drainage Area Upstream of Crossing:** 3.33 square miles. **Estimated Migration Flows:**  
anadromous adult salmonids = 3.0–92.7 c.f.s; resident/2+ = 2.0–24.0 c.f.s.; 1+/y-o-y = 1.0–10.5  
c.f.s. **Passage Evaluation:** **GRAY:** as determined by the first-phase evaluation filter due to the  
constriction of the channel width through the crossing and insufficient residual depths at culvert  
inlet and outlet. FishXing estimated that the crossing met the 8-8-16ft/sec and 0.5 minimum depth  
passage criteria for adult anadromous salmonids for 68% of the range of migration flows (31.9-  
92.7 c.f.s.). The crossing failed to meet passage criteria for all juvenile salmonid age classes.  
Actual passage of adults and possibly resident/2+ juvenile salmonids is probably higher because  
the only criteria violation was “lack-of-depth”.

**Preferred Treatment:** Because the current crossing is properly sized and fairly passable, no  
treatment is recommended at this point. Recommend periodic inspection to ensure that back-  
watering effect by tail-water control remains effective.

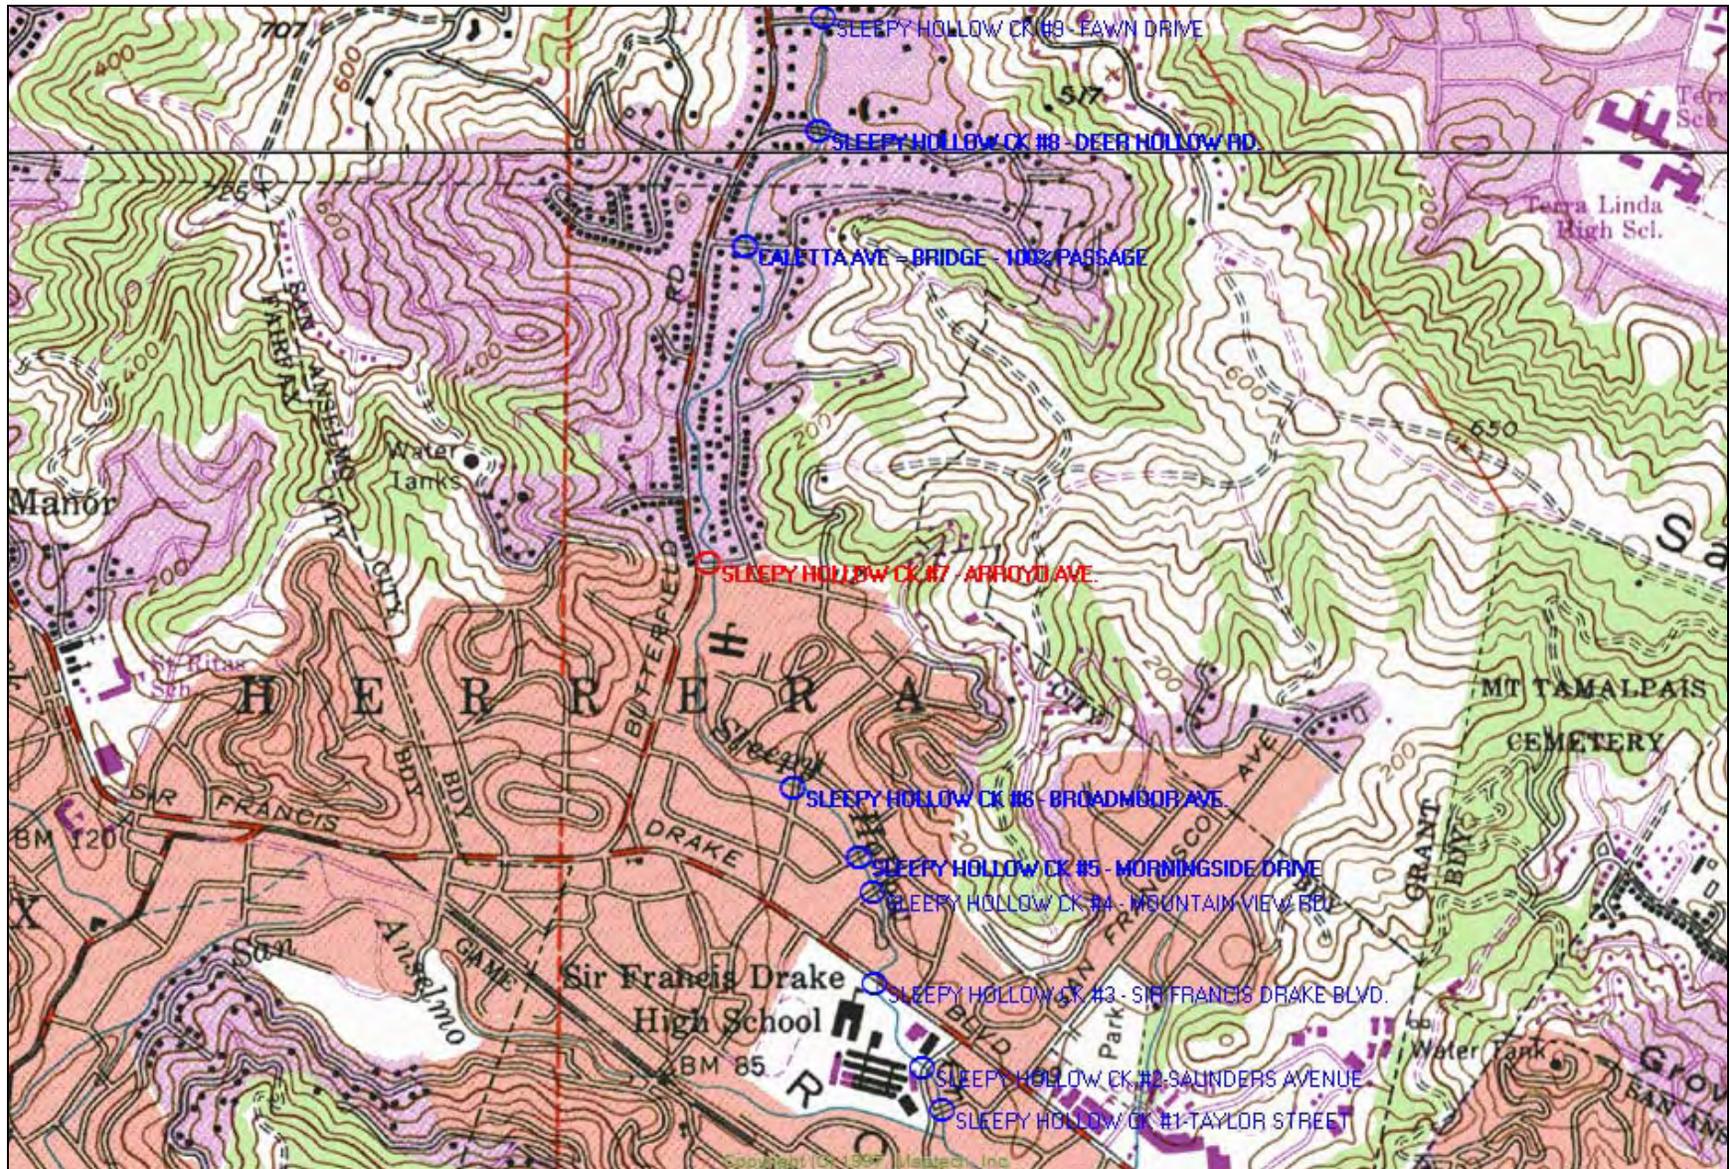
Site ID# SH-07: Sleepy Hollow Creek #7/Arroyo Avenue; Corte Madera Creek

**Crossing Type:** Arch culvert with open bottom. **Corrugations:** None. **Dimensions:** 9.35' Rise x 13.8' Span **Length:** 39.8' **Slope:** -0.95% **Modifications:** None. **Rustline Height:** N/A **Ave. Active Channel Width:** 18.4' **Fill Estimate:** 612 Cubic Yards. **Overall Condition:** Good. **Sizing:** Properly-sized; HW/D = 1 on a storm flow with more than a 100-year recurrence interval.

**Drainage Area Upstream of Crossing:** 3.07 square miles. **Estimated Migration Flows:** anadromous adult salmonids = 3.0–85.5 c.f.s; resident/2+ = 2.0–22.1 c.f.s.; 1+/y-o-y = 1.0–9.6 c.f.s. **Passage Evaluation: GRAY:** as determined by the first-phase evaluation filter due to the constriction of the channel width through the crossing. However, FishXing estimated that the crossing met the passage criteria for adult and all juvenile age classes of anadromous salmonids for all migration flows. Although classified as “open-bottom”, the crossing does have concrete supports at the inlet and outlet set perpendicular to the stream channel with were 0.8' and 0.4' deep (respectively) at low flow.

**Preferred Treatment:** Because the current crossing is properly sized and 100% passable, no treatment is recommended at this point. Recommend periodic inspection to ensure that back-watering effect by tail-water control remains effective.

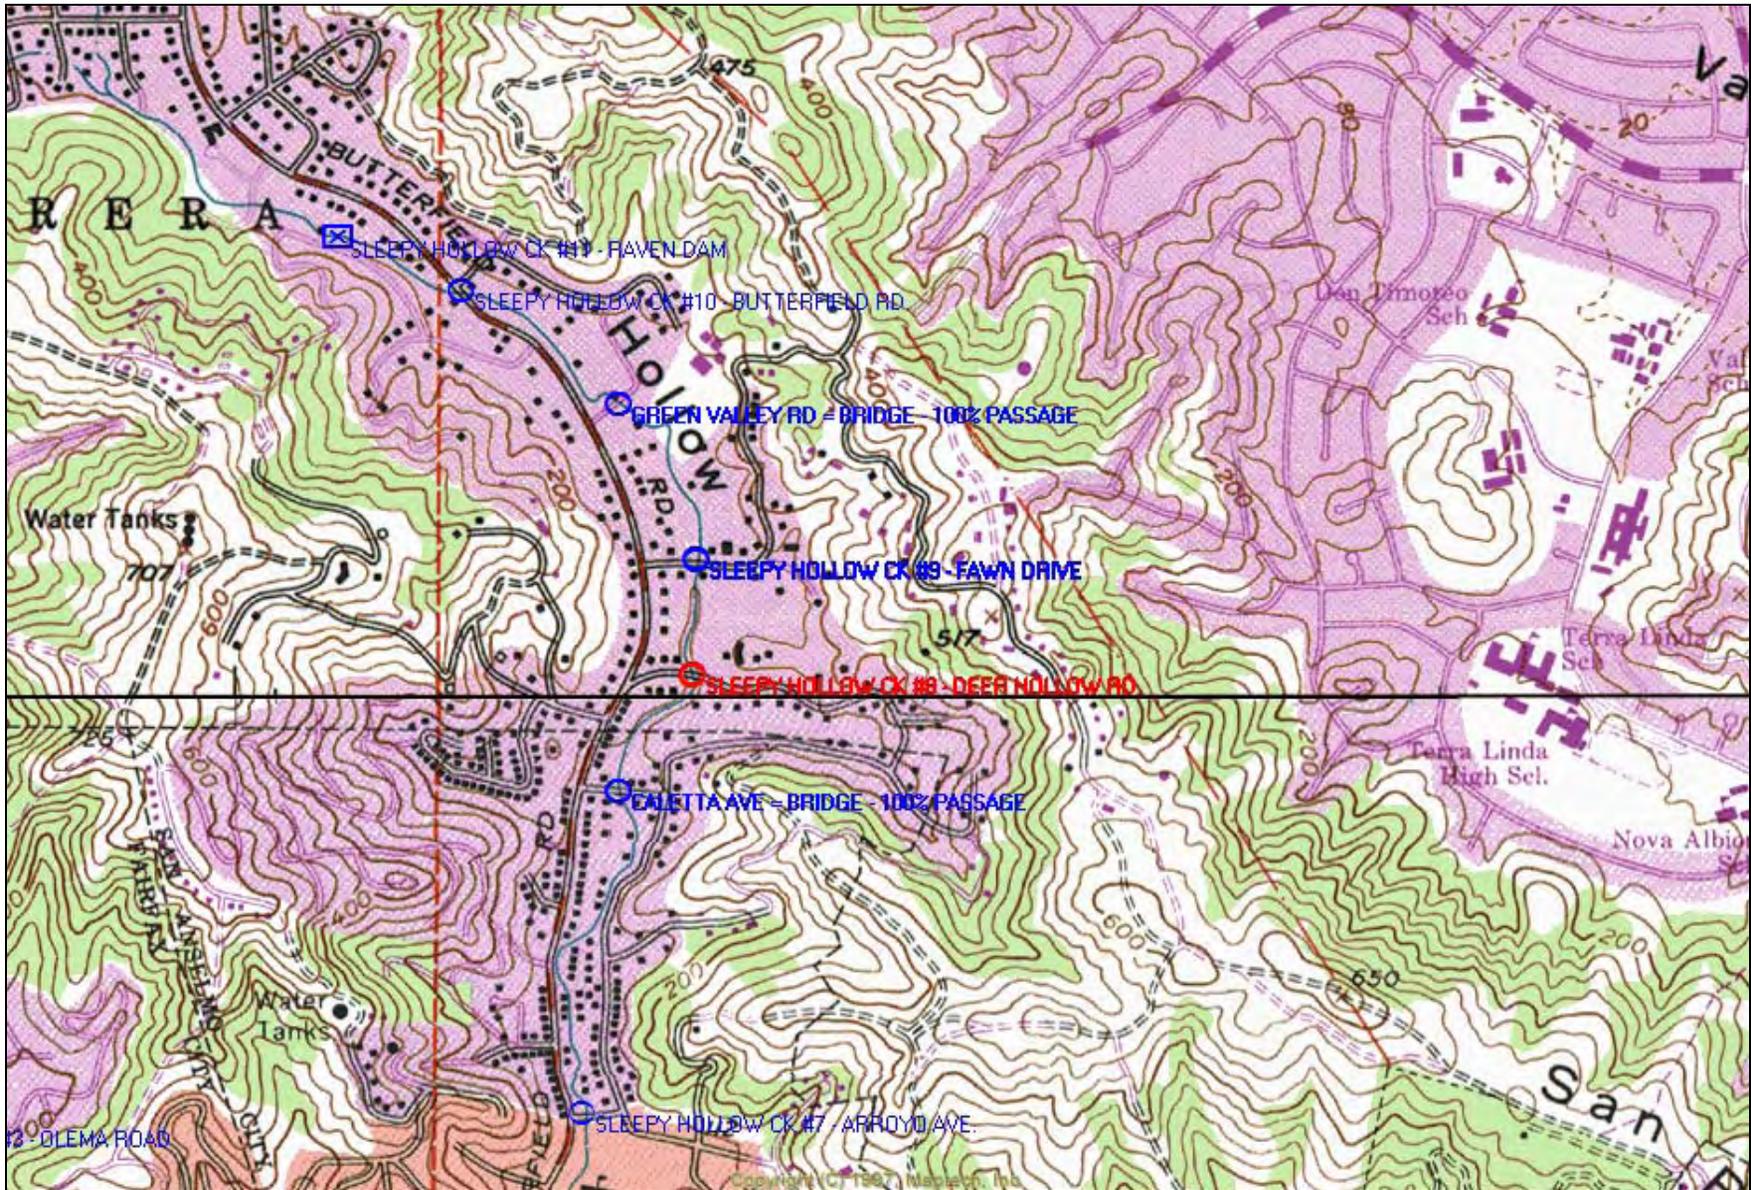
**Site ID# SH-08 aka MR-081: Sleepy Hollow Creek #8/Deer Hollow Road; Corte Madera Creek**

**Crossing Type:** Box culvert, Concrete.    **Corrugations:** None.    **Dimensions:** 11.8' H x 13.0' W  
**Length:** 27.3'    **Slope:** 0.84%    **Modifications:** None.    **Rustline Height:** N/A    **Average Active Channel Width:** 18.4'    **Fill Estimate:** 739 Cubic Yards.    **Overall Condition:** Fair– floor is worn.    **Sizing:** Properly-sized; HW/D = 1 on a storm flow with more than a 100-year recurrence interval.

**Drainage Area Upstream of Crossing:** 2.44 square miles.    **Estimated Migration Flows:** anadromous adult salmonids = 3.0–68.0 c.f.s; resident/2+ = 2.0-17.6 c.f.s.; 1+/y-o-y = 1.0-7.7 c.f.s.    **Passage Evaluation: RED:** the Green-Gray-Red filter determined this crossing fails to meet passage criteria for all species of adult salmonids and all age classes of juveniles. Outlet is perched 5.8 feet (residual height) and spills over a sloped bedrock/concrete drop.

**Preferred Treatment:** Because the current crossing is properly sized, a retrofit is recommended to improve conditions for fish passage. At least five to six boulder weirs are required to sufficiently raise the tail-water elevation and corner baffles within the culvert will increase depths and decrease velocities. Or consider feasibility of constructing a concrete fish ladder onto the bedrock outcrop at the culvert outlet in conjunction with a series of sloped, concrete weirs with low-flows notches through the box culvert to increase depths. Recommend consulting with CDFG and NOAA hydraulic engineers for design assistance.

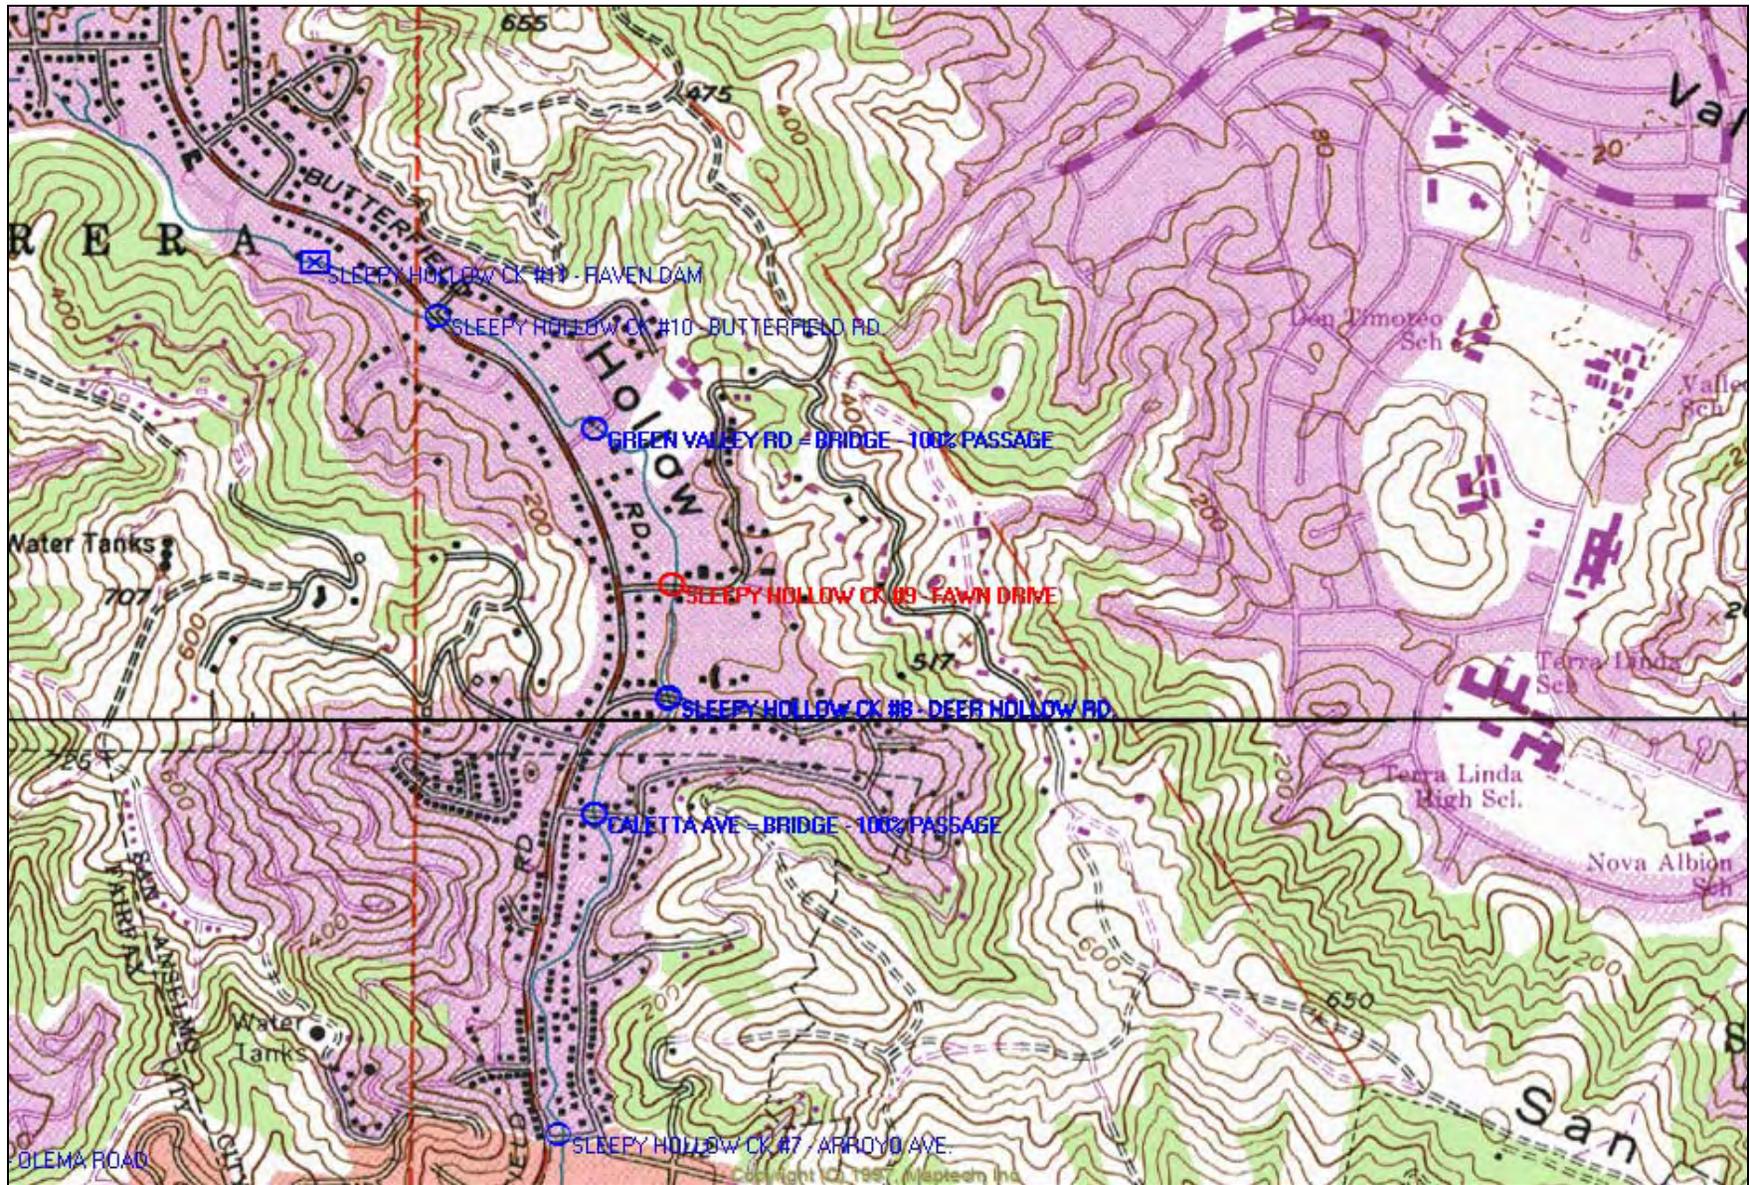
Site ID# SH-09 aka MR-082: Sleepy Hollow Creek #9/Fawn Drive; Corte Madera Creek

**Crossing Type:** Box culvert, Concrete.    **Corrugations:** None.    **Dimensions:** 8.5' height x 13.0' width    **Length:** 48.9'    **Slope:** 4.21%    **Modifications:** None.    **Rustline Height:** N/A    **Average Active Channel Width:** 18.4'    **Fill Estimate:** 767 Cubic Yards.    **Overall Condition:** Good.    **Sizing:** Properly-sized; HW/D = 1 on a storm flow with more than a 100-year recurrence interval.

**Drainage Area Upstream of Crossing:** 2.34 square miles.    **Estimated Migration Flows:** anadromous adult salmonids = 3.0–65.2 c.f.s; resident/2+ = 2.0-16.9 c.f.s.; 1+/y-o-y = 1.0-7.3 c.f.s.    **Passage Evaluation: RED:** FishXing determined this crossing failed to meet the 8-16-16 ft/sec passage criteria for adult steelhead and all age classes of juveniles. For adults, FishXing indicated a lack-of-depth up to 30 c.f.s. (then excessive velocities occur at higher flows), thus some adult steelhead may burst through this moderately steep, yet short box culvert. The concave invert provides additional depth not accounted for by FishXing.

**Preferred Treatment:** Because the current crossing is properly sized, fish passage could be cost-effectively improved by installing fully-spanning, sloped concrete weirs within the box culvert, an outlet beam with a low-flow notch, and possibly one to two downstream boulder weirs to raise tail-water elevation. Recommend consulting with CDFG and NOAA hydraulic engineers for design assistance.
