**CATALOG OF STREAM CROSSINGS WITH CULVERTS AND  
OTHER MANMADE IMPEDIMENTS TO FISH PASSAGE  
LOCATED ON ANADROMOUS STREAM REACHES WITHIN  
SLEEPY HOLLOW CREEK, CORTE MADERA CREEK  
WATERSHED, MARIN COUNTY, CA.**

**Prepared for Friends of the Corte Madera Creek Watershed**

**By  
Ross Taylor and Associates**

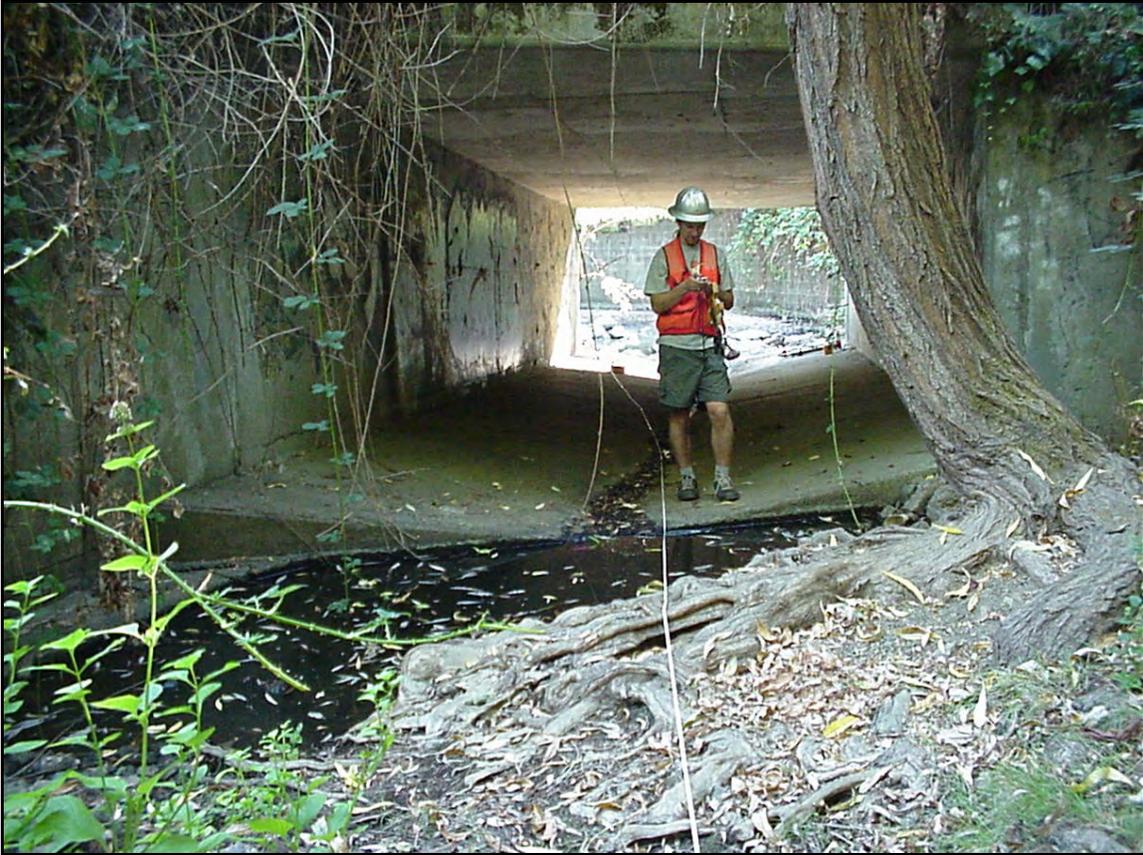
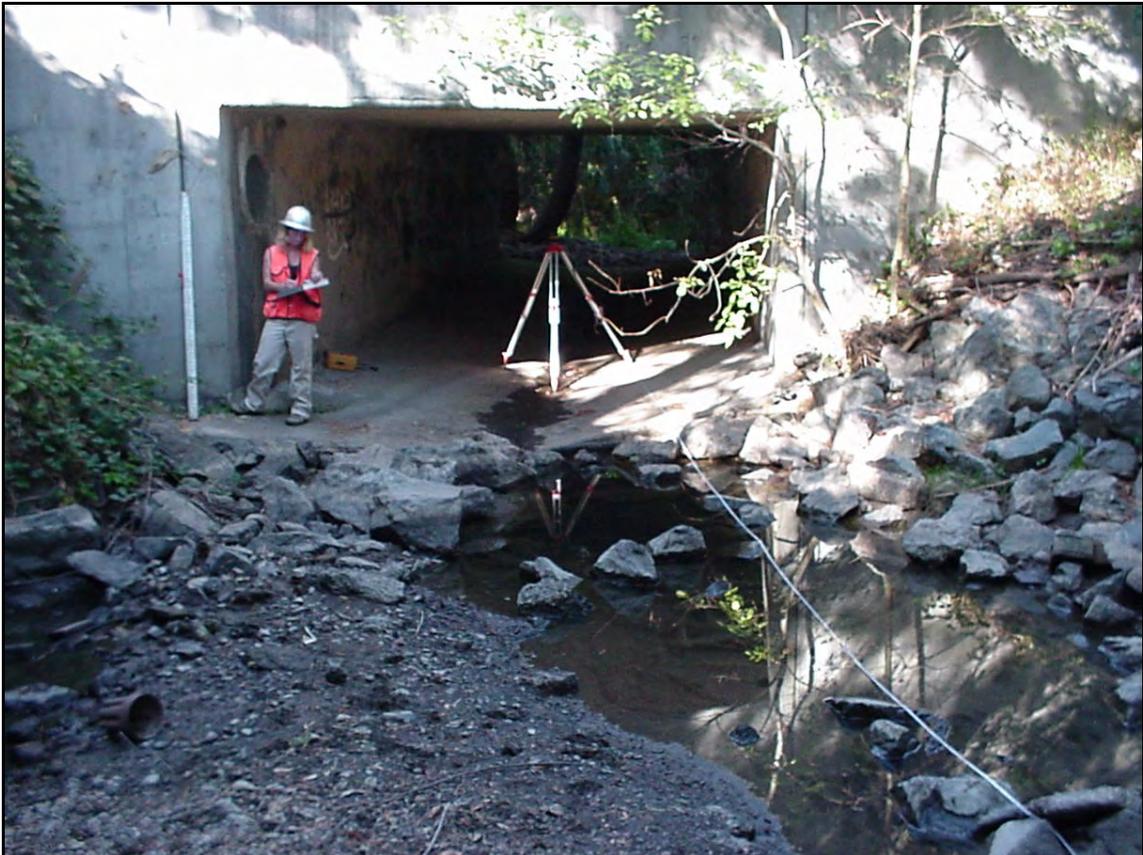
**Site ID# SH-09 aka MR-082: Sleepy Hollow Creek #9/Fawn Drive; Corte Madera Creek**

**Crossing Type:** Box culvert, Concrete.    **Corrugations:** None.    **Dimensions:** 8.5' height x 13.0' width    **Length:** 48.9'    **Slope:** 4.21%    **Modifications:** None.    **Rustline Height:** N/A    **Average Active Channel Width:** 18.4'    **Fill Estimate:** 767 Cubic Yards.    **Overall Condition:** Good.    **Sizing:** Properly-sized; HW/D = 1 on a storm flow with more than a 100-year recurrence interval.

**Drainage Area Upstream of Crossing:** 2.34 square miles.    **Estimated Migration Flows:** anadromous adult salmonids = 3.0–65.2 c.f.s; resident/2+ = 2.0-16.9 c.f.s.; 1+/y-o-y = 1.0-7.3 c.f.s.    **Passage Evaluation: RED:** FishXing determined this crossing failed to meet the 8-16-16 ft/sec passage criteria for adult steelhead and all age classes of juveniles. For adults, FishXing indicated a lack-of-depth up to 30 c.f.s. (then excessive velocities occur at higher flows), thus some adult steelhead may burst through this moderately steep, yet short box culvert. The concave invert provides additional depth not accounted for by FishXing.

**Preferred Treatment:** Because the current crossing is properly sized, fish passage could be cost-effectively improved by installing fully-spanning, sloped concrete weirs within the box culvert, an outlet beam with a low-flow notch, and possibly one to two downstream boulder weirs to raise tail-water elevation. Recommend consulting with CDFG and NOAA hydraulic engineers for design assistance.

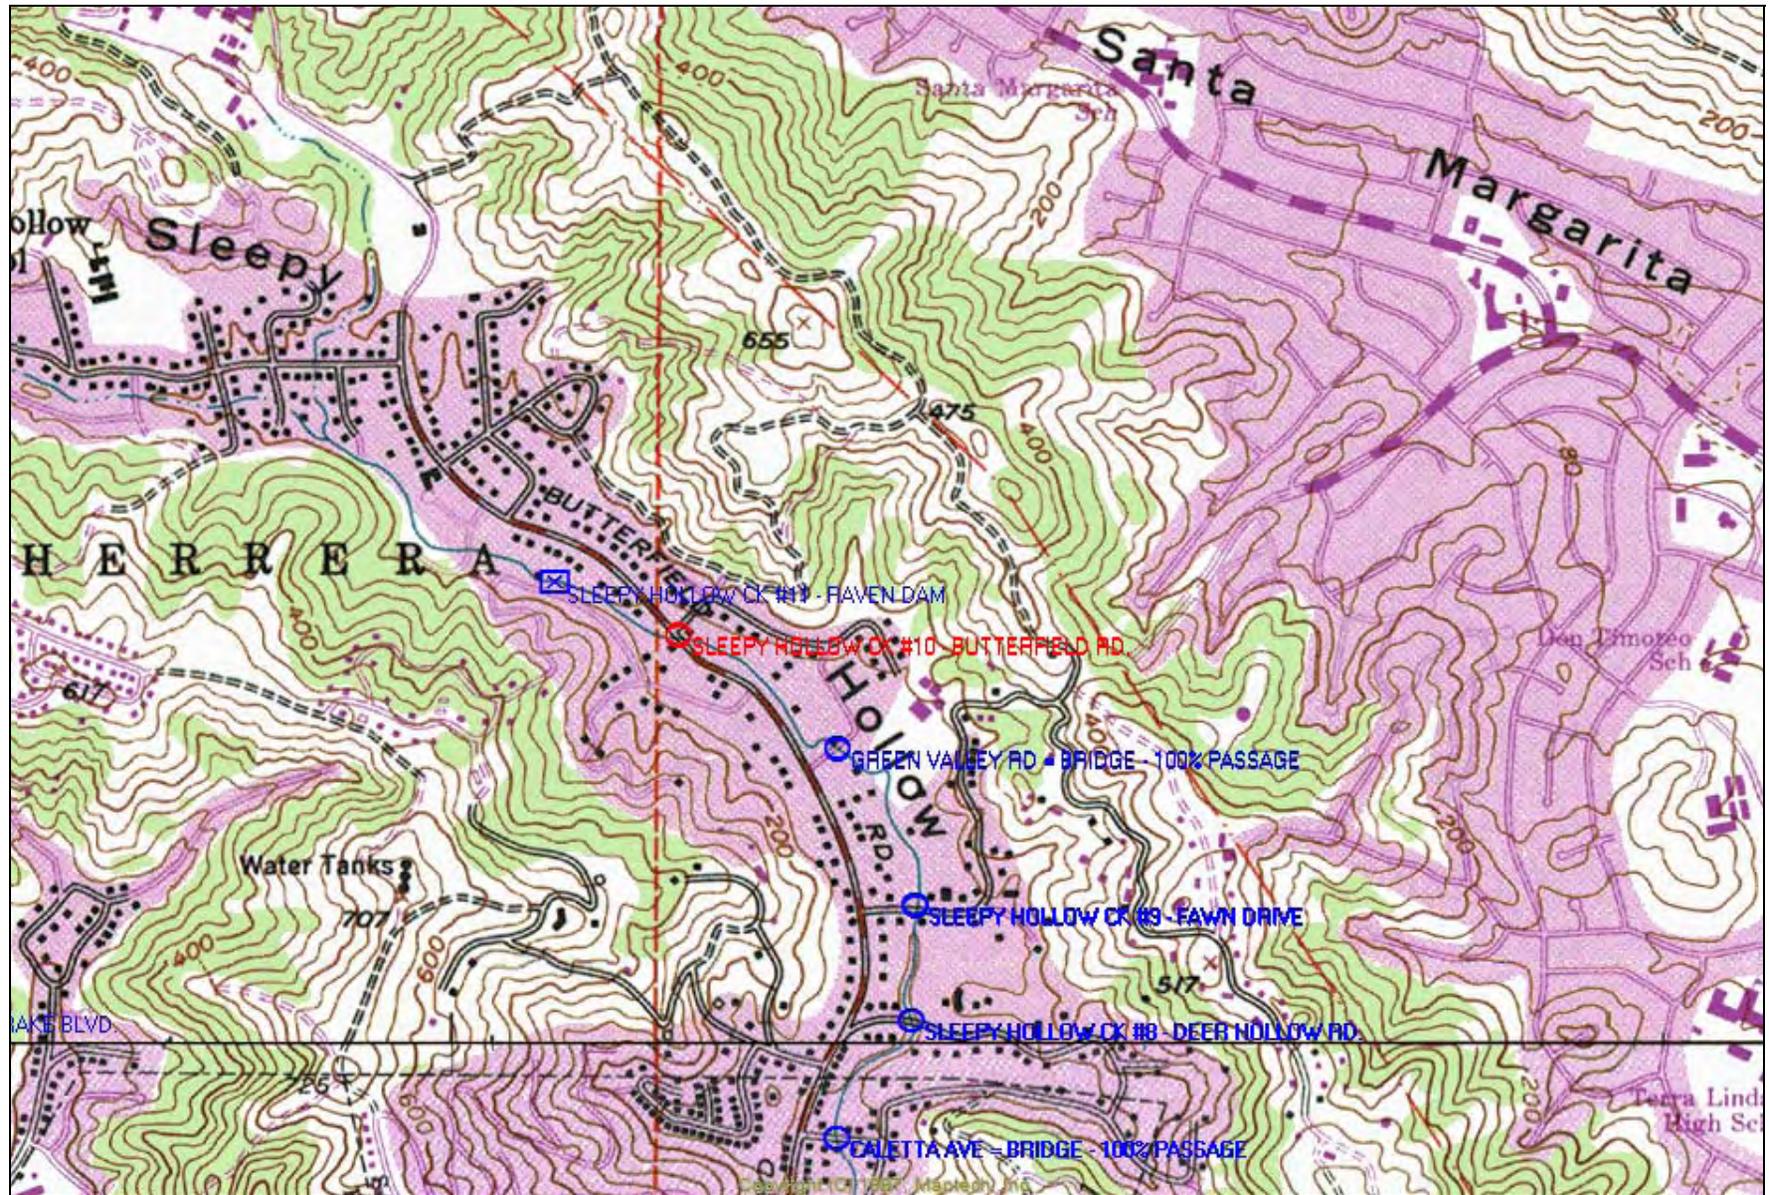
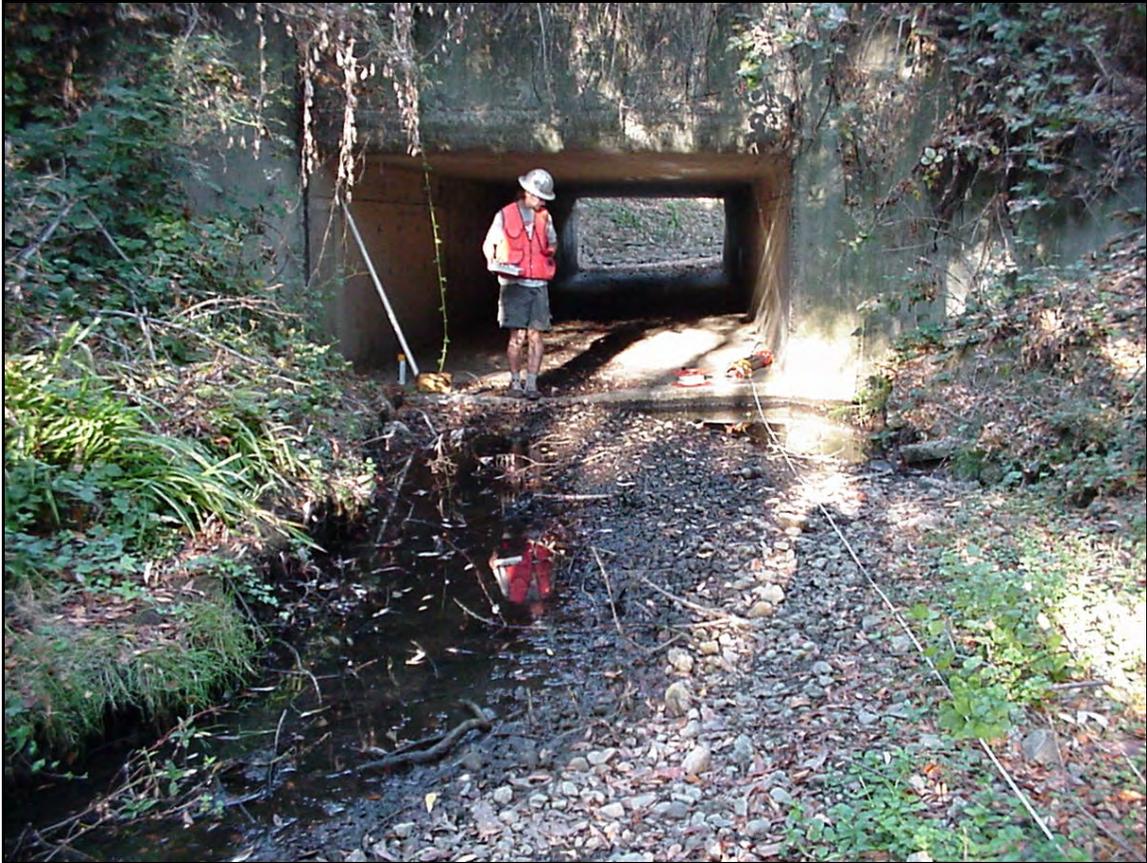
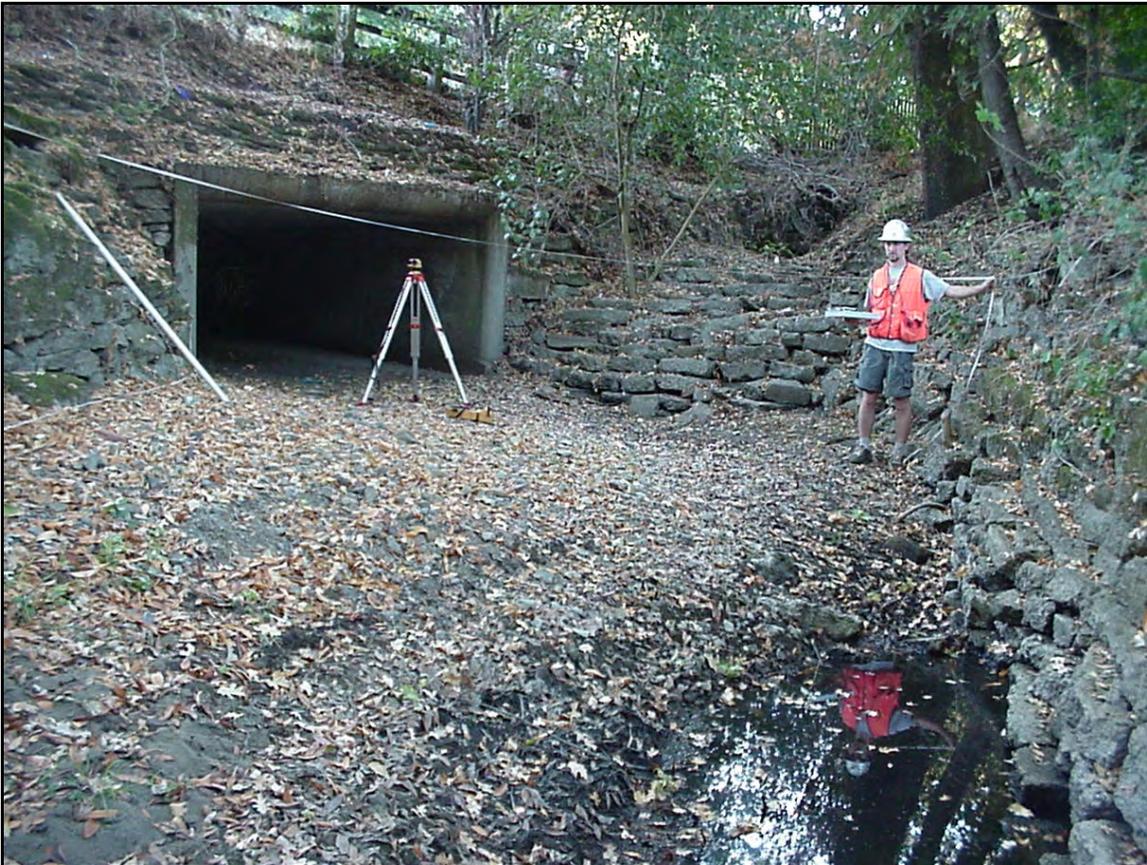
Site ID# SH-10 aka MR-083: Sleepy Hollow Creek #10/Butterfield Road; Corte Madera Creek

**Crossing Type:** Box culvert, Concrete.    **Corrugations:** None.    **Dimensions:** 6.15' height x 11.8' width    **Length:** 75.3'    **Slope:** 0.81%    **Modifications:** None.    **Rustline Height:** N/A    **Average Active Channel Width:** 18.4'    **Fill Estimate:** 1,347 Cubic Yards.    **Overall Condition:** Fair—floor is worn.    **Sizing:** Adequately Undersized; HW/D = 1 on a storm flow with approximately a 96-year recurrence interval.

**Drainage Area Upstream of Crossing:** 1.99 square miles.    **Estimated Migration Flows:** anadromous adult salmonids = 3.0–55.4 c.f.s; resident/2+ = 2.0-14.3 c.f.s.; 1+/y-o-y = 1.0-6.2 c.f.s.    **Passage Evaluation: GRAY:** FishXing estimated this crossing met the 8-16-16 ft/sec passage criteria for adult steelhead on 37% of the range of estimated migration flows and failed to meet the passage criteria for all age classes of juvenile salmonids. For adults and resident trout/2+ juveniles the only criteria violation was lack-of-depth, thus some passage probably occurs regardless of the FishXing output.

**Preferred Treatment:** Because the current crossing is properly sized, fish passage could be cost-effectively improved by installing two downstream boulder weirs to raise tail-water elevation and back-water the culvert. However, more serious passage impediments within Sleepy Hollow Creek should be treated prior to this crossing including Raven Dam located 1,000' upstream.

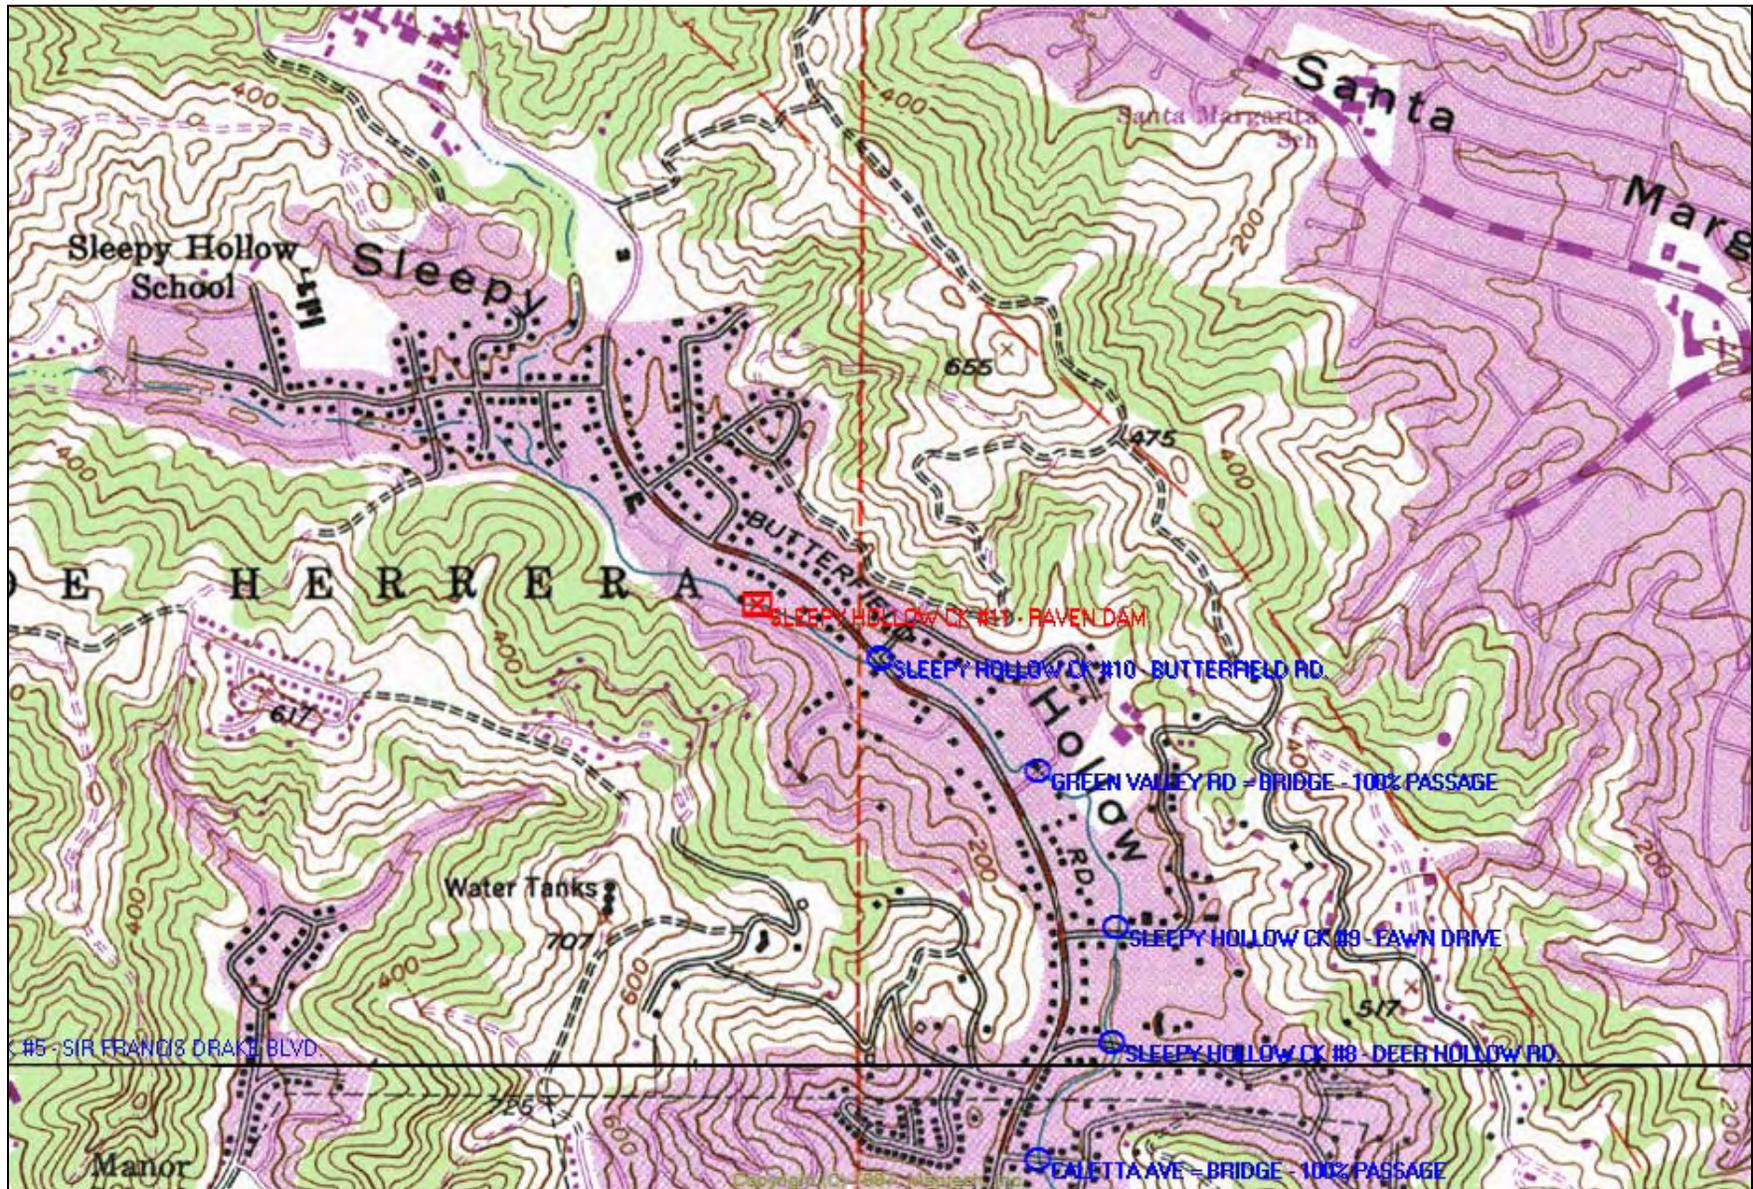
Site ID# SH-11: Sleepy Hollow Creek #11/Raven Dam; Corte Madera Creek

**Crossing Type:** Dam, concrete set on bedrock outcrop. **Corrugations:** N/A. **Dimensions:** dam spans a 20.7' width and is 2.6' thick. **Length:** 14.7' from upstream edge of dam to downstream edge of bedrock outcrop. **Slope:** Not applicable **Modifications:** None. **Rustline Height:** N/A **Average Active Channel Width:** 19.4' **Fill Estimate:** Not applicable. **Overall Condition:** Good. **Sizing:** Not applicable since a dam is an open structure with no top or sides to limit flow.

**Drainage Area Upstream of Crossing:** 1.97 square miles. **Estimated Migration Flows:** anadromous adult salmonids = 3.0–54.9 c.f.s; resident/2+ = 2.0-14.2 c.f.s.; 1+/y-o-y = 1.0-6.2 c.f.s. **Passage Evaluation: RED:** as determined by the first-phase evaluation filter for the excessive drop over the dam. FishXing was utilized to assess changes in drop height at varying discharges. At 20 c.f.s. drop = 8.4'; at 50 c.f.s. drop = 8.2'; at 100 c.f.s. drop = 8.0'; and at 150 c.f.s. drop = 7.9'. Total drop occurs in two stages: flow drops from lip of dam onto bedrock outcrop, length of outcrop is 12 feet, followed by a final drop into a large downstream pool.

**Preferred Treatment:** Explore options for dam removal and restoration/re-grade of the stream channel. However, three downstream crossings (SH-01, 08, 09) should first be treated to restore adult steelhead passage up to Raven Dam.
