**CATALOG OF STREAM CROSSINGS WITH CULVERTS AND
OTHER MANMADE IMPEDIMENTS TO FISH PASSAGE
LOCATED ON ANADROMOUS STREAM REACHES WITHIN
FAIRFAX CREEK, CORTE MADERA CREEK WATERSHED,
MARIN COUNTY, CA.**

Prepared for Friends of the Corte Madera Creek Watershed

**By
Ross Taylor and Associates**

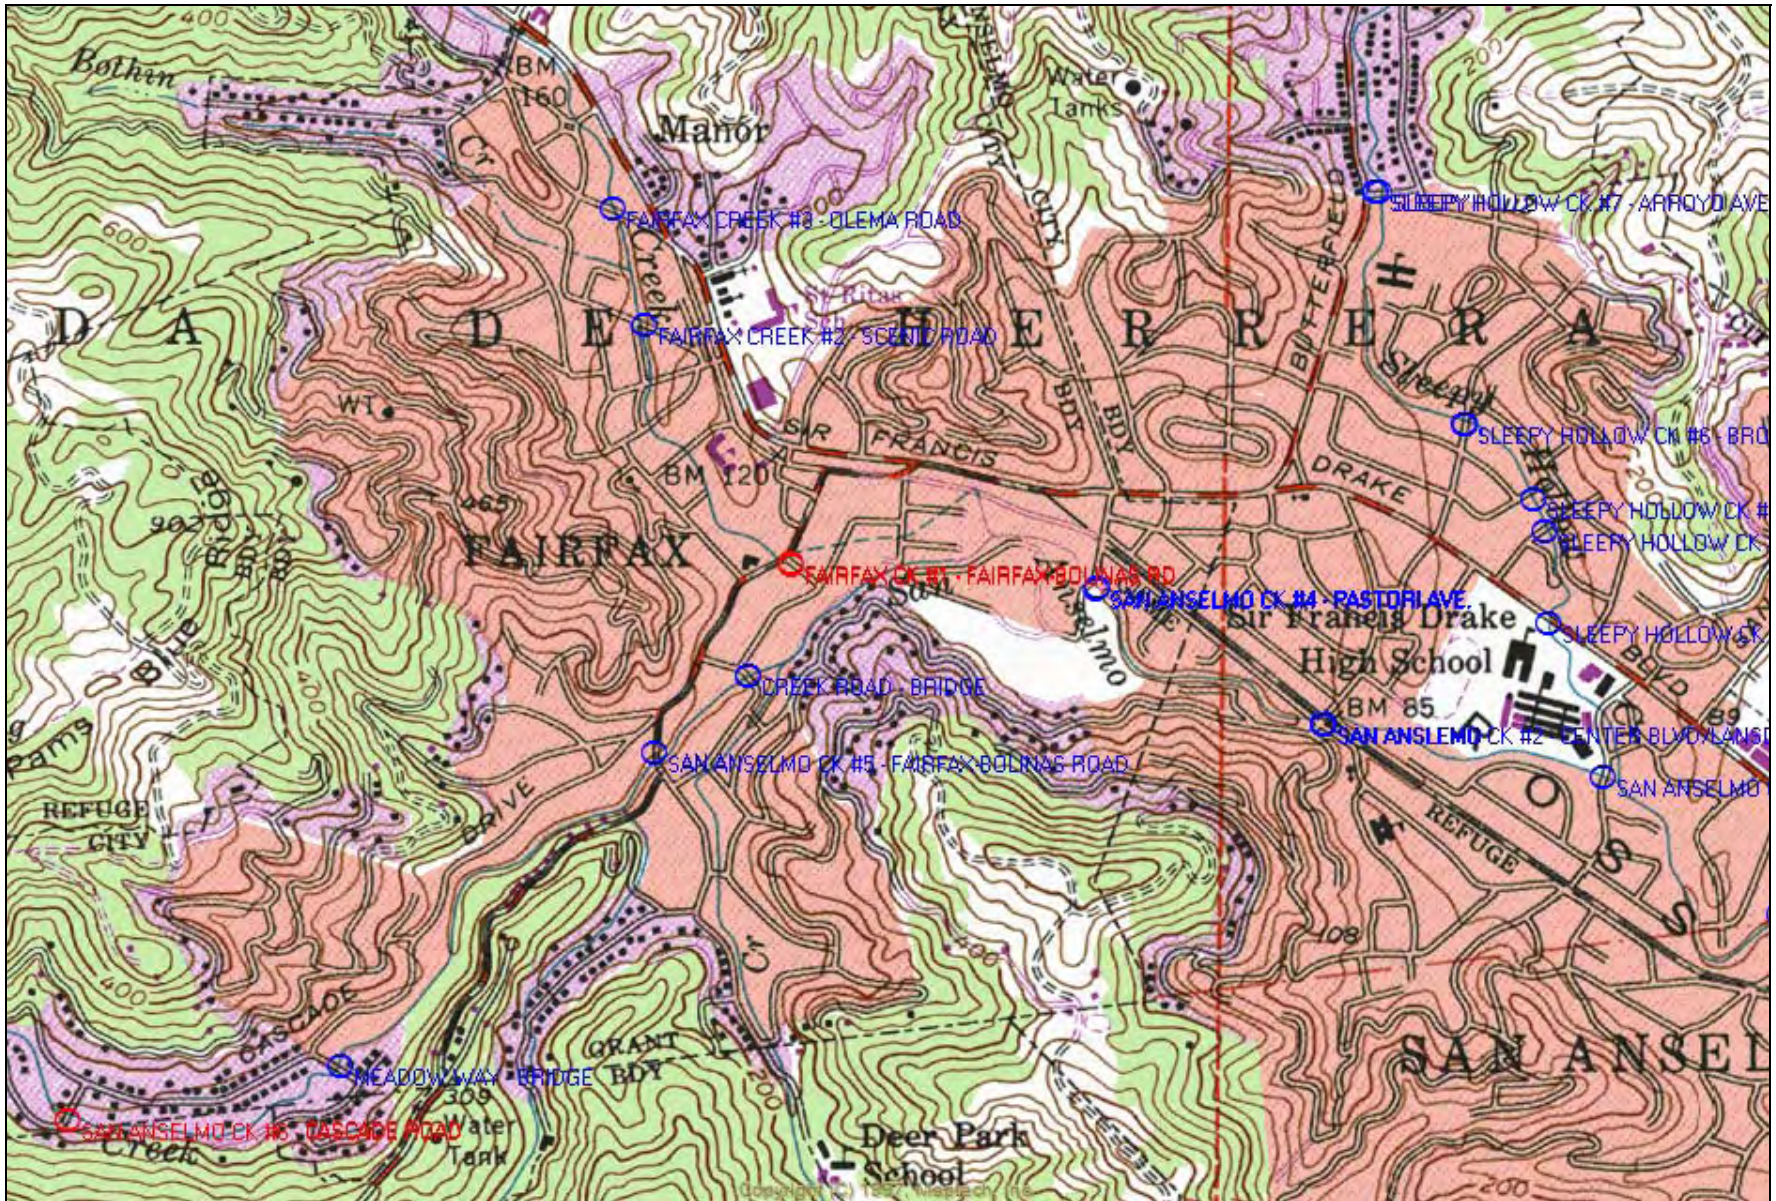
Site ID# FX-01 aka MR-080: Fairfax Creek/Bolinas Avenue; San Anselmo Creek; Corte Madera Creek

Crossing Type: Box culvert, Concrete. **Corrugations:** None. **Dimensions:** 6.35' H x 9.9' W. **Length:** 458.0' **Slope:** 0.94% **Modifications:** None. **Rustline Height:** N/A **Average Active Channel Width:** 11.1' **Fill Estimate:** 3,014 Cubic Yards. **Overall Condition:** Fair– culvert invert worn to rebar. **Sizing:** Extremely Undersized; HW/D = 1 on a storm flow with approximately a six-year recurrence interval. Bolinas Avenue is overtopped on approximately a 29-year storm flow.

Drainage Area Upstream of Crossing: 3.56 square miles. **Estimated Migration Flows:** anadromous adult salmonids = 3.0–99.1 c.f.s; resident/2+ = 2.0-25.7 c.f.s.; 1+/y-o-y = 1.0-11.2 c.f.s. **Passage Evaluation: RED:** the Green-Gray-Red filter determined this crossing failed to meet passage criteria for all species of adult salmonids and all age classes of juveniles due to a residual drop at the outlet >3.0'. The long (>450') flat concrete floor make it highly unlikely that an adult steelhead could pass through the culvert even if it was able to leap into the culvert.

Habitat: Quantity = approximately 10,800' of *potential* fish-bearing habitat upstream of Site ID# FX-01, Olema Dam (≈5,250' upstream) is also a complete barrier. Quality = within the vicinity of the crossing, rated as “poor” for the ranking matrix based on Taylor and Associates survey crew’s field notes and interpretation of previous habitat assessment (Rich, 2000). The crossing was surveyed by Taylor and Associates on 7/24/02 for the County of Marin’s passage inventory and there was continuous flow in the channel. At 2:30PM the air temp = 23°C and the water temp = 18°C. The survey crew noted a channel confined by concrete walls in a residential area, few pools, and a moderately dense riparian zone of hardwoods. The crew noted moderately abundant numbers (10-50 fish) of fish of unknown species downstream of Site ID# FX-01.

Preferred Treatment: Treatment options at this site are problematic because of several factors. A retrofit is probably not feasible because the box culvert is undersized and currently the inlet overtops on less than a 10-year storm flow, thus further reduction of capacity by baffles or weirs is not recommended. The crossing’s outlet is within 25 feet of the confluence of Fairfax Creek and San Anselmo Creek, thus there is insufficient room for a series of downstream weirs to raise tail-water elevation. A full replacement may be cost-prohibitive due to the length of the existing crossing; however flood-flow capacity could be improved with a new crossing. This box culvert has effectively eliminated Fairfax Creek as a steelhead spawning and rearing tributary of Corte Madera Creek.

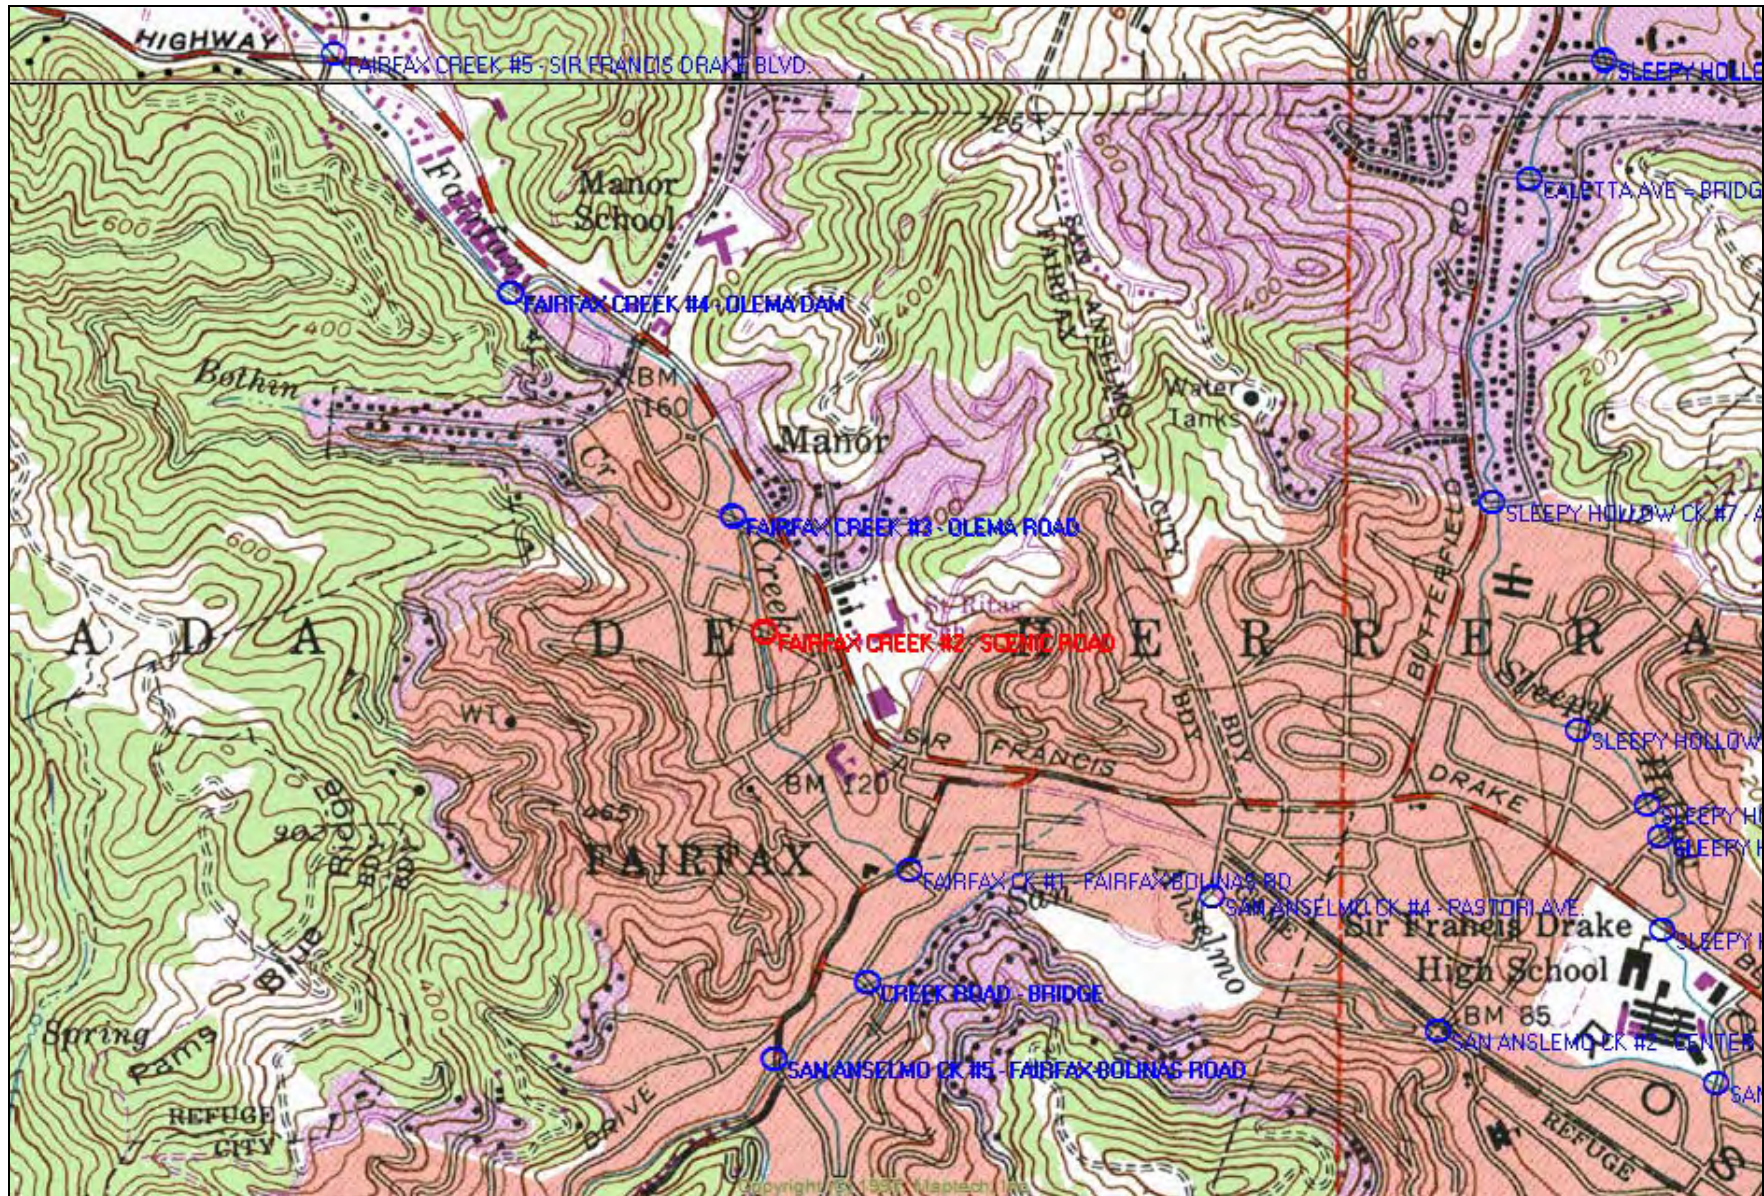
Site ID# FX-02: Fairfax Creek/Scenic Road; San Anselmo Creek; Corte Madera Creek

Crossing Type: Box culvert, concrete. **Corrugations:** None. **Dimensions:** 11.1' H x 14.0' W
Length: 40.0' **Slope:** 0.03% **Modifications:** None. **Rustline Height:** N/A **Average Active Channel Width:** 14.0' **Fill Estimate:** 650 Cubic Yards. **Overall Condition:** Good. **Sizing:** Properly sized; HW/D = 1 on a storm flow with more than a 100-year recurrence interval.

Drainage Area Upstream of Crossing: 3.13 square miles. **Estimated Migration Flows:** anadromous adult salmonids = 3.0–87.2 c.f.s; resident/2+ = 2.0–22.6 c.f.s.; 1+/y-o-y = 1.0–9.8 c.f.s. **Passage Evaluation: GRAY:** as determined by the first-phase evaluation filter due to inadequate residual depths at the culvert inlet and outlet. FishXing estimated that the crossing met the 8-16-16 ft/sec swimming/leaping velocities and 0.5 minimum depth passage criteria for adult anadromous salmonids for 90% of the estimated migration flows (11.8–87.2 c.f.s.), met passage criteria for resident trout/2+ juveniles for 94% of the estimated migration flows (3.2–22.6 c.f.s.) and met passage criteria for 1+/y-o-y juvenile salmonids for 74% of the estimated migration flows (3.2–9.7 c.f.s.).

Habitat: Quantity = approximately 8,800' of *potential* fish-bearing habitat upstream of Site ID# FX-02, Olema Dam (≈3,250' upstream) is a complete barrier. Quality = rated as “fair” for the ranking matrix based on Taylor and Associates survey crew’s field notes and interpretation of previous habitat assessment (Rich, 2000). The crossing was surveyed by Taylor and Associates on 6/10/05 and there was continuous flow in the channel. At 2:00PM the air temp = 21°C and the water temp = 16°C. The survey crew noted a channel confined by concrete walls in a residential area, several pools, some suitable spawning-sized substrates, and a dense riparian zone of mostly hardwoods. The crew noted abundant numbers (50–100 fish) roach downstream of Site ID# FX-02.

Preferred Treatment: No treatment is recommended at this site because the box culvert currently provides ample passage for all age classes of anadromous salmonids, is properly-sized for storm flow conveyance, and is in good condition. Recommend periodic inspection for maintenance and to ensure that culvert remains back-watered.

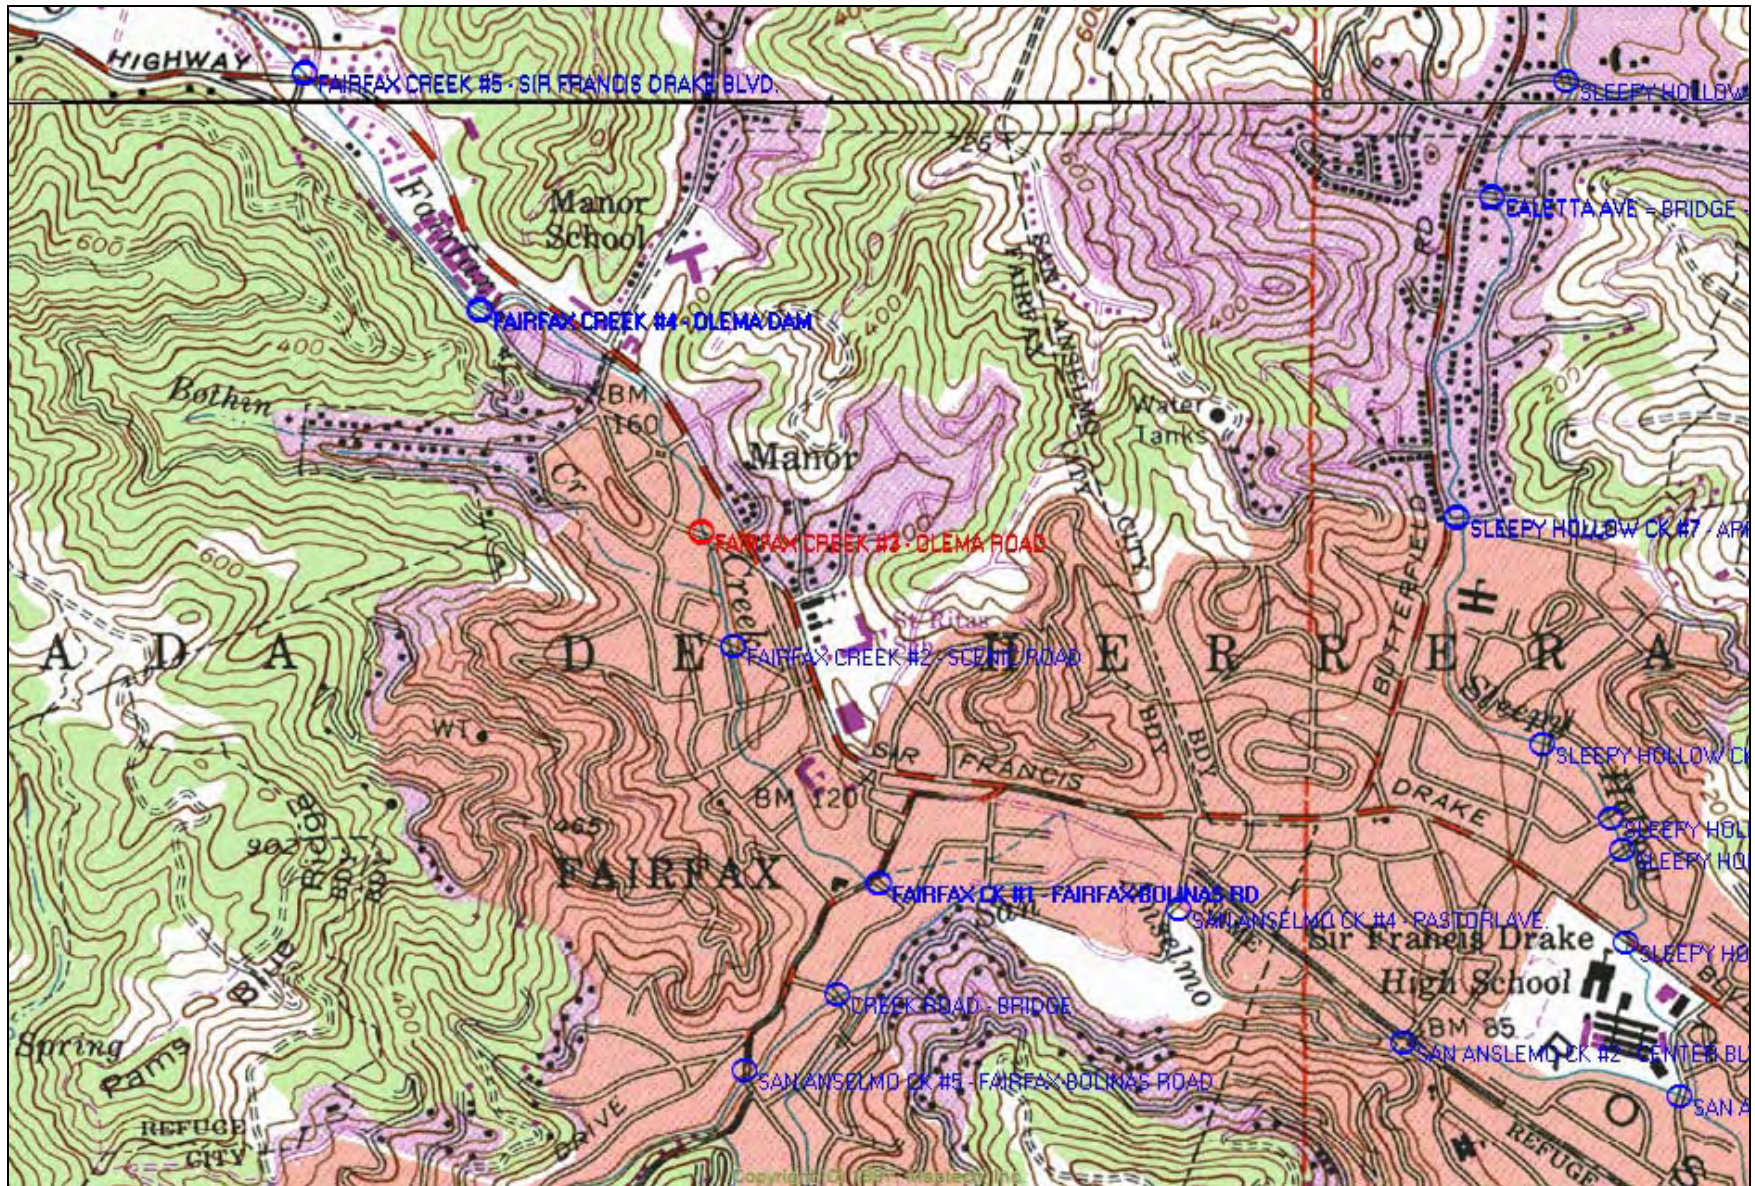
Site ID# FX-03: Fairfax Creek/Olema Road; San Anselmo Creek; Corte Madera Creek

Crossing Type: Box culvert, Concrete. **Corrugations:** None. **Dimensions:** 10.3' H x 14.0' W
Length: 44.0' **Slope:** 0.64% **Modifications:** None. **Rustline Height:** N/A **Average Active Channel Width:** 13.1' **Fill Estimate:** 546 Cubic Yards. **Overall Condition:** Good. **Sizing:** Properly Undersized; HW/D = 1 on a storm flow with more than a 100-year recurrence interval.

Drainage Area Upstream of Crossing: 2.75 square miles. **Estimated Migration Flows:** anadromous adult salmonids = 3.0–76.6 c.f.s; resident/2+ = 2.0-19.8 c.f.s.; 1+/y-o-y = 1.0-8.6 c.f.s. **Passage Evaluation: GRAY:** as determined by the first-phase evaluation filter due to inadequate residual depths at the culvert inlet and outlet. FishXing estimated that the crossing met the 8-16-16 ft/sec swimming/leaping velocities and 0.5 minimum depth passage criteria for adult anadromous salmonids for 59% of the estimated migration flows (33.5-76.6 c.f.s.), met passage criteria for resident trout/2+ juveniles for 10% of the estimated migration flows (17.9-19.8 c.f.s.) and failed to meet passage criteria for 1+/y-o-y juvenile salmonids due to leap at outlet at lower migration flows and excessive velocities at the upper range of migration flows.

Habitat: Quantity = approximately 8,000' of *potential* fish-bearing habitat upstream of Site ID# FX-03, Olema Dam approximately 2,450' upstream is a complete barrier. Quality = rated as “fair” for the ranking matrix based on Taylor and Associates survey crew’s field notes and interpretation of previous habitat assessment (Rich, 2000). The crossing was surveyed by Taylor and Associates on 6/08/05 and there was continuous flow in the channel. At 4:45PM the air temp = 16°C and the water temp = 16°C. The survey crew noted a channel with sections confined by concrete walls and rip-rap, several pools, some undercut banks, pool-tails and riffles with suitable spawning-sized substrates, and a dense riparian zone of mostly hardwoods with some conifers. The crew noted extremely abundant numbers (>100 fish) roach both upstream and downstream of Site ID# FX-03.

Preferred Treatment: Recommend raising the tail-water elevation with two or three boulder weirs to back-water this box culvert. However, two more serious impediments to fish passage in Fairfax Creek should be treated first (FX-01 and then FX-04).

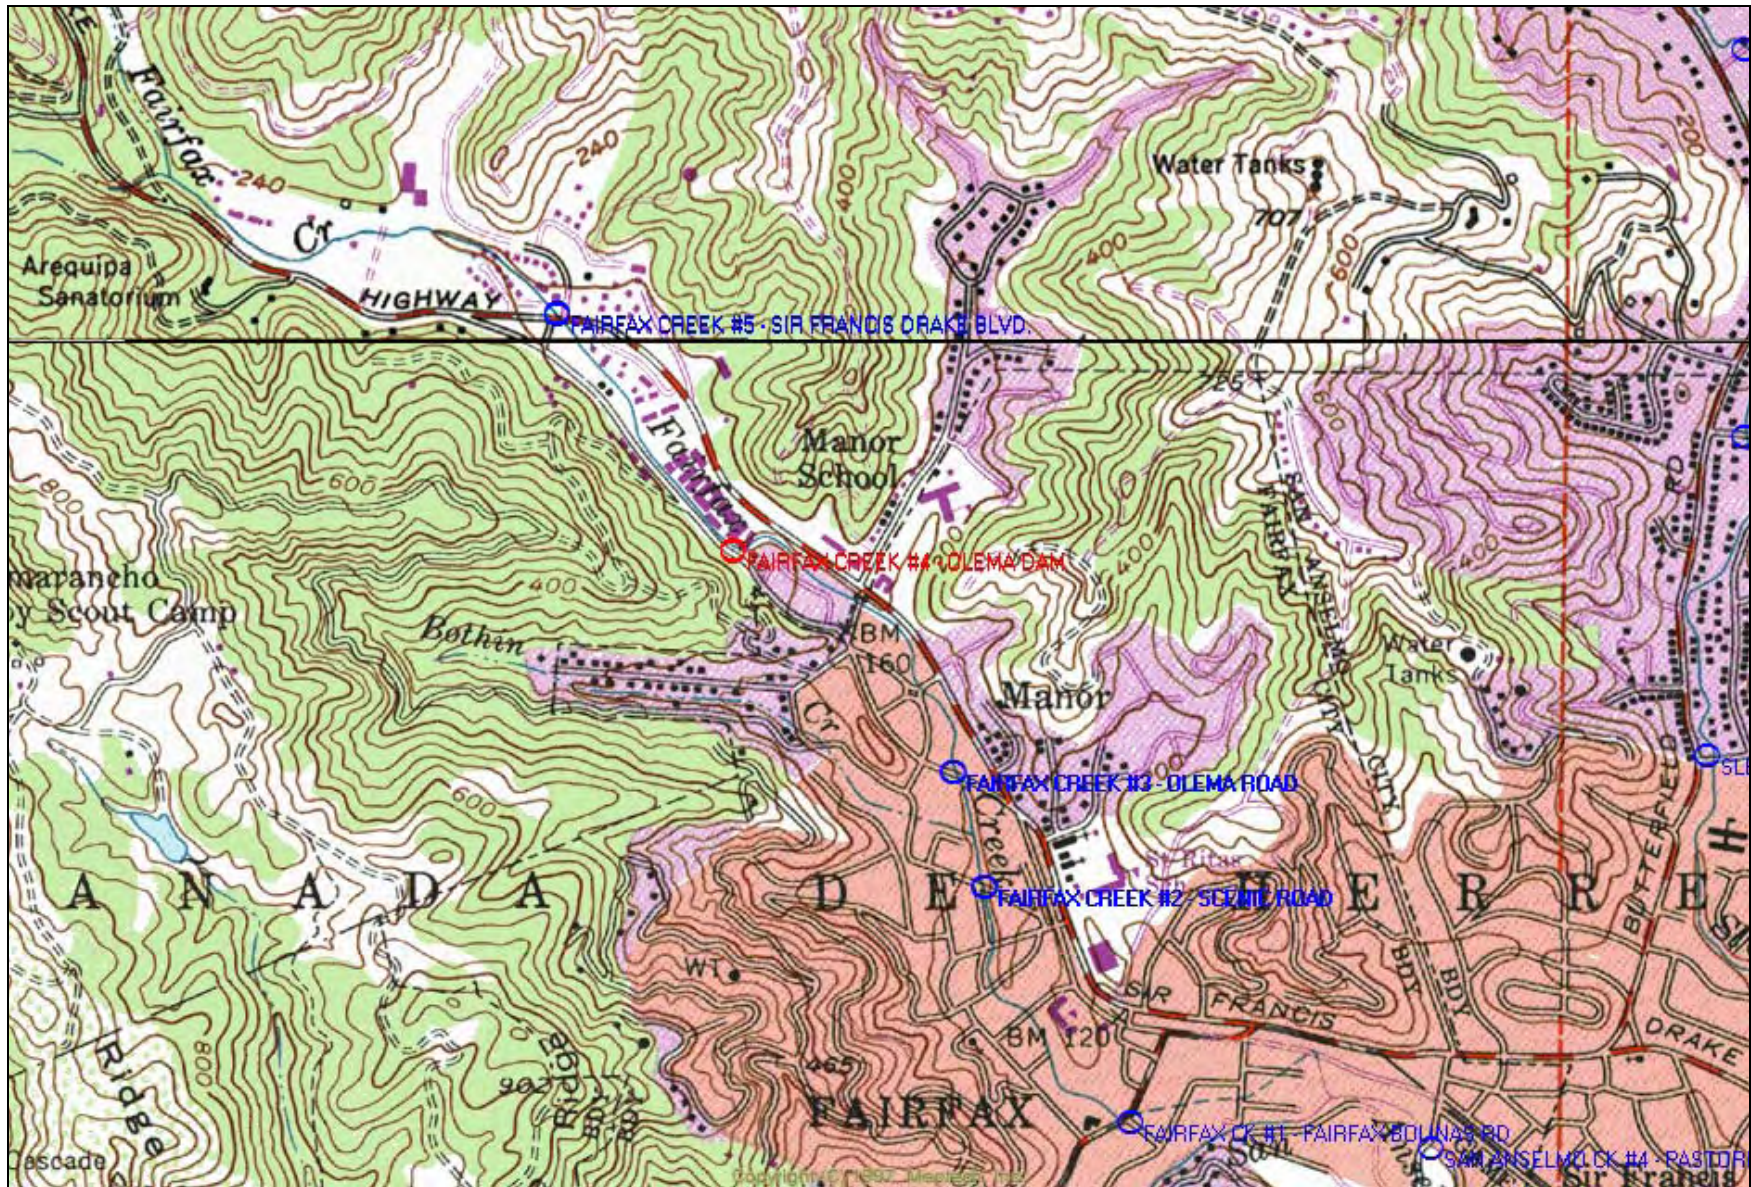
Site ID# FX-04: Fairfax Creek/Olema Dam; San Anselmo Creek; Corte Madera Creek

Crossing Type: Dam, concrete set on natural bedrock outcrop. **Corrugations:** N/A.
Dimensions: dam spans a 22.0' width and is 2.5' thick. The low-flow notch cut into the dam is approximately nine feet in width. **Length:** 16.0' from upstream edge of dam to downstream edge of bedrock outcrop. **Slope:** N/A **Modifications:** None. **Rustline Height:** N/A **Average Active Channel Width:** 15.8' **Fill Estimate:** Not applicable. **Overall Condition:** Fair, noticeable cracks in dam face and possible slumping. **Sizing:** Not applicable since a dam is an open structure with no top or sides to limit flow.

Habitat: Quantity = approximately 5,500' of *potential* fish-bearing habitat upstream of Site ID# FX-04. Quality = rated as “fair” for the ranking matrix based on Taylor and Associates survey crew’s field notes and interpretation of previous habitat assessment (Rich, 2000). The crossing was surveyed by Taylor and Associates on 7/09/05 and there was continuous flow in the channel. At 10:15 AM the air temp = 18°C and the water temp = 15°C. The survey crew noted a channel with sections confined by concrete walls, several pools, pool-tails and riffles with suitable spawning-sized substrates, and a dense riparian zone of hardwoods and brush. The right-bank side of the pool downstream of the dam is heavily armored with riprap and a concrete crib wall. The crew noted extremely abundant numbers (>100 fish) roach both upstream and downstream of Site ID# FX-04.

Preferred Treatment: Recommend exploring options for dam removal and channel restoration. However, the culvert at the mouth of Fairfax Creek (FX-01) should first be treated to restore adult steelhead passage up to Olema Dam. Consideration must be made to potential effects of channel re-grade to private properties adjacent to the stream channel as well as upstream crossings.

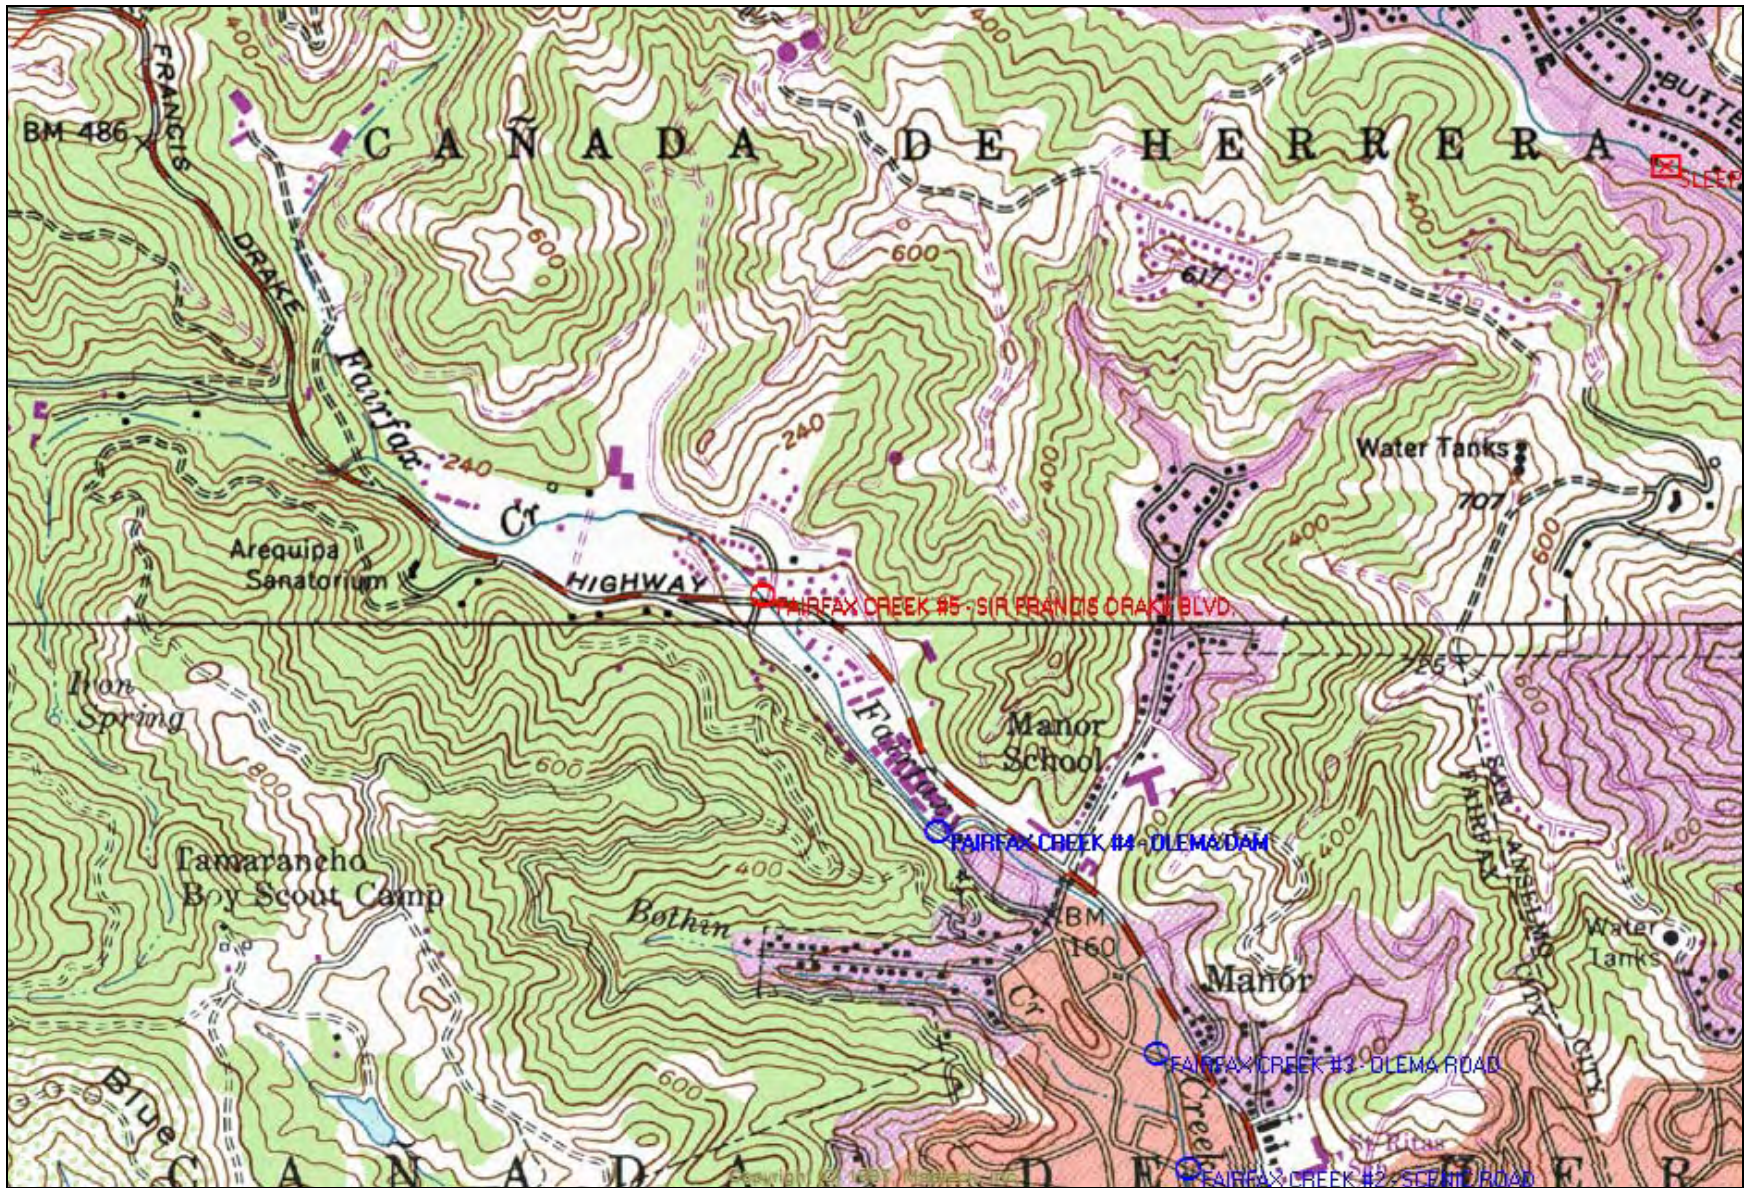
Site ID# FX-05: Fairfax Creek/Sir Francis Drake Blvd.; San Anselmo Creek; Corte Madera Creek

Rustline Height: 1.8'. **Average Active Channel Width:** 15.4' **Fill Estimate:** 1,531 cubic yards. **Overall Condition:** Extremely poor, lower 40.6' has rusted-through invert, some sagging of culvert too. **Sizing:** Undersized, HW/D = 1 on a storm flow between a 10 and 25-year recurrence interval.

Drainage Area Upstream of Crossing: 2.04 square miles. **Estimated Migration Flows:** anadromous adult salmonids = 3.0–56.8 c.f.s; resident/2+ = 2.0-14.7 c.f.s.; 1+/y-o-y = 1.0-6.4 c.f.s. **Passage Evaluation: GRAY:** as determined by the first-phase evaluation filter due to inadequate residual depths at the culvert inlet and outlet. FishXing estimated that the crossing met the 8-16-16 ft/sec swimming/leaping velocities and 0.5 minimum depth passage criteria for adult anadromous salmonids for 78% of the estimated migration flows (5.4-47.3 c.f.s.), met passage criteria for resident trout/2+ juveniles for 34% of the estimated migration flows (2.0-5.7 c.f.s.) and failed to meet passage criteria for 1+/y-o-y juvenile salmonids (leap and velocity). Actual passage conditions may be worse due unfavorable hydraulic conditions created by the damaged outlet and the paved invert.

Habitat: Quantity = approximately 3,500' of *potential* fish-bearing habitat upstream of Site ID# FX-05. Quality = rated as "fair" for the ranking matrix based on Taylor and Associates survey crew's field notes and interpretation of previous habitat assessment (Rich, 2000). The crossing was surveyed by Taylor and Associates on 7/09/05 and there was continuous flow in the channel. At 1:30 PM the air temp = 22°C and the water temp = 16°C. The survey crew noted a channel with sections confined by rip-rap banks, several pools, pool-tails and riffles with suitable spawning-sized substrates, and a dense riparian zone of hardwoods and brush. No fish were observed in the channel adjacent to Site ID# FX-05.

Preferred Treatment: Due to poor condition and inadequate sizing, recommend replacement with a properly-sized open-bottom arch or an embedded circular SSP culvert. Project should be implemented primarily for maintenance purposes. Poor candidate for treatment with grant funds.
