# **PROSPECTS FOR IMPROVING RIPARIAN CANOPY AND PHYSICAL HABITAT FOR FISH ON ROSS CREEK**

**Geomorphic Reconnaissance Report  
March 7, 2007**

**Prepared for  
Friends of Corte Madera Creek Watershed**

**Matt Smeltzer  
Fluvial Geomorphology Consulting**

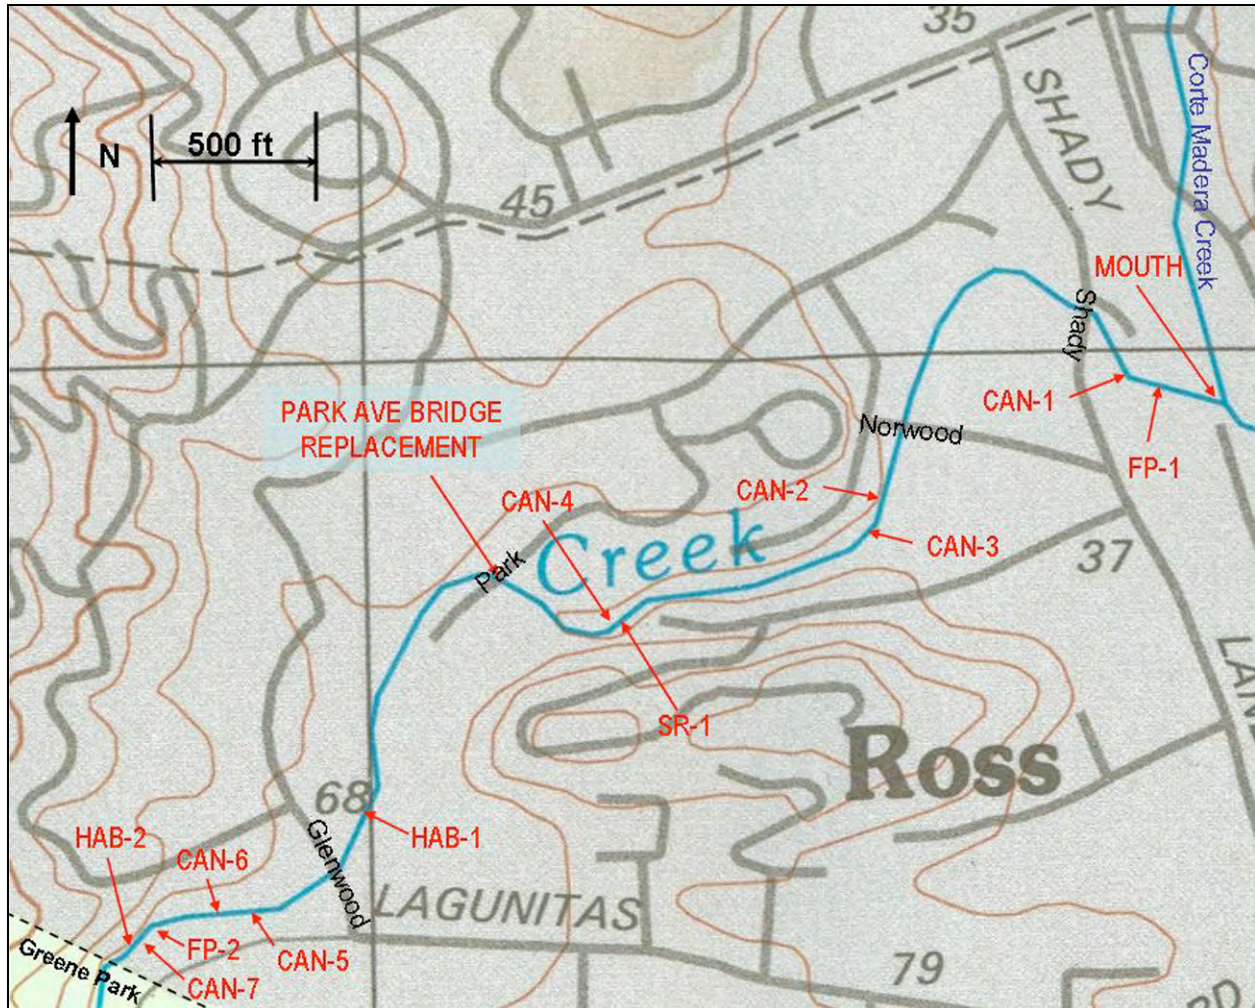
Figure 2. Detail map of Ross Creek study reach showing locations of recommended canopy and physical fish habitat improvement projects described in Tables 3-6.

If the only management objectives were to prevent against continuing severe bank erosion and to protect private property, then priority stabilization work would only be recommended at the 5 Class B\* sites comprising 255 lineal ft. Instead, thirteen individual recommended projects were formulated to achieve multiple objectives, including enhancement of riparian canopy cover, aquatic habitat, fish passage, floodplain connectivity, water quality, bank stability, and native vegetation (Table 2). The locations, existing conditions, and recommended treatment actions for each of these projects are summarized in Tables 3-7, and the locations are mapped on Figure 2.
