Lower COM Corte Madera Creek Restoration Project
100% Design Basis Report
January 31, 2022

FRIENDS OF
CORTE MADERA CREEK
WATERSHED

Geomorph Design Group

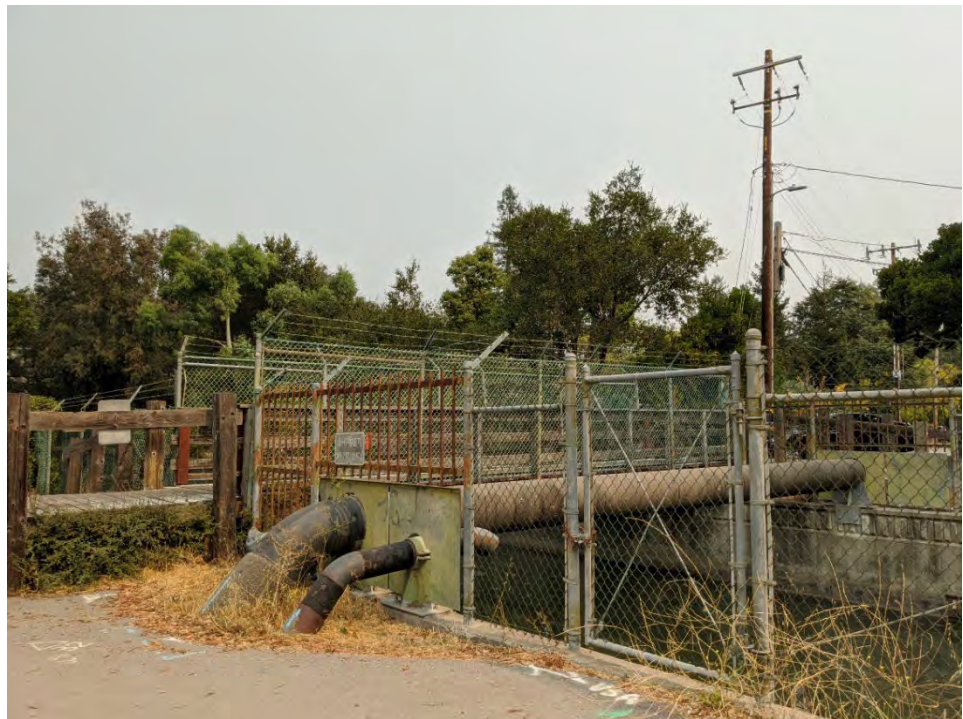
Photo 1. Looking upstream from the right bank access way to the Stadium Way Pedestrian Bridge, utility crossings over the channel near the bridge, and the terminus of overhead utilities routed underground at the pole in the background.

The only overhead electric and phone lines in the project area terminate at the power pole near the east landing of Stadium Way pedestrian bridge (Photo 1, sheet C6).

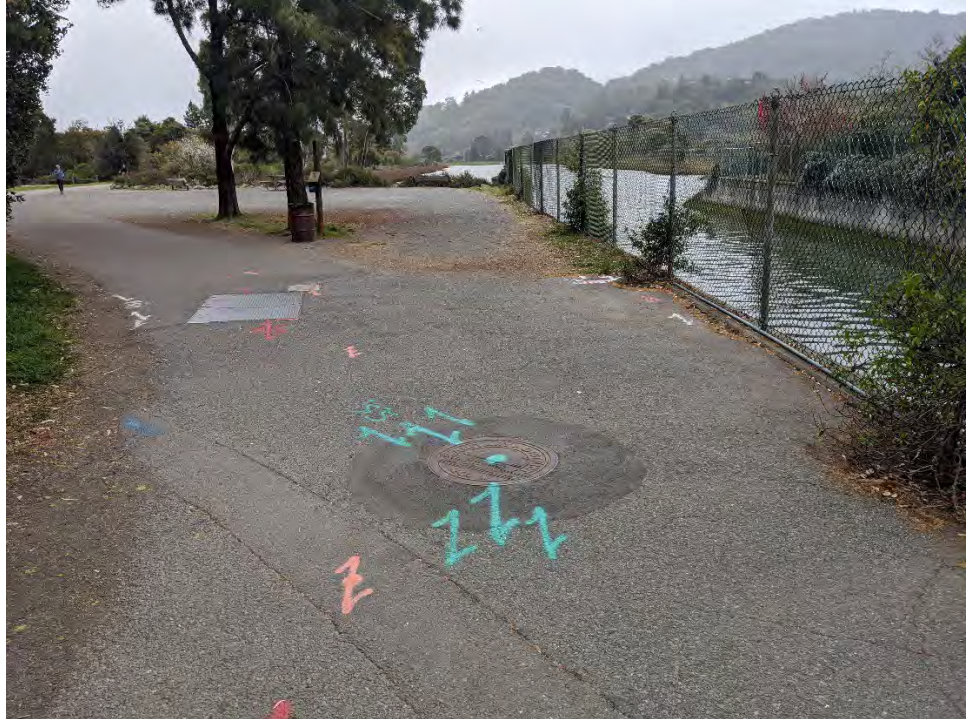
Photo 2. Looking downstream from the left bank paved multi-use pathway (MUP) where the sanitary sewer and other utilities running under the MUP turn approx. 45 degrees to the SE to depart from the edge of the channel and continue under or adjacent to the MUP. This photo also shows the flat triangular gravel-covered area with picnic tables and benches.

channel wall intact in the upstream majority of the project reach. The 100% design also provides flexibility for anticipated pathway improvements where it is bordered by the flat gravel-covered triangular open area (see Section 2.5, Photo 2).

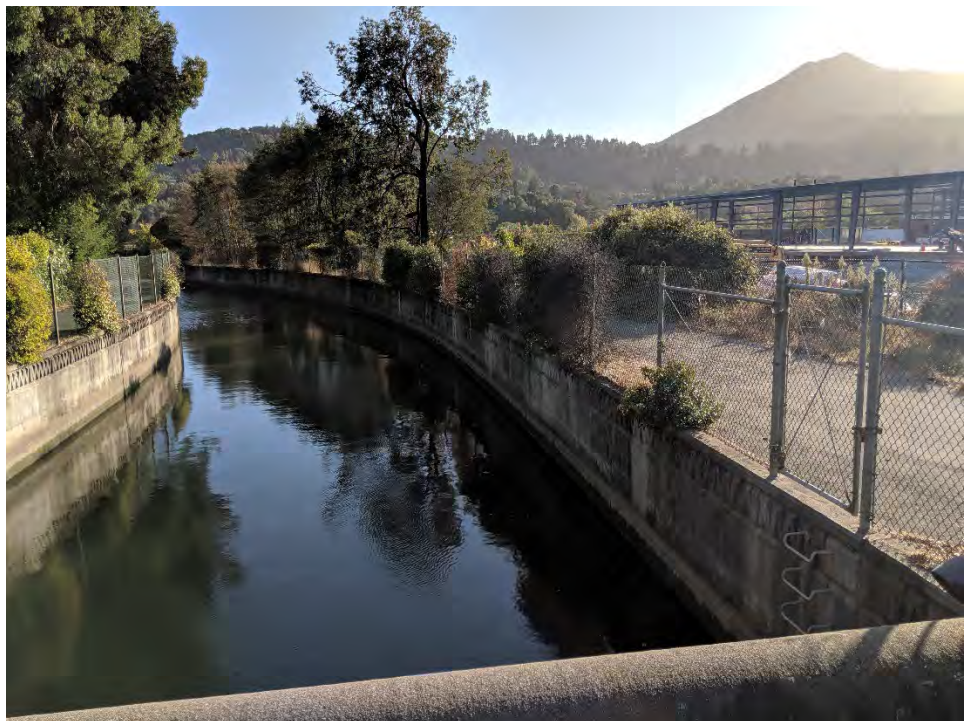
Photo 3. Looking downstream to the existing concrete channel from the Stadium Way pedestrian bridge.

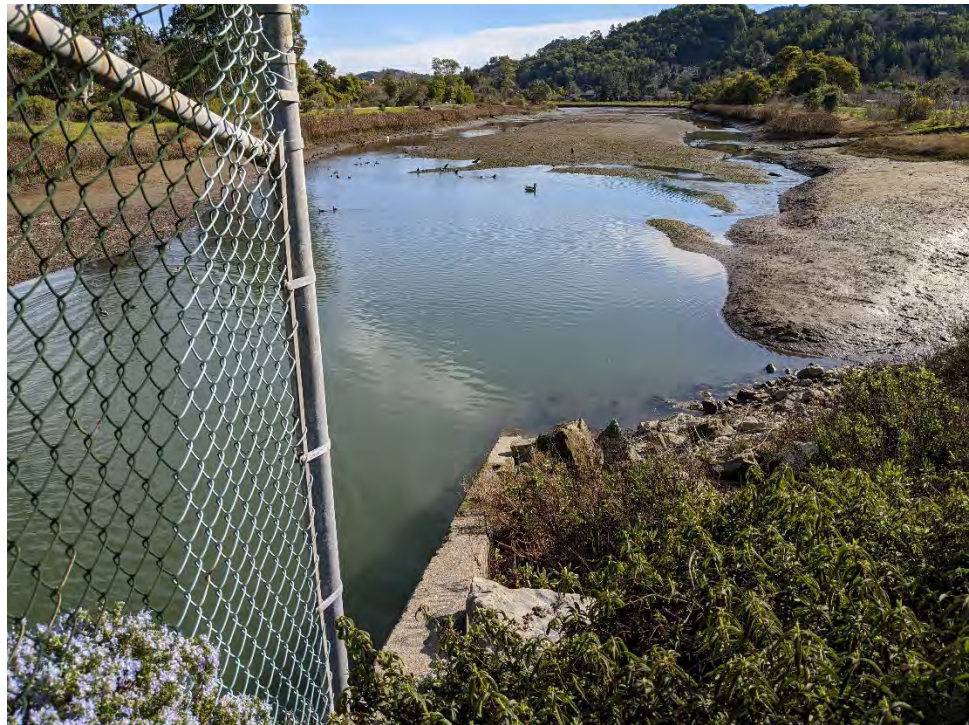
Photo 4. Looking downstream from the concrete channel terminus to the earthen channel beyond. Sedimentation in the earthen channel prevents tides lower than 1.7 feet NAVD88 from occurring in the project reach.

The earthen channel portion of the Army Corps flood control channel begins immediately downstream from the concrete channel (Photo 4). The upstream end of the earthen channel is referred to as the “stilling basin” because it has a deeper dredging maintenance profile for dissipating energy where flows narrowly confined by the concrete channel suddenly widen within the earthen channel. The earthen channel has rip-rap lined banks in this expansion zone. Note that there is another separate “stilling basin” depression built into the concrete channel floor near the downstream end of the concrete channel (sheet C5), but it is filled with sediment.

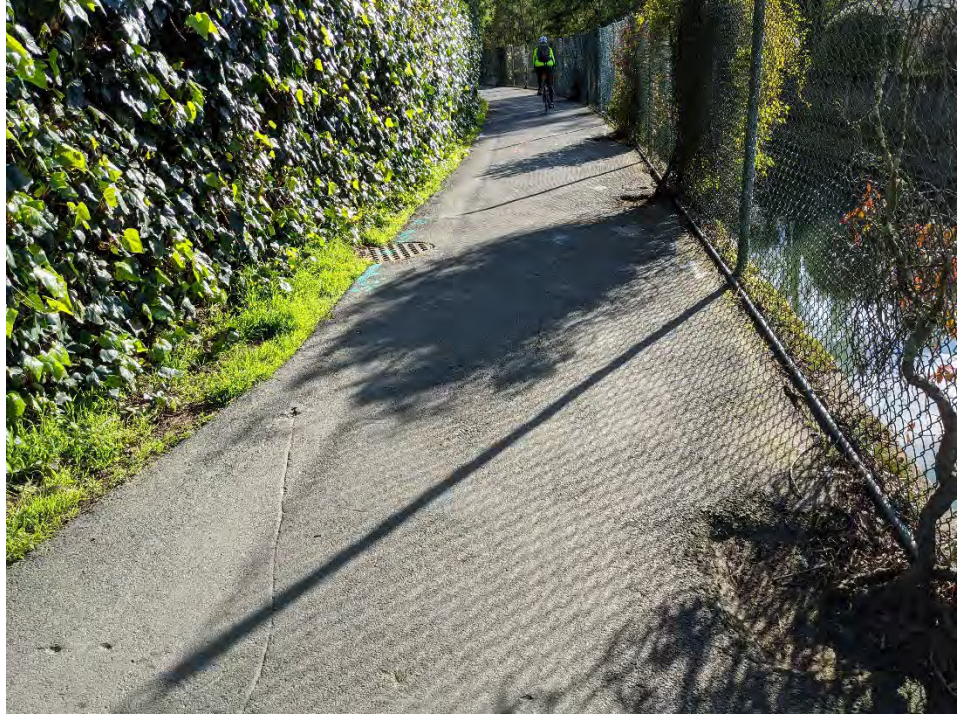
Photo 5. Looking downstream to the Multi-Use Pathway (MUP) running along the top of the left (east) concrete channel wall. Note the sanitary sewer (SS) manhole and green paint marking the SS utility line running under the pathway at depth and offset from the left channel wall.

The 100% design plans show the survey-located limits of the paved multi-use pathway (MUP) (Marin Bike Route 20) (Photo 5). The MUP crosses over Stadium Way pedestrian bridge and upstream from the Stadium Way pedestrian bridge, it runs along the top of the right (west) channel wall (Photo 6). Downstream from Stadium Way pedestrian bridge, the pathway runs along the top of the left (east) channel wall for about 300 feet before it turns 45 degrees to the southeast about 110 feet from the downstream end of the concrete channel. The section of the MUP between Stadium Way and the 45-degree turn is confined between a chain-link fence on the top of the concrete channel wall and an ivy-covered fence on the other side. The paving, which starts at the edge of the concrete channel, is ~8 feet wide and the two fences are ~10.5 feet apart, relatively narrow for such a busy path with no shoulders. Near the downstream end of the project area, the MUP connects with and runs along the top of the east side earthen channel berm down to Bon Air Road.

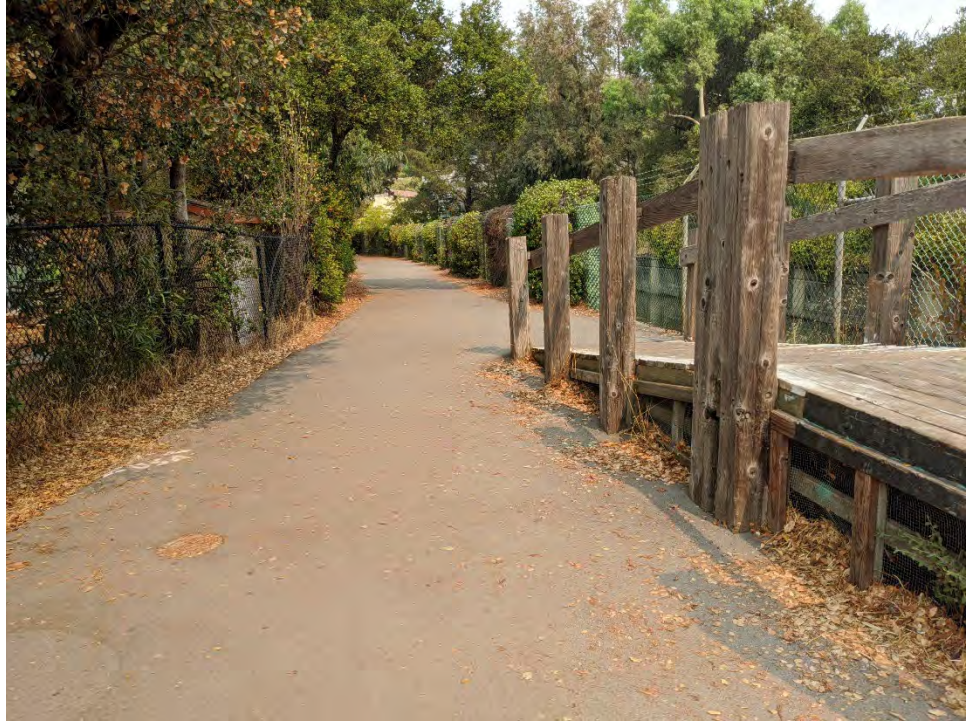
Photo 6. Looking upstream to the Multi-Use Pathway (MUP) running along the top of the right (west) concrete channel wall. The MUP crosses over the channel via the Stadium Way pedestrian bridge.

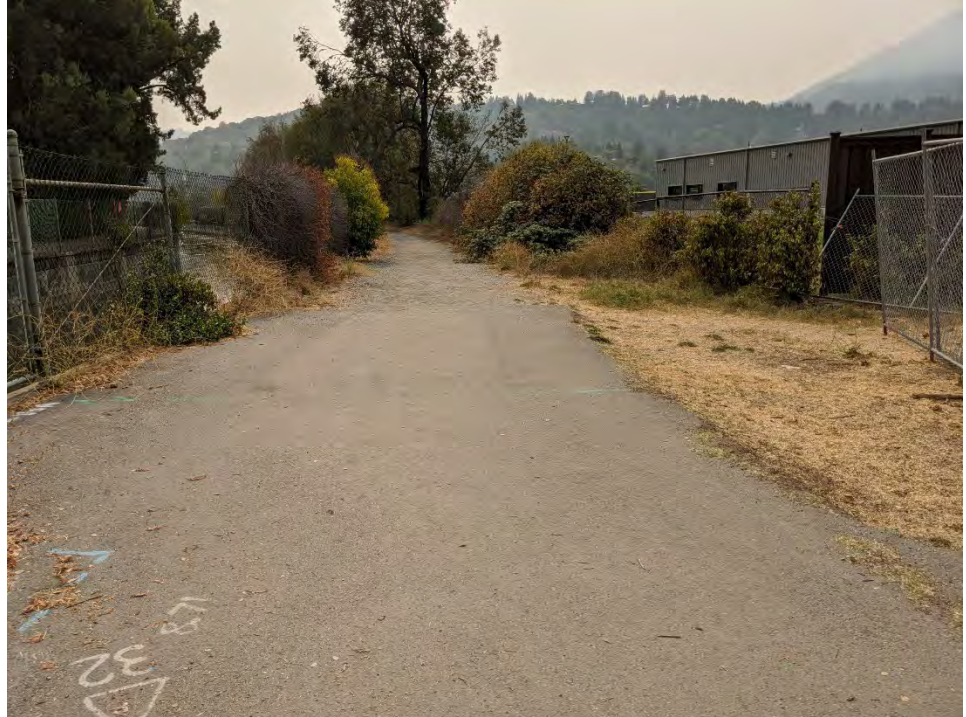
Photo 7. Looking downstream from the Stadium Way pedestrian bridge to the gravel access way running along the top of the right (west) channel wall connecting between the Multi-Use Pathway (MUP) and the west earthen channel berm.

There is an approximately 6-foot-wide plus gravel access way running along the top of the right (west) channel wall connecting from the west berm adjacent to the earthen channel downstream from the project area to the MUP at the west landing of Stadium Way pedestrian bridge (Photo 7). The project will eliminate this access way.

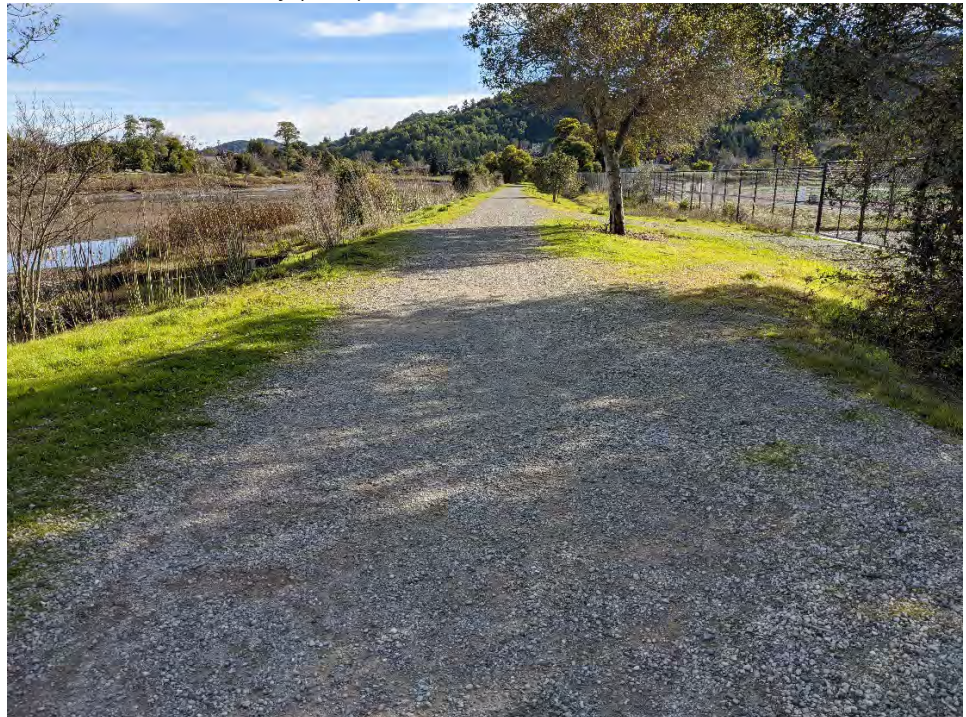
Photo 8. Looking downstream to the west earthen channel berm. Construction access is through the fence gate at the right side of the photo. The 14"-dbh oak tree may need to be pruned or removed to accommodate access. Equipment and materials will be staged on the berm downstream from the access point in the background of the photo. Additional oak trees will be planted along the berm downstream from the project area to meet mitigation requirements.

There are berms on both sides of the earthen channel downstream from the project area (see sheet C3, Photo 8). As shown on sheet C4, the 100% design will avoid impacting these berms by setting the grading limits upstream from and creekward from the berms. As shown at sheet C8, the design will provide flexibility for potential future upstream extension of the right (west) berm by providing a flat, unvegetated top of bank setback from the

The 100% design plans show a template-palette based revegetation plan keyed to the different tidal fluctuation dependent elevation horizons and corresponding vegetation community habitat types. Trees planted in the upland habitat areas are expected to be sufficient in number to mitigate tree removal required by the project per the requirements of the resource agencies. Additional oak trees will be planted landward from the top of bank within the setback from the COM M&O building as well as along the west earthen channel berm to meet mitigation planting objectives as needed (Photo 8).

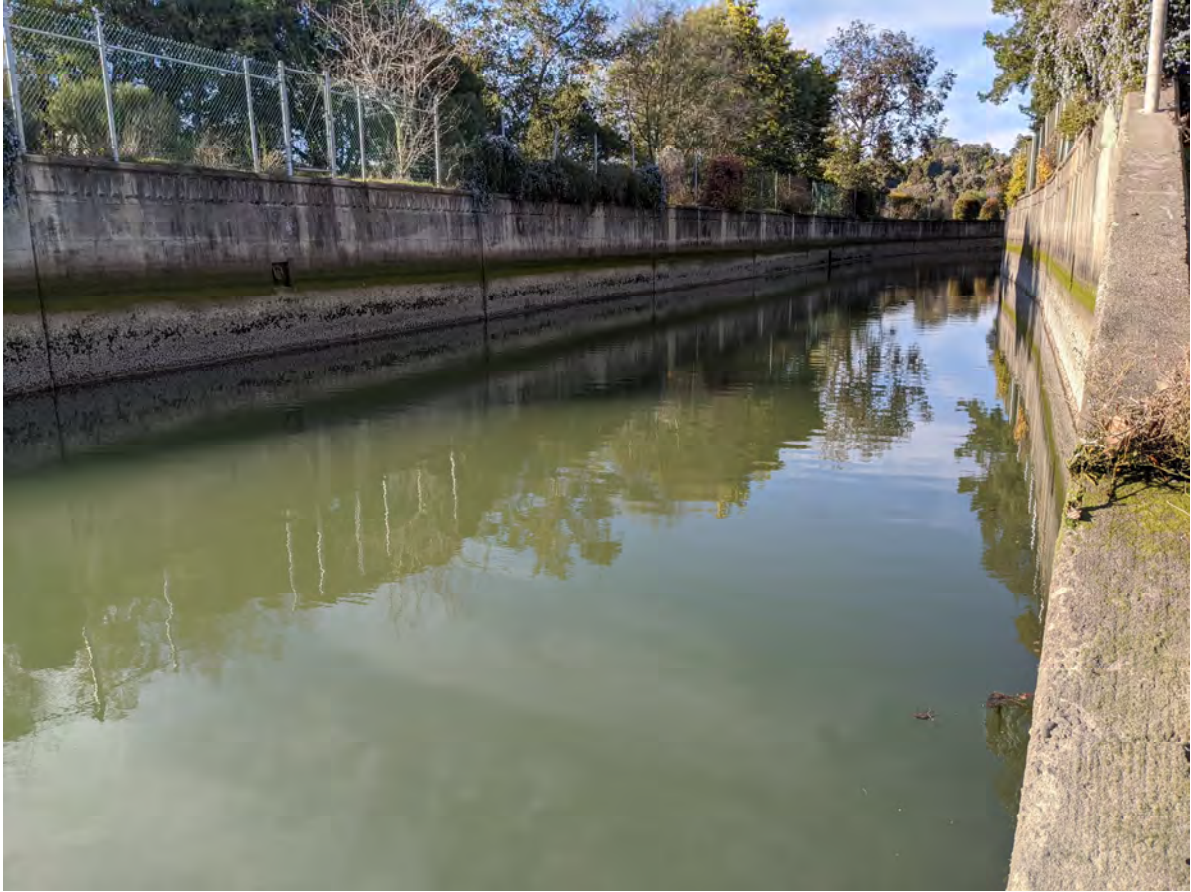
Looking upstream from near the Army Corps of Engineers Concrete Channel outlet during near minimum tidal elevation (February 2020)

Under existing conditions, Corte Madera Creek flows within an approximately rectangular concrete channel comprised of an approximately 33-foot-wide 18-inch-thick steel-reinforced flat concrete channel floor with approximately 18-foot-high vertical steel-reinforced concrete retaining walls on both sides. The channel walls are 12-inches-wide at the top increasing to 30-inches wide at the bottom. The walls and floor are structurally integral and the floor is, structurally, the foundation for the walls.
