Basis of Design Report
Corte Madera Creek Fish Passage Project

Existing Fish Passage Conditions and
Analysis of Resting Pool Performance

December 2021

Michael Love & Associates
Hydrologic Solutions

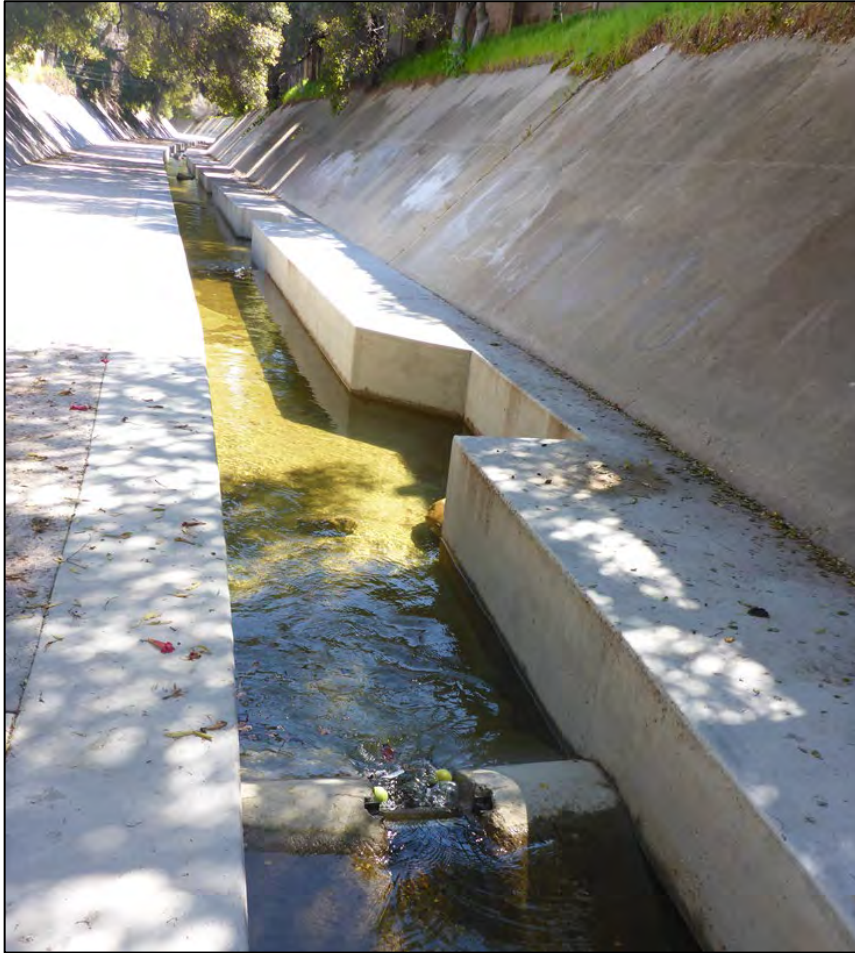
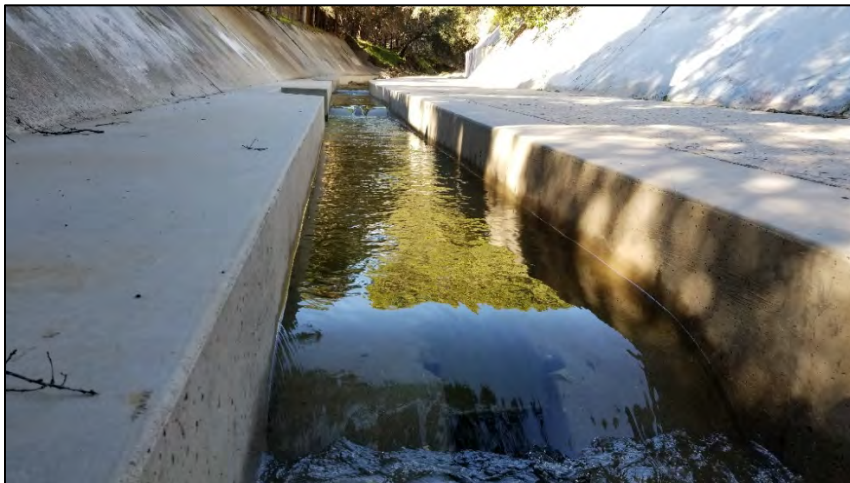
Figure 2. Mission Creek fish passage retrofit with low-flow channel, pocket pools, and rounded weirs to control depth (bottom photo: M. Garelo).

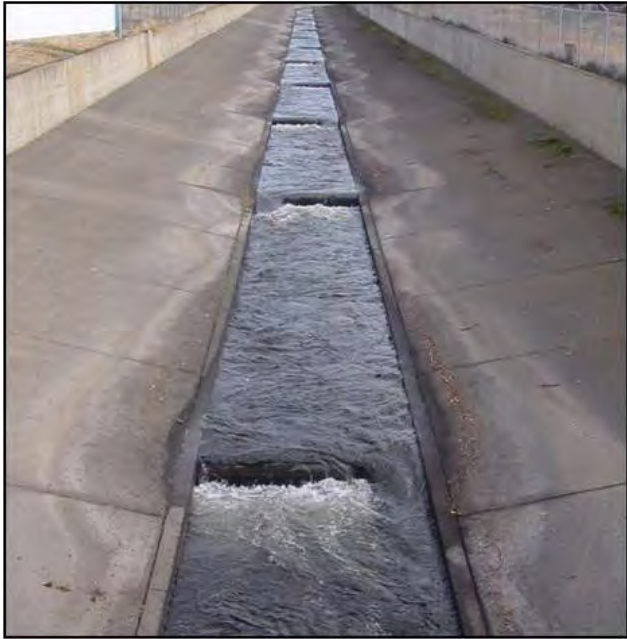
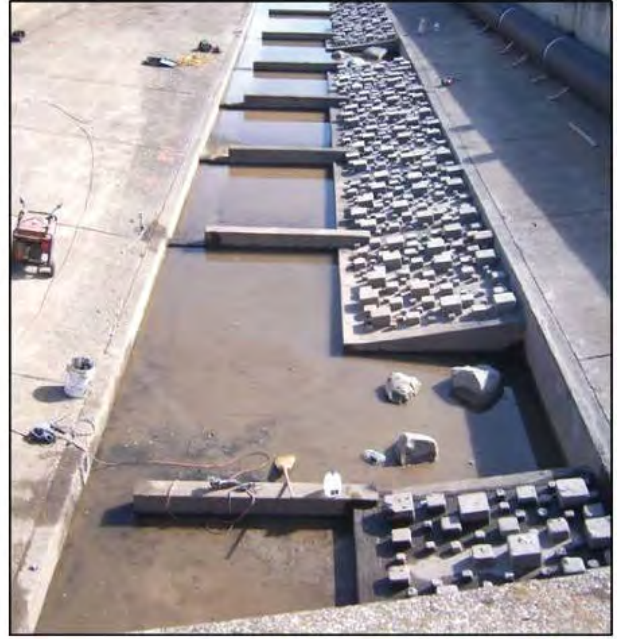
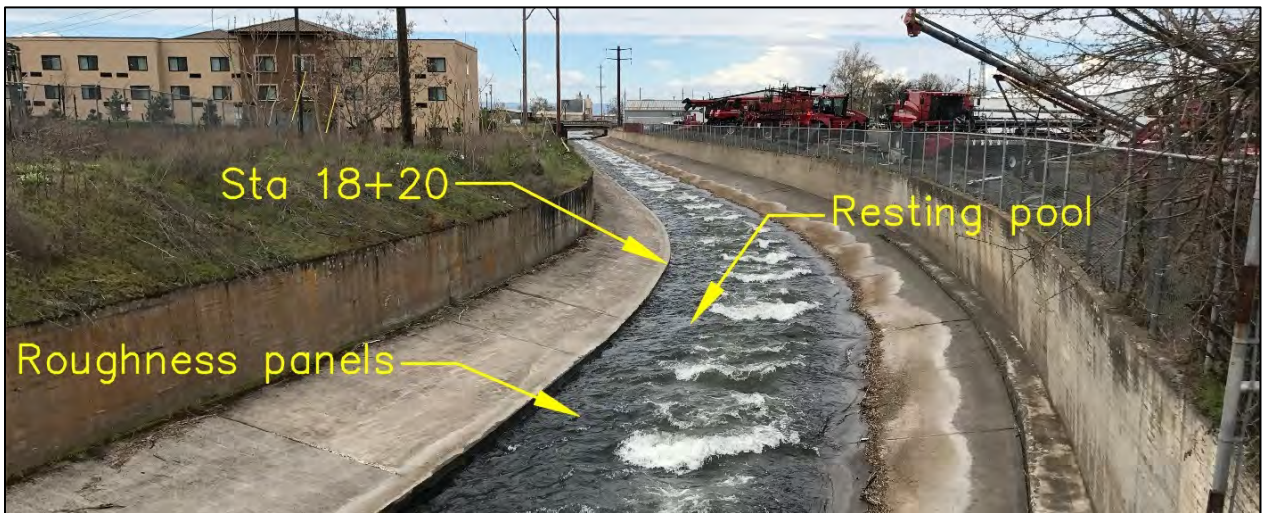
Figure 3. Mill Creek flood control channel fish passage modifications, replacing a baffled low-flow channel (top left) with new baffles, roughness panels, and resting pools (top right and bottom) (photos from TriState Steelheaders and Patrick Powers).

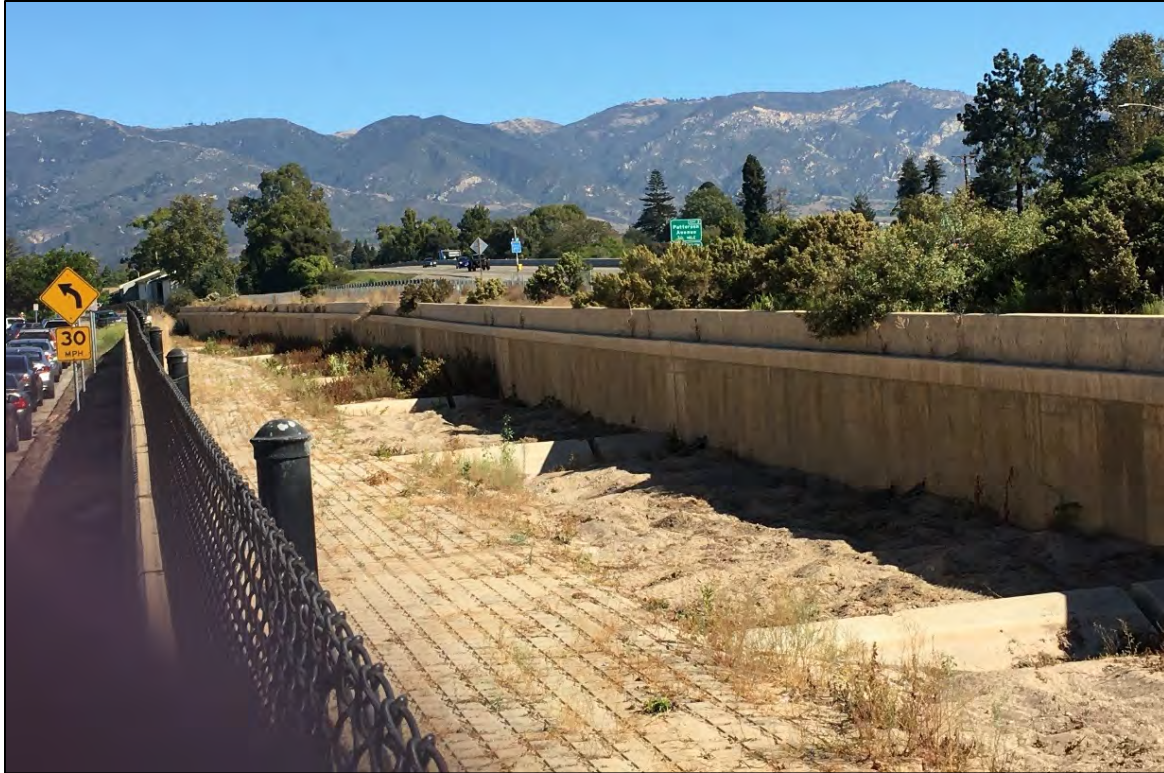
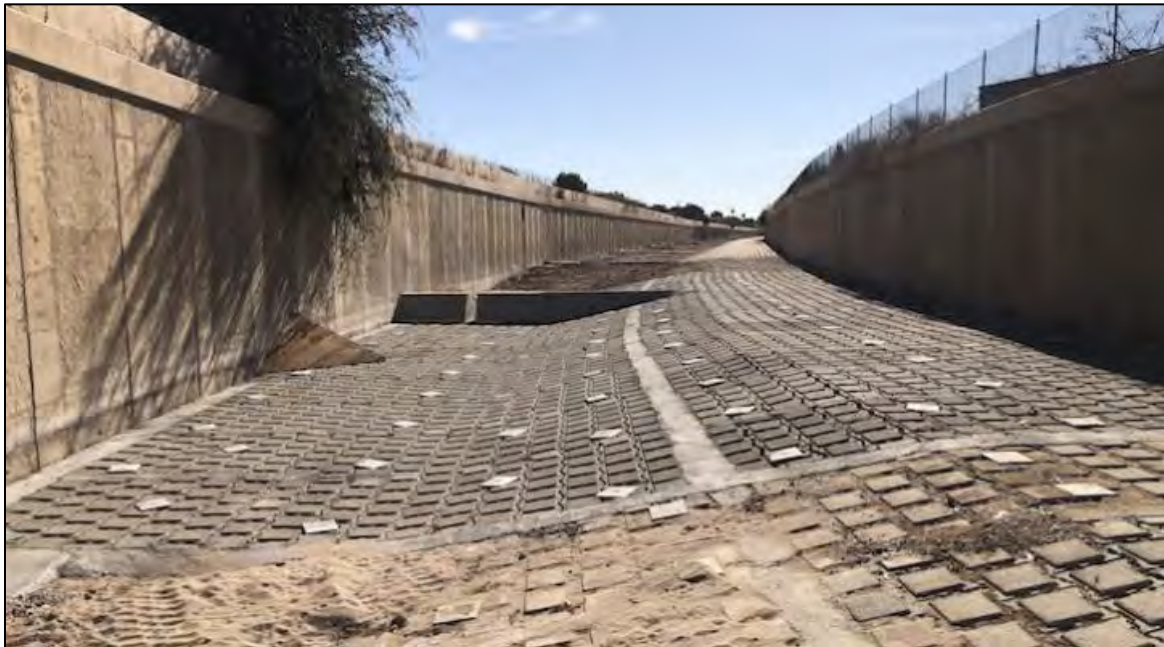
Figure 4. San Jose Creek flood control channel with rounded baffles for passage of adult Steelhead (top photos: Ed Zapel; bottom photo: City of Goleta).

A new paved flood control channel was constructed on lower San Jose Creek, in Goleta CA in 2011. It included a bottom consisting of articulated concrete blocks that allowed for groundwater recharge. The bottom had a cross slope, concentrating flow on the left side of the channel. Concrete baffles, resembling speed-humps, were placed along the left edge of the channel to concentrate flow and reduce velocities for passage of adult Steelhead (Figure 4). They included a slot to drain the pools behind the baffles as the stream dries. Downstream of each baffle is a wooden “deflector” to improve the hydraulics on the downstream side of the baffle. There remains a fish barrier at the upstream limit of the project, which is to be replaced in the near future. Therefore, there is no biological monitoring data for this project.

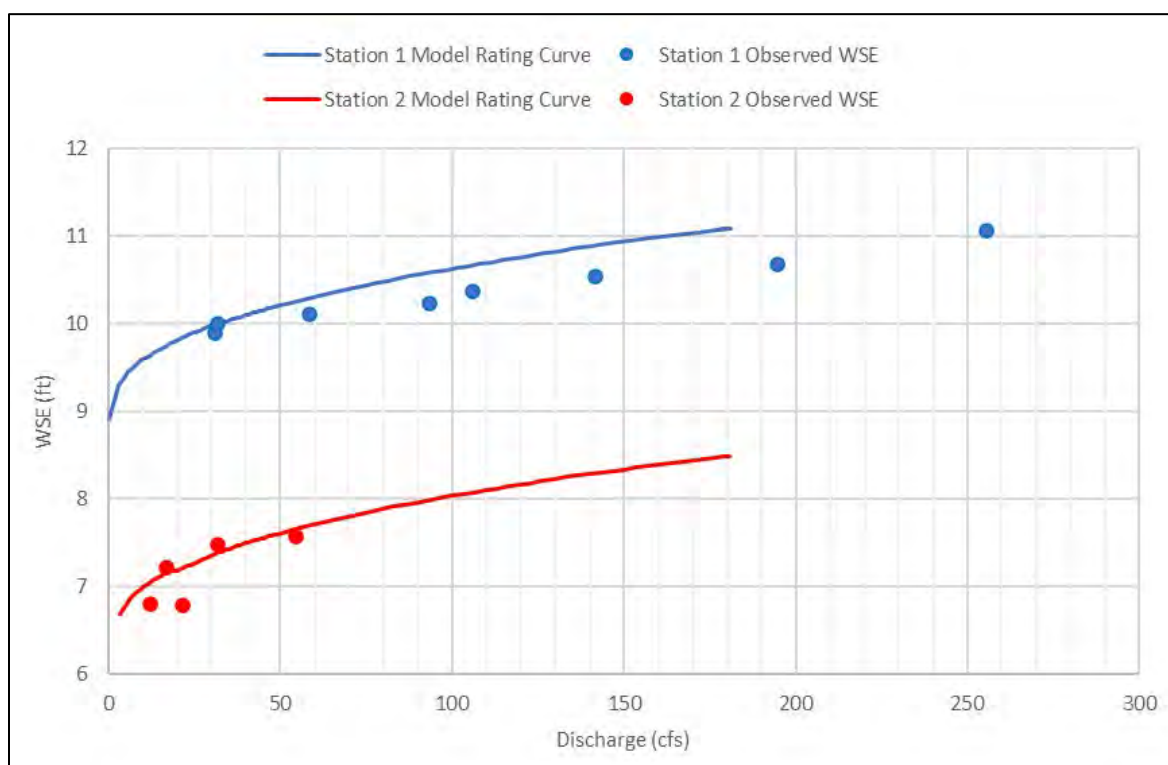
Figure 7. Fish passage model calibration of Manning's roughness coefficient using (n) of 0.013 to observed water surface elevations (WSEs) at two locations in the upper third of the Unit 3 concrete channel.

The previous fish passage study included the installation of stage gages and monitoring of flow events at five locations within the Unit 3 concrete channel. This effort is documented and described in the Fish Passage Assessment and Alternatives Analysis (MLA-JAA, 2007). Stations 1 (located a short distance downstream of the existing fish ladder) and Station 2 (located upstream of Kentfield Hospital bridge near Station 361+00) were used for the calibration process and are located within upper portions of Unit 3, upstream of tidal influence. The 2D HEC-RAS model was run for a large range of flows to develop rating curves at each of the two monitoring stations. The rating curves were then compared to the observed data and the roughness coefficient of the concrete channel was adjusted to obtain a best fit. Figure 7 displays the resulting rating curves for a roughness coefficient of 0.013, which provides the best fit for the observed water surface elevations at Stations 1 and 2. The roughness coefficient of 0.013 was used to determine depth and velocities for the fish passage flows (14 to 180 cfs) and for sediment transport capacity flows, estimated to be around 500 cfs.

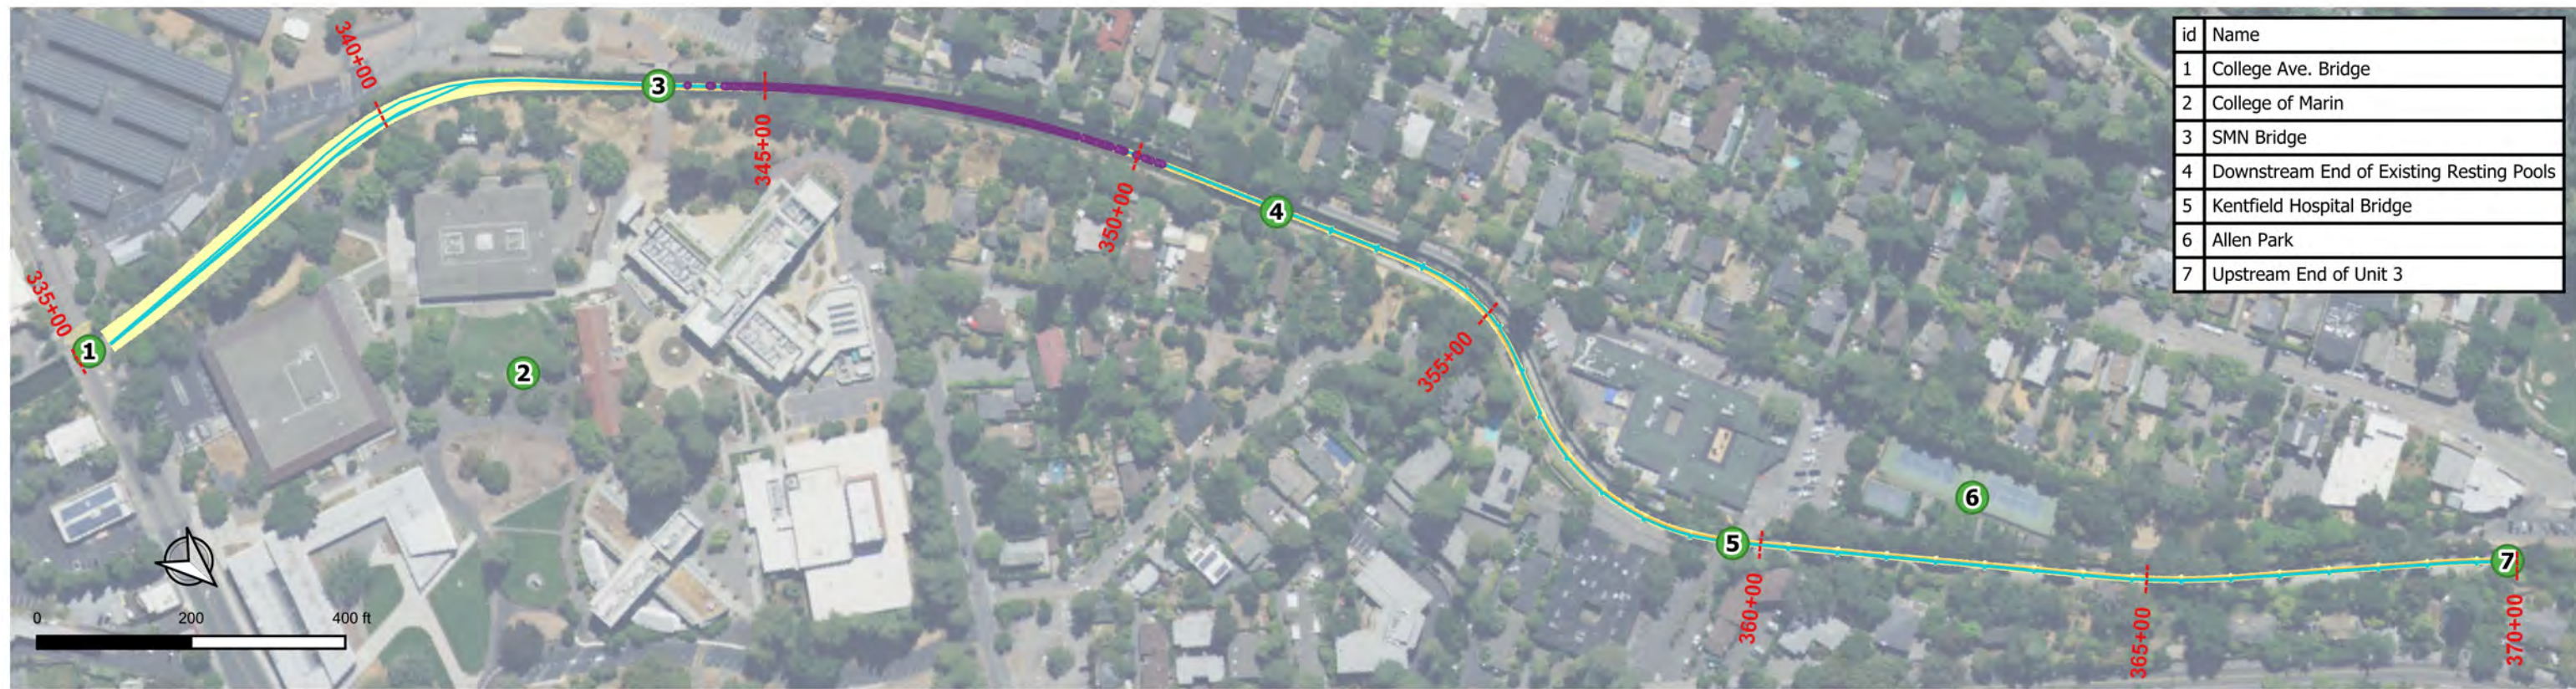
FIGURE 13

Ross, CA
Corte Madera Creek, Existing Conditions
Species: Adult Steelhead
Flow: 14 cfs
Boundary Condition: 0 ft Tide

Summary figures for select flows/tidal boundary conditions are presented in Figure 13 through Figure 16 and in Attachment 2. Each of these figures show (1) the location and body length of each surrogate fish that became fatigued within Unit 3, (2) the cumulative percent of the population that successfully swam through the entirety of Unit 3 and the lengths of the successful fish, (3) the three potential swimming routes applied to the analysis (which depended on the body size of the surrogate fish and corresponding minimum water depth for swimming), (4) location of the existing resting pools, and (5) water velocity encountered along each of the three fish routes.

As seen in Figure 13, at the low passage flow of 14 cfs with a low tide of 0.0 feet, all of the surrogate fish become exhausted before reaching the location of the downstream-most existing resting pool, thus resulting in 0% success. At the same flow of 14 cfs but at a higher tide of 4.0 feet (Figure 14), the tidal backwater extends upstream of the first resting pool encountered. As such, nearly all the surrogate fish reach the first resting pool without becoming fatigued and successfully pass through Unit 3. The velocities encountered by the fish within the channel are generally between 4.0 and 5.5 ft/s while the velocities in the resting pools are negligible.

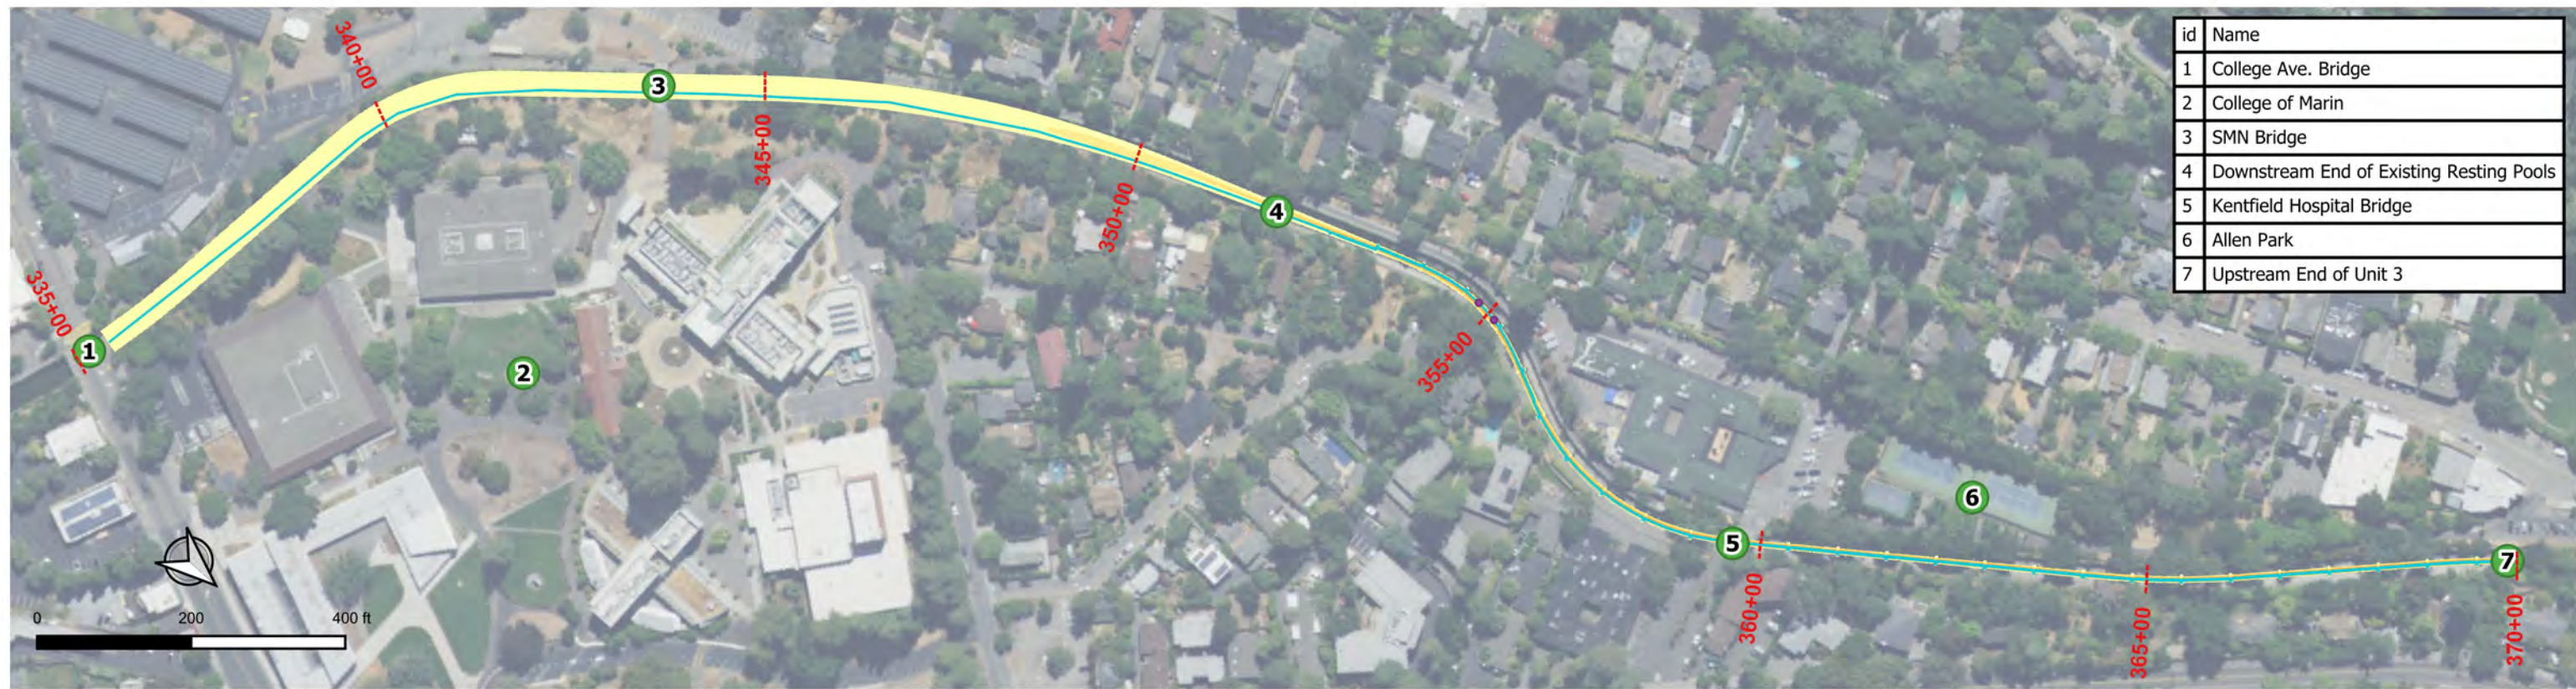
FIGURE 14

Ross, CA
Corte Madera Creek, Existing Conditions
Species: Adult Steelhead
Flow: 14 cfs
Boundary Condition: 4 ft Tide

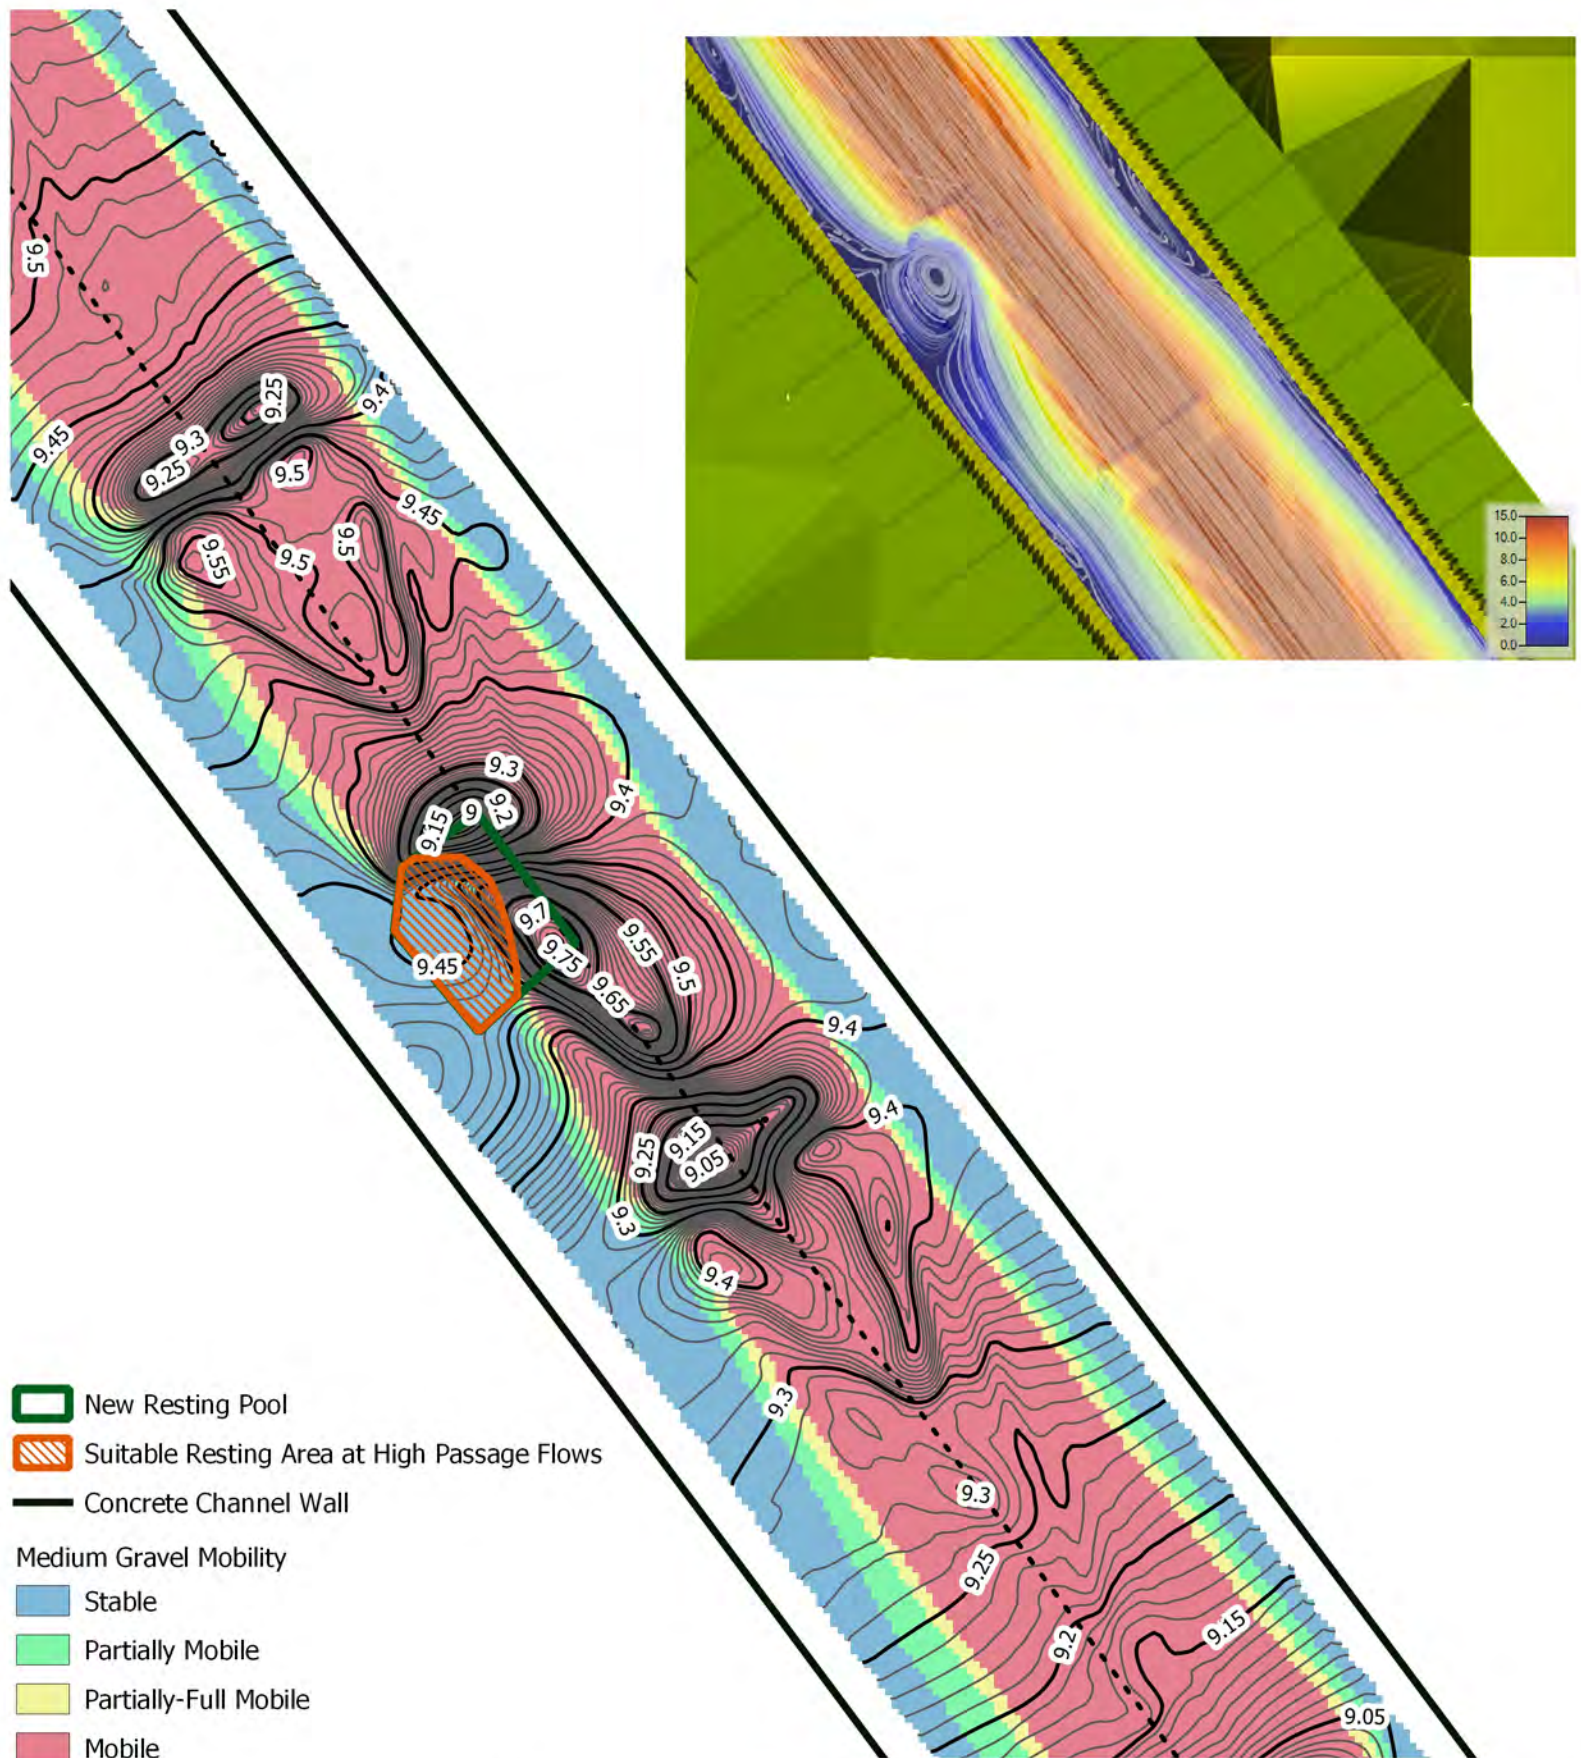
FIGURE 25 - 500 cfs - Shear

Corte Madera Creek, Proposed Conditions

Flow: 500 cfs

Boundary Condition: 0 ft Tide

Using the 2D model results, the potential for sedimentation within the pool at the estimated critical discharge of 500 cfs was evaluated by examining the bed shear stress within the pools in the straight channel segments (Figure 25) and within the channel bends (Figure 26). The suitable fish resting area at 180 cfs was mapped and shear stresses at 500 cfs within this area were examined to estimate potential for sedimentation within the resting area. The results show that the Alternative 2 pool has relatively low shear stress, such that bed material within the mapped resting area of the pool would not be mobilized at 500 cfs. Based on the 2D model results, the sedimentation potential of the Alternative 2 pool configuration appears more prone to sedimentation than Alternative 1.

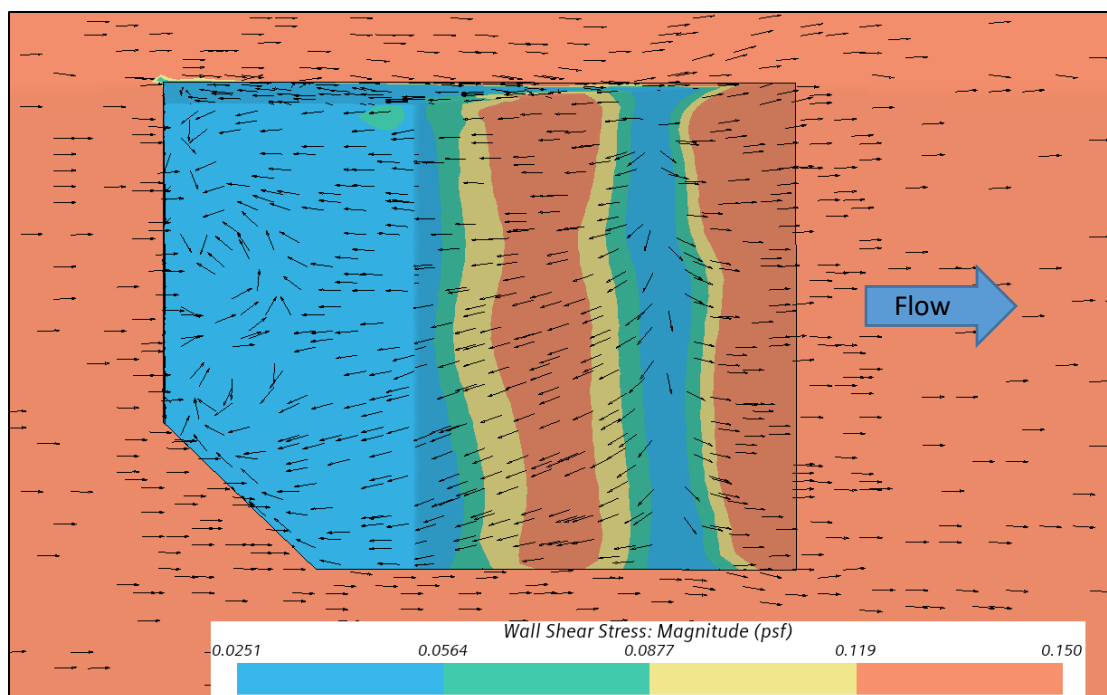
Figure 30. Shear stress applied to the channel bed and Alternative 2 pool bottom at 500 cfs. Orange represents shear stress sufficient to fully mobilize the dominate particle size of 8 mm, while yellows are partially-fully mobile, greens are partially mobile, and blues represents stable.

The shear stress magnitudes are relatively low in the pool but substantially greater across the pool tailout. The pool bottom appears potentially prone to sedimentation due to the low shear stress. A vertical eddy from the flow separation at the head of the pool causes a flow reversal along the bottom of the pool. This results in the direction of shear stresses to be reversed, with them going in the upstream direction. This may tend to mobilize deposited sediment towards the bottom of the pool rather than downstream. Given the complex interaction of the shear and water velocities near the bottom, the likely extents and patterns of sedimentation within the pool are difficult to predict.

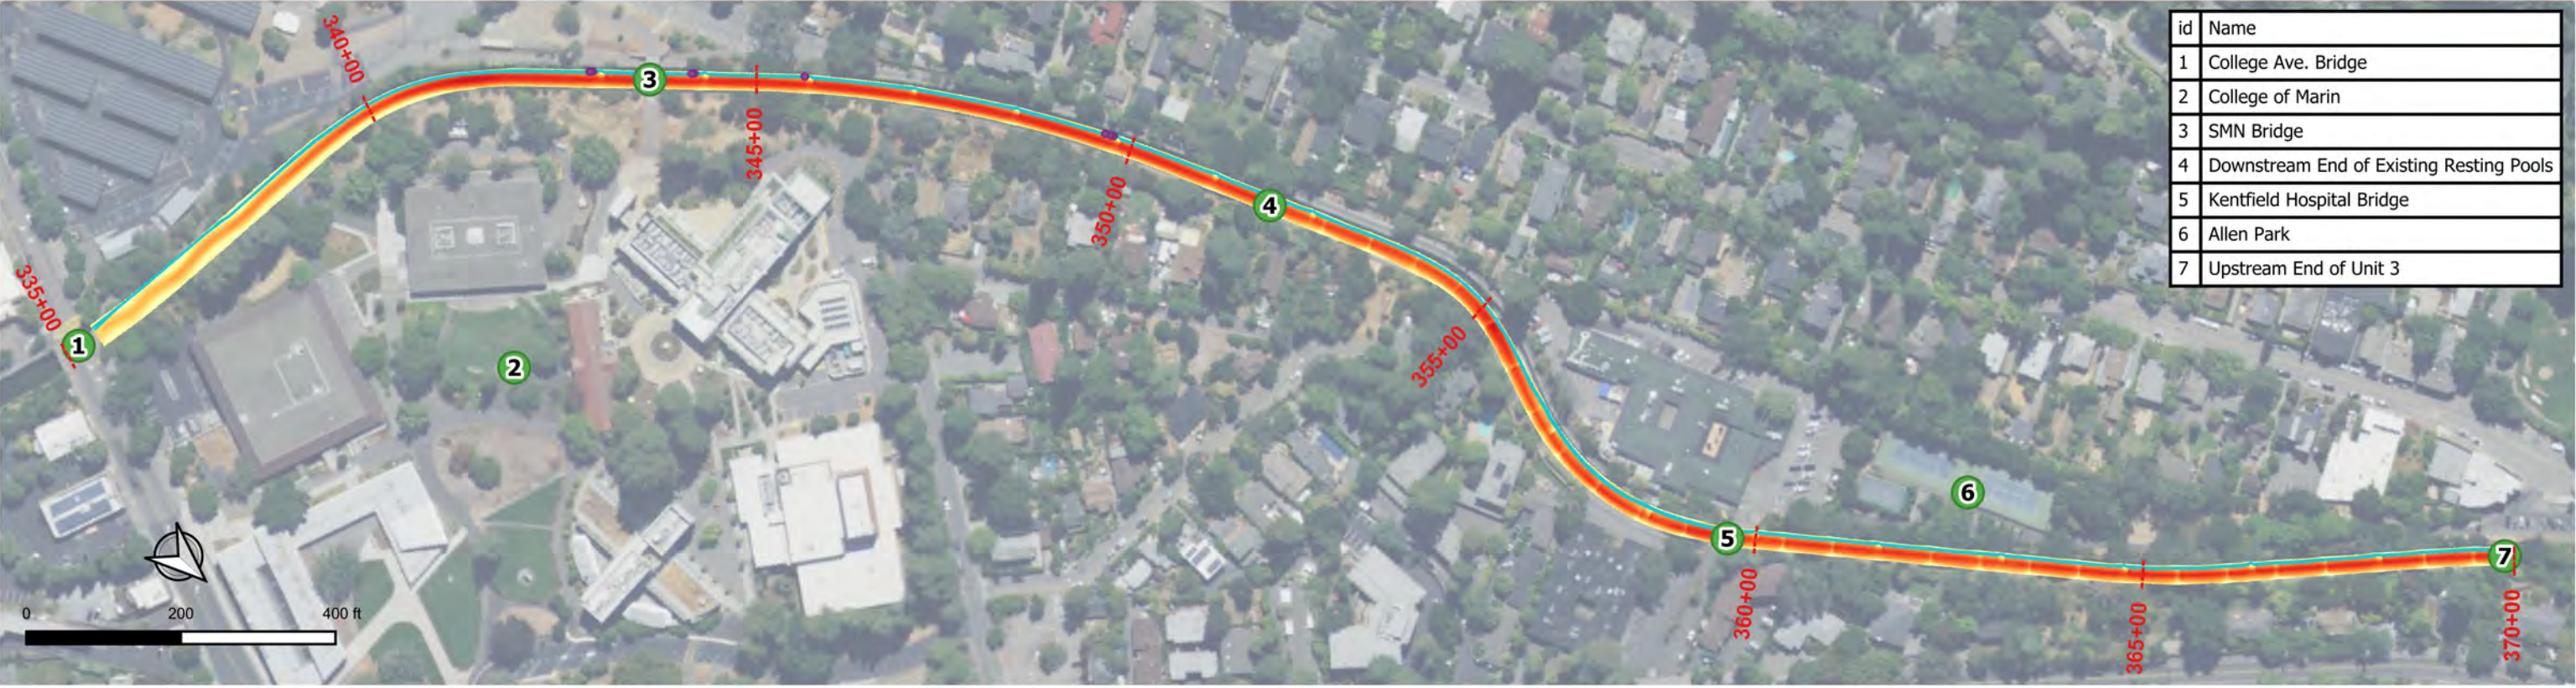
FIGURE 42
Alternative 4 Resting Pools
Corte Madera Creek, Final Proposed Conditions
Species: Adult Steelhead
Flow: 180 cfs (10% Exceedance)
Boundary Condition: 0 ft Tide

Each of the 16 pools were found to provide adequate resting volume at the high passage flow of 180 cfs and a low tide of 0.0 feet (Figure 42). The fish passage analysis resulted in 99.0% of the surrogate fish able to pass successfully through the Unit 3 channel at the 180 cfs flow and zero tide and 99.3% passage at the low passage flow of 14 cfs and zero tide. In both situations, only the smallest and weakest swimming individuals in the population were unable to succeed. Therefore, using Alternative 4 resting pool geometry and placing the 16 pools at their indicated locations, passage success rates equal or exceed 99% for all fish passage flows and tides.

The proposed project is anticipated to dramatically improve passage conditions. At the high fish passage flow and a tide of 0.0 feet (NAVD88), the project is anticipated passage for up to 99% of the Steelhead population based on results from the 2D hydraulic model and Fish-REALMS analysis (Figure 42). The passage rate is anticipated to be equal or greater than 99.0% at lower flows and higher tides.

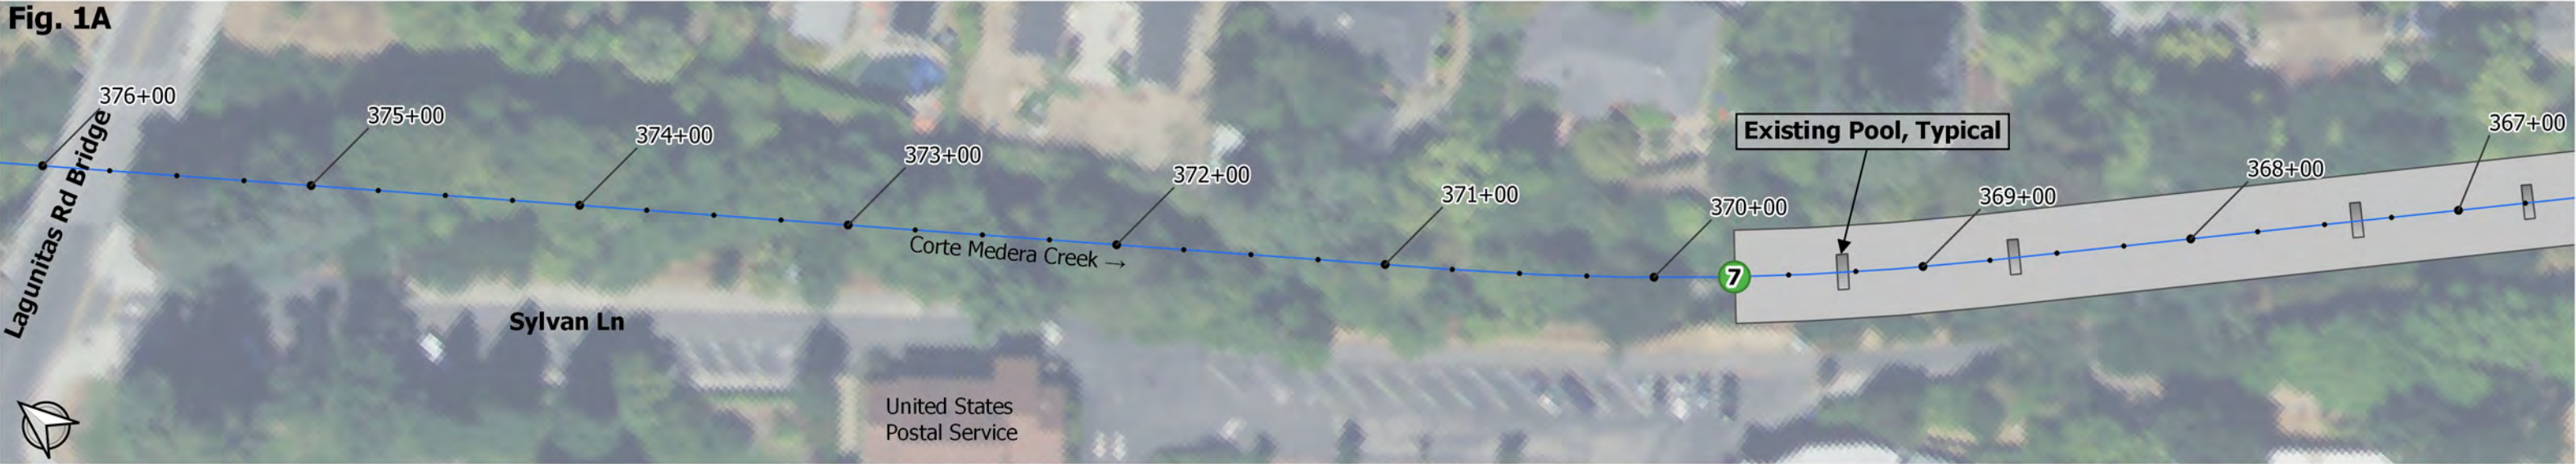
Layout of Existing Unit 3 Channel

id	Name
1	College Ave. Bridge
2	College of Marin
3	SMN Bridge
4	Downstream End of Existing Resting Pools
5	Kentfield Hospital Bridge
6	Allen Park
7	Upstream End of Unit 3

FIGURE 1
Ross, CA
Corte Madera Creek
Unit 3 Resting Pools
Existing Conditions

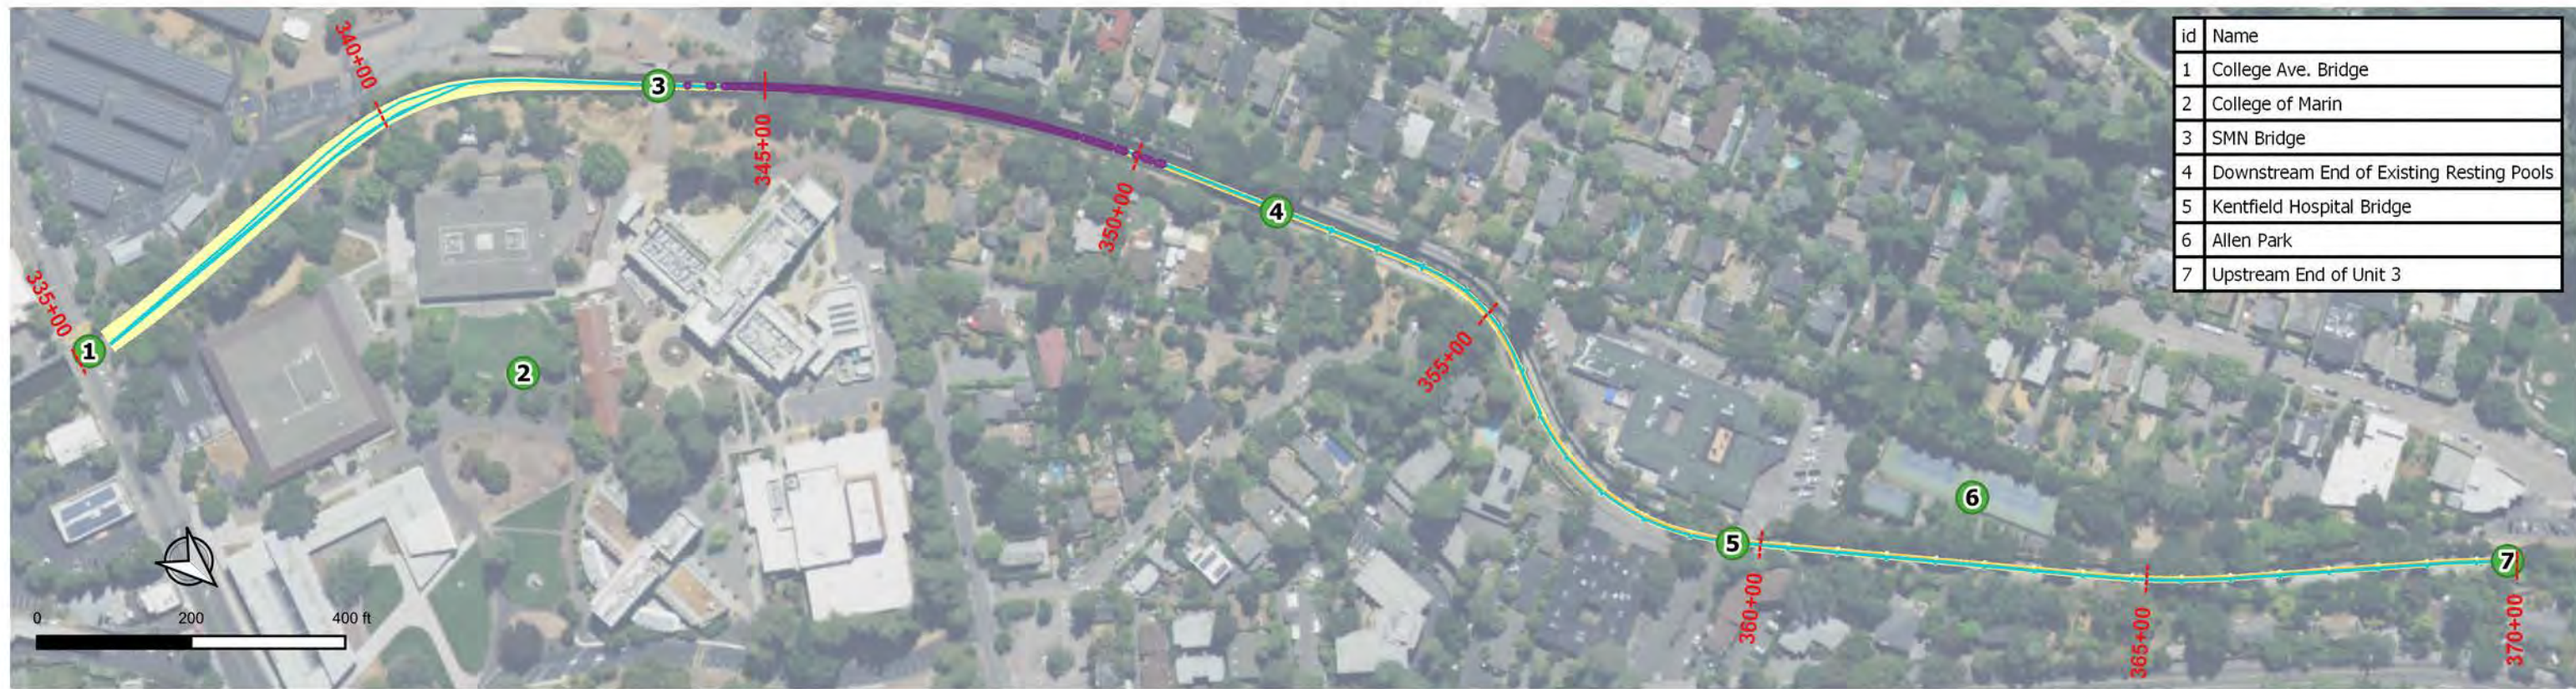
FIGURE 1

Ross, CA
Corte Madera Creek, Existing Conditions
Species: Adult Steelhead
Flow: 14 cfs
Boundary Condition: 0 ft Tide

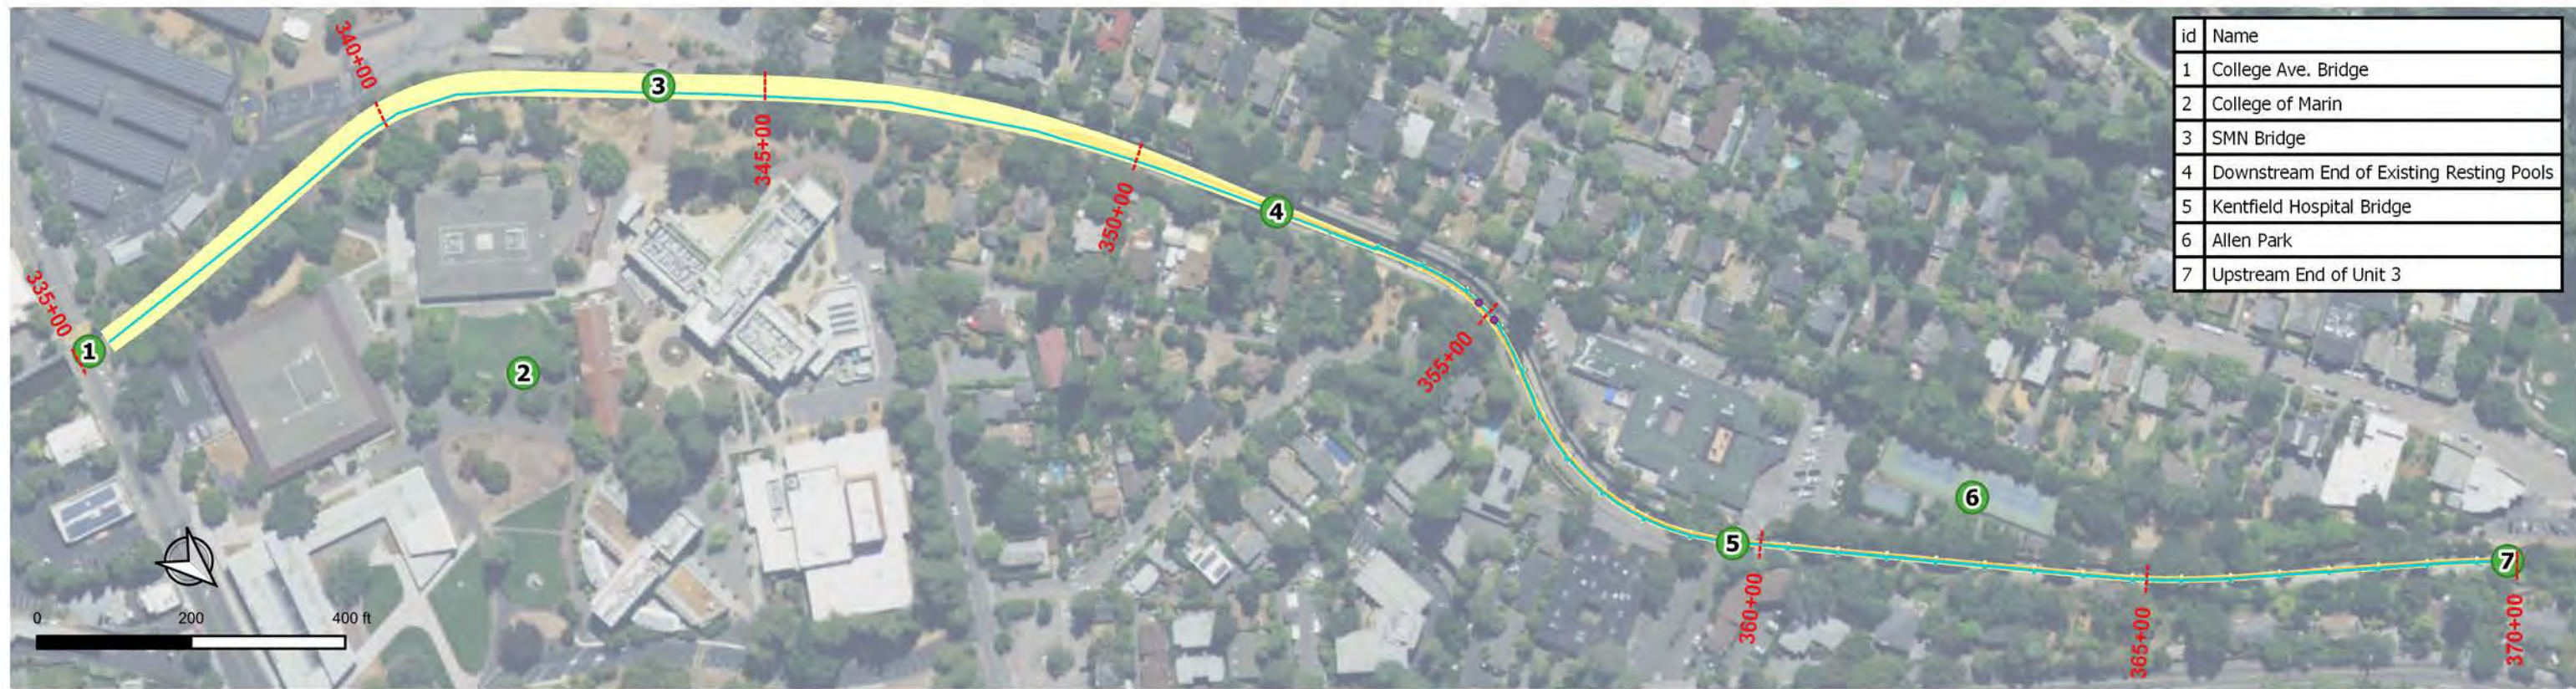
FIGURE 2

Ross, CA
Corte Madera Creek, Existing Conditions
Species: Adult Steelhead
Flow: 14 cfs
Boundary Condition: 4 ft Tide

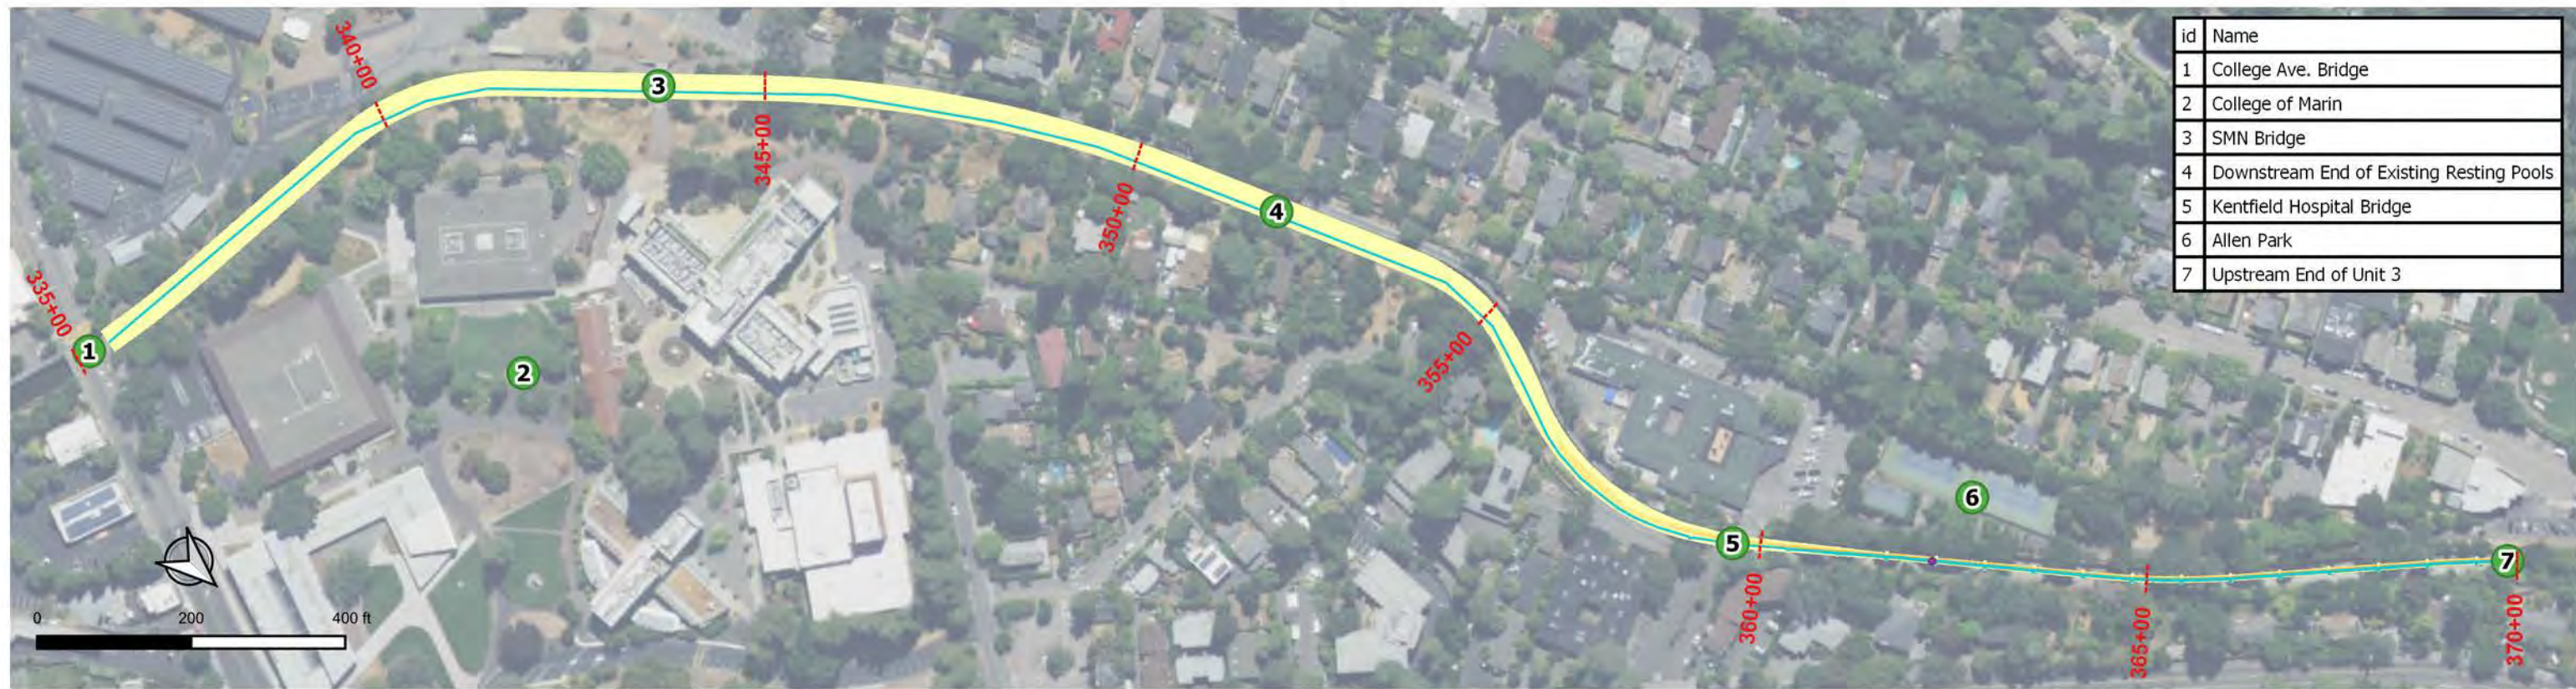
FIGURE 3

Ross, CA
Corte Madera Creek, Existing Conditions
Species: Adult Steelhead
Flow: 14 cfs
Boundary Condition: 7 ft Tide
