Basis of Design Report
Corte Madera Creek Fish Passage Project

Existing Fish Passage Conditions and
Analysis of Resting Pool Performance

December 2021

Michael Love & Associates
Hydrologic Solutions

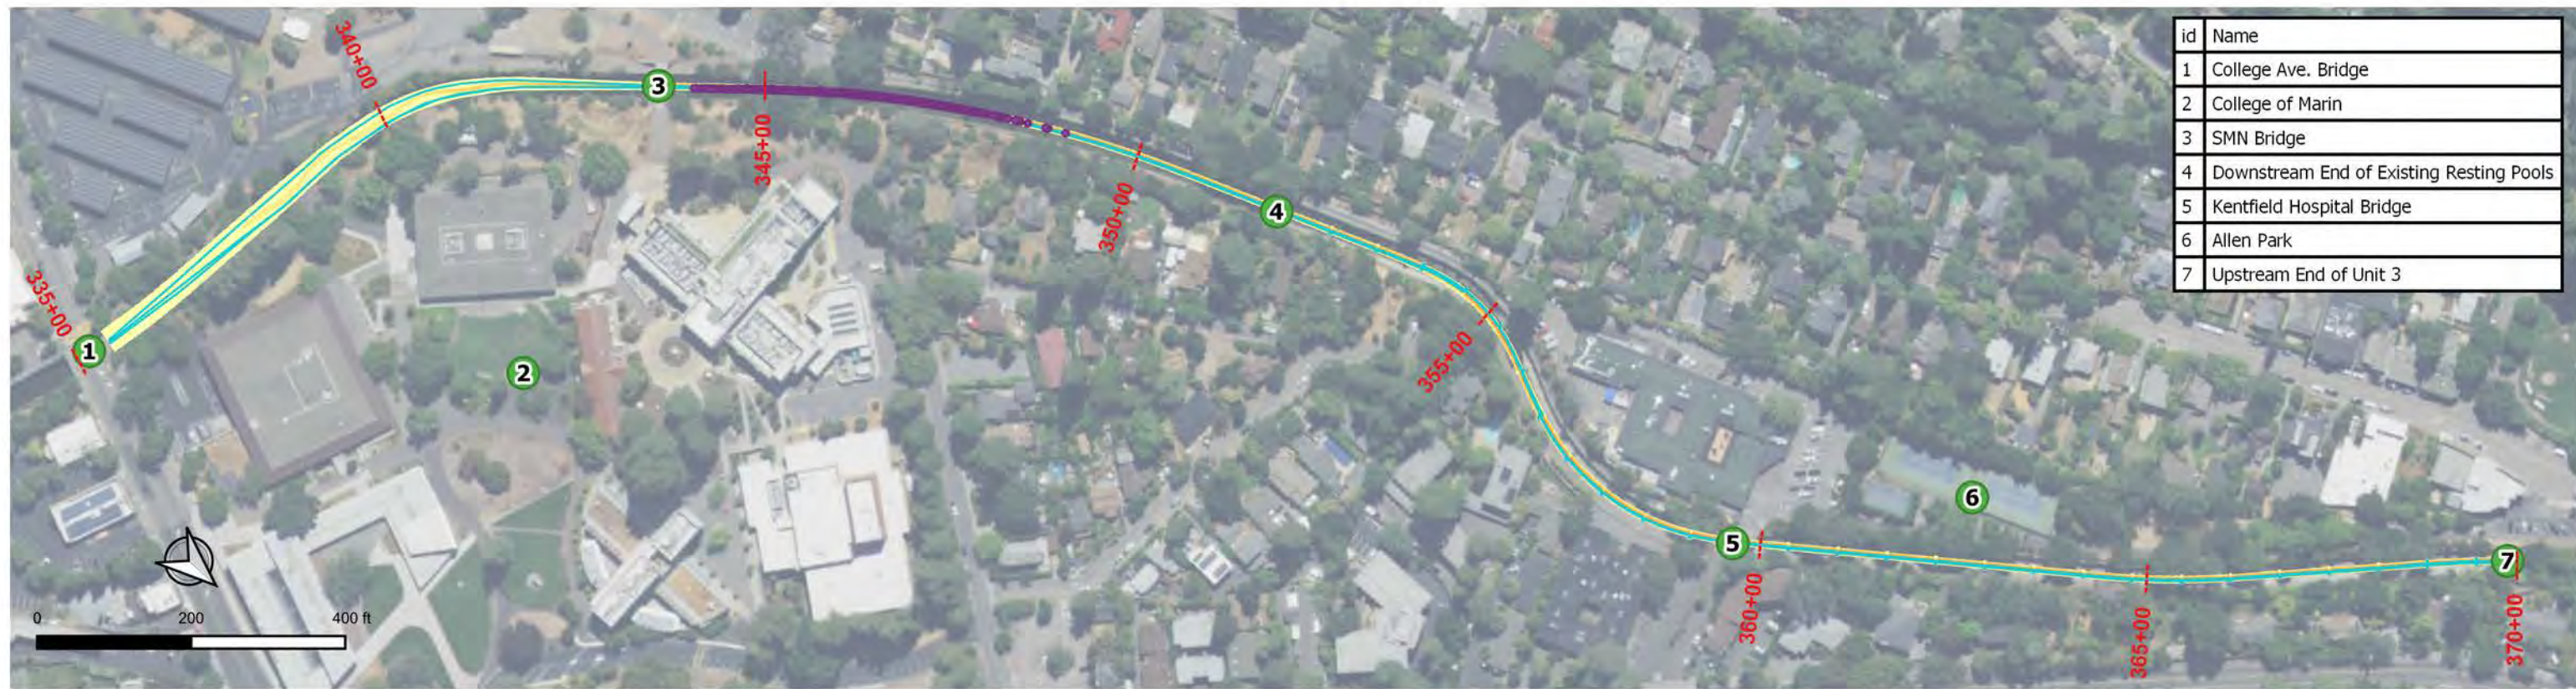
FIGURE 4

Ross, CA
Corte Madera Creek, Existing Conditions
Species: Adult Steelhead
Flow: 20 cfs
Boundary Condition: 0 ft Tide

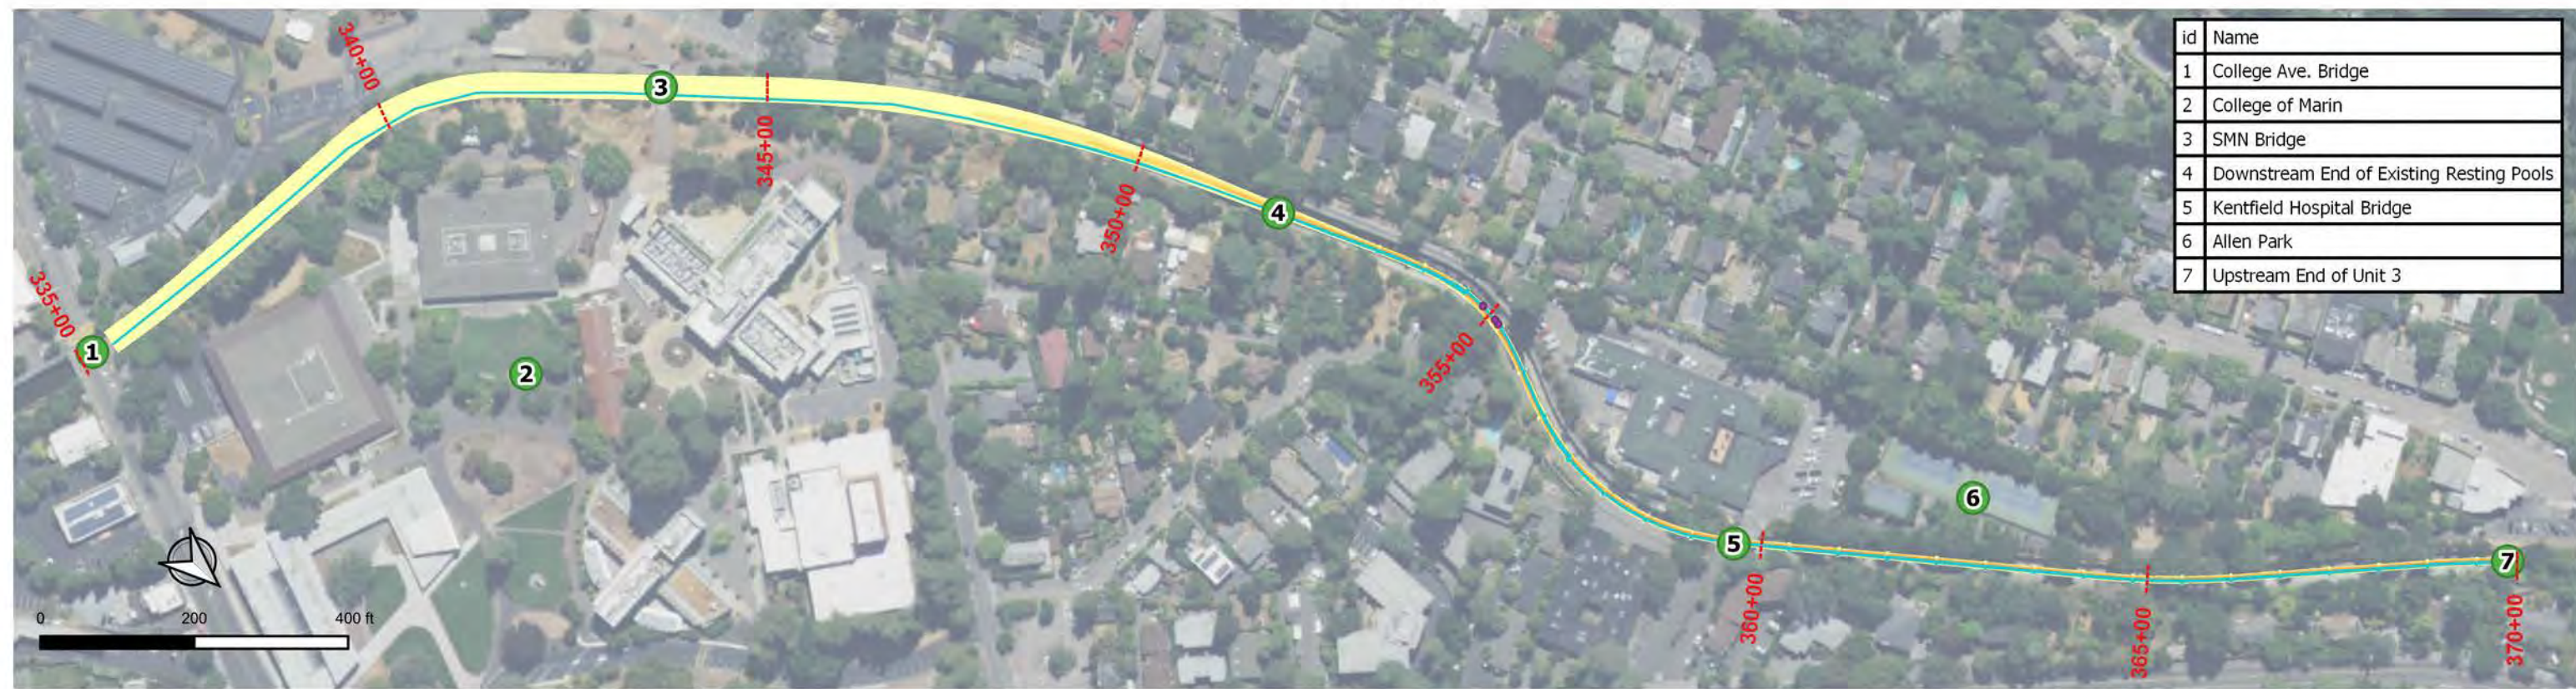
FIGURE 5

Ross, CA
Corte Madera Creek, Existing Conditions
Species: Adult Steelhead
Flow: 20 cfs
Boundary Condition: 4 ft Tide

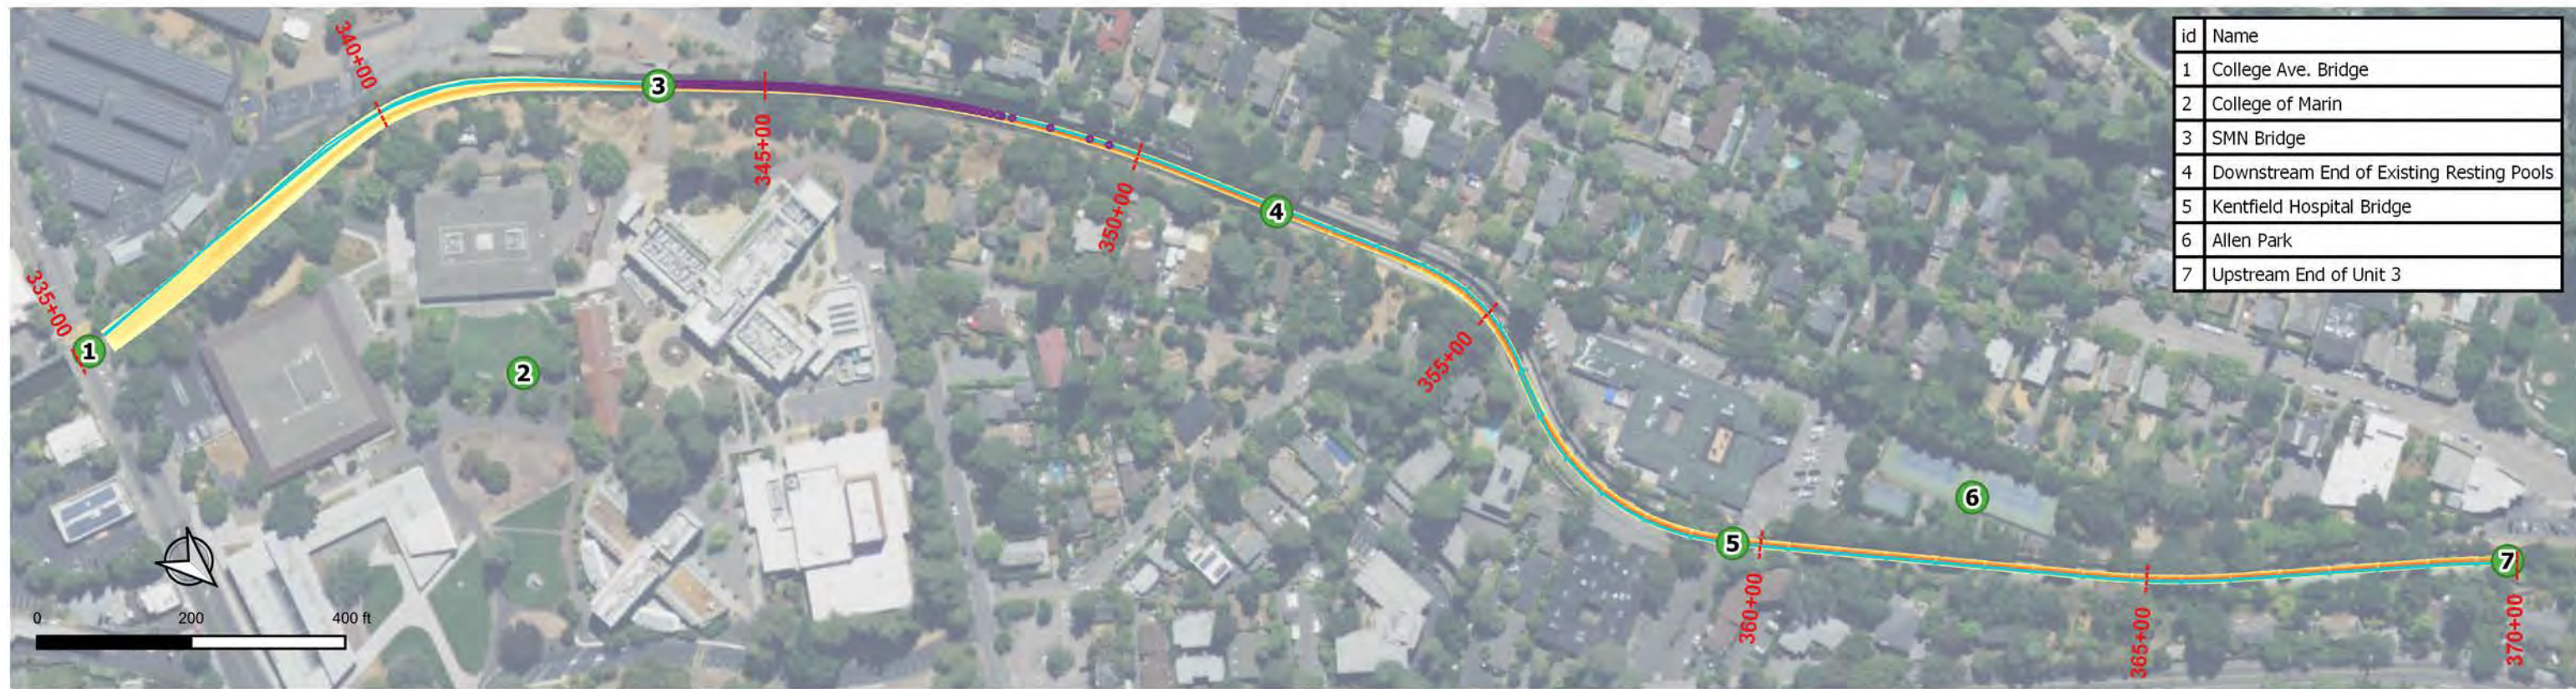
FIGURE 6

Ross, CA
Corte Madera Creek, Existing Conditions
Species: Adult Steelhead
Flow: 20 cfs
Boundary Condition: 7 ft Tide

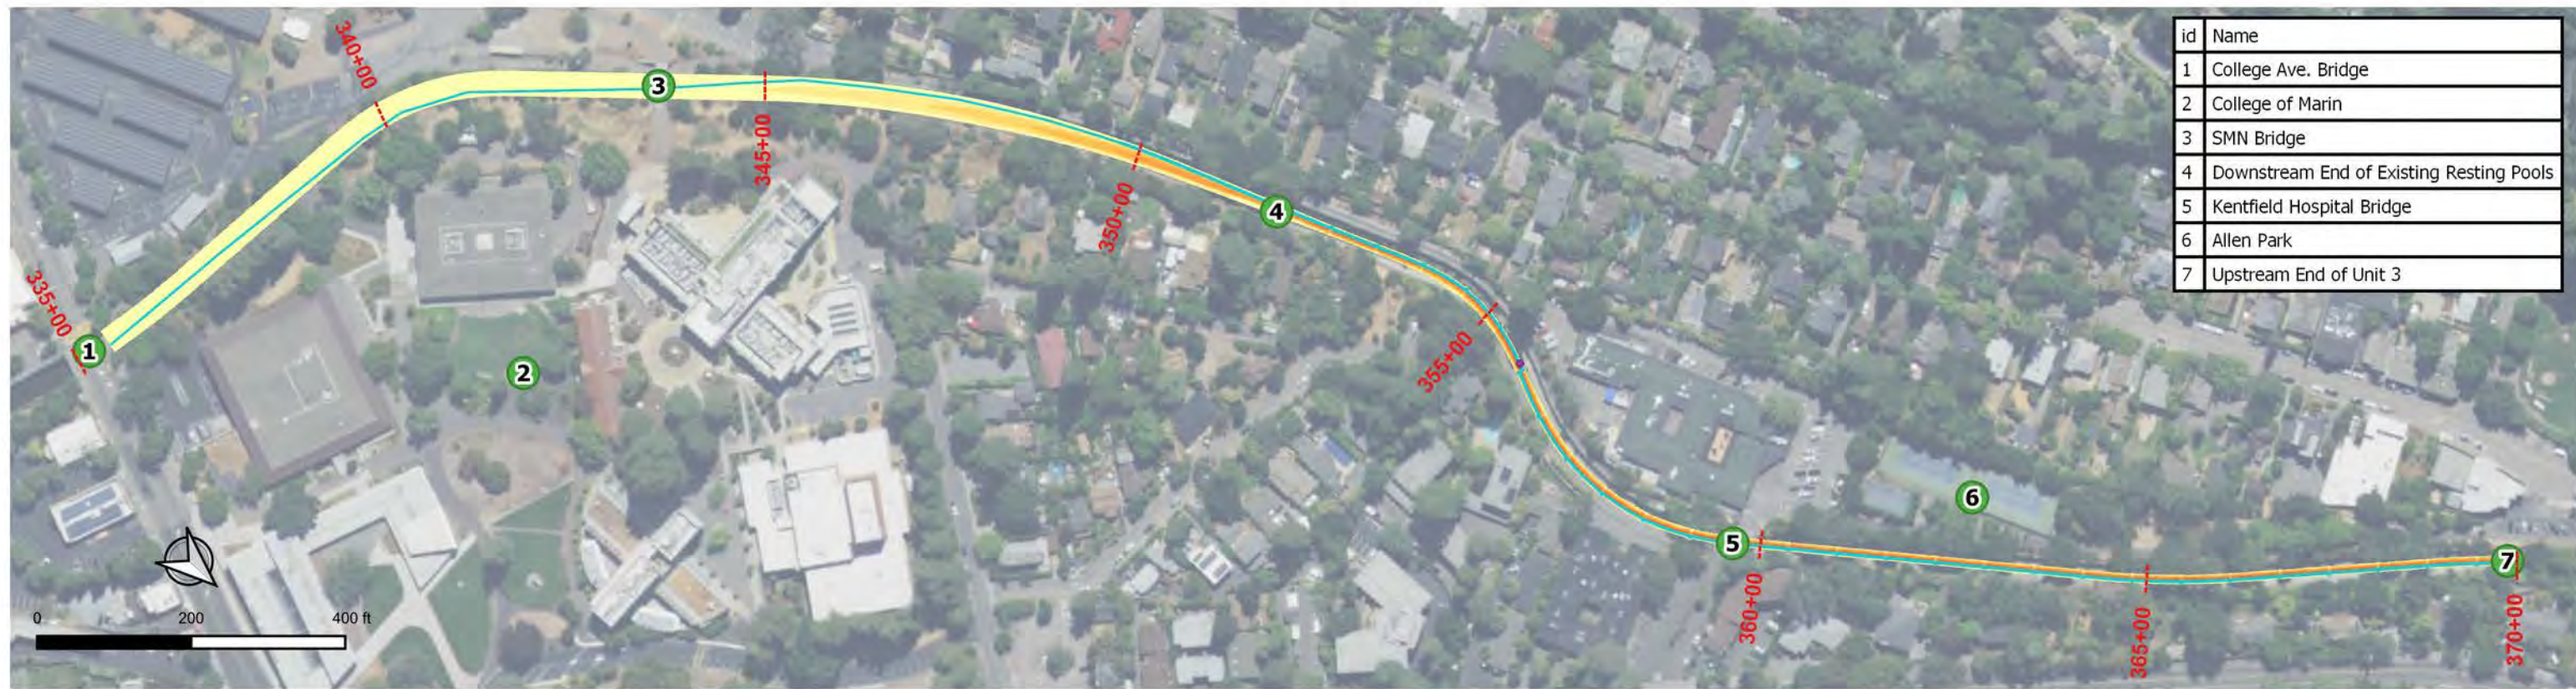
FIGURE 7
 Ross, CA
 Cortes Madera Creek, Existing Conditions
 Species: Adult Steelhead
 Flow: 35 cfs
 Boundary Condition: 0 ft Tide

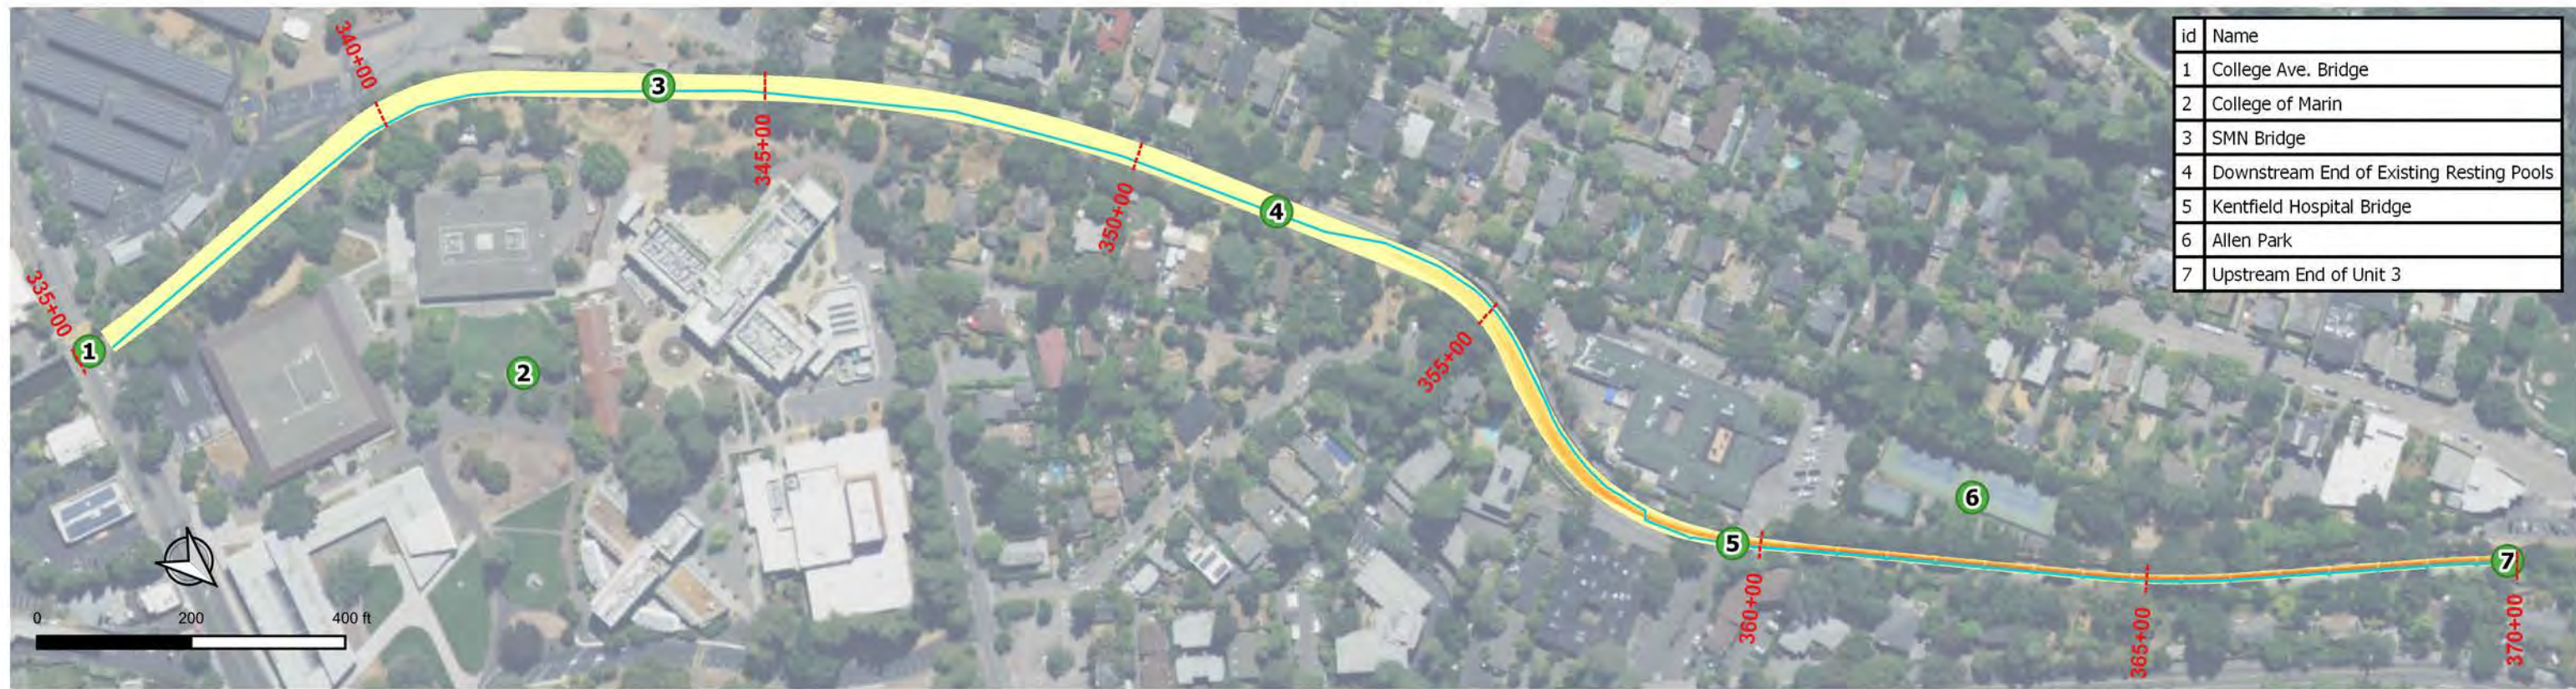
FIGURE 8

Ross, CA
Corte Madera Creek, Existing Conditions
Species: Adult Steelhead
Flow: 35 cfs
Boundary Condition: 4 ft Tide

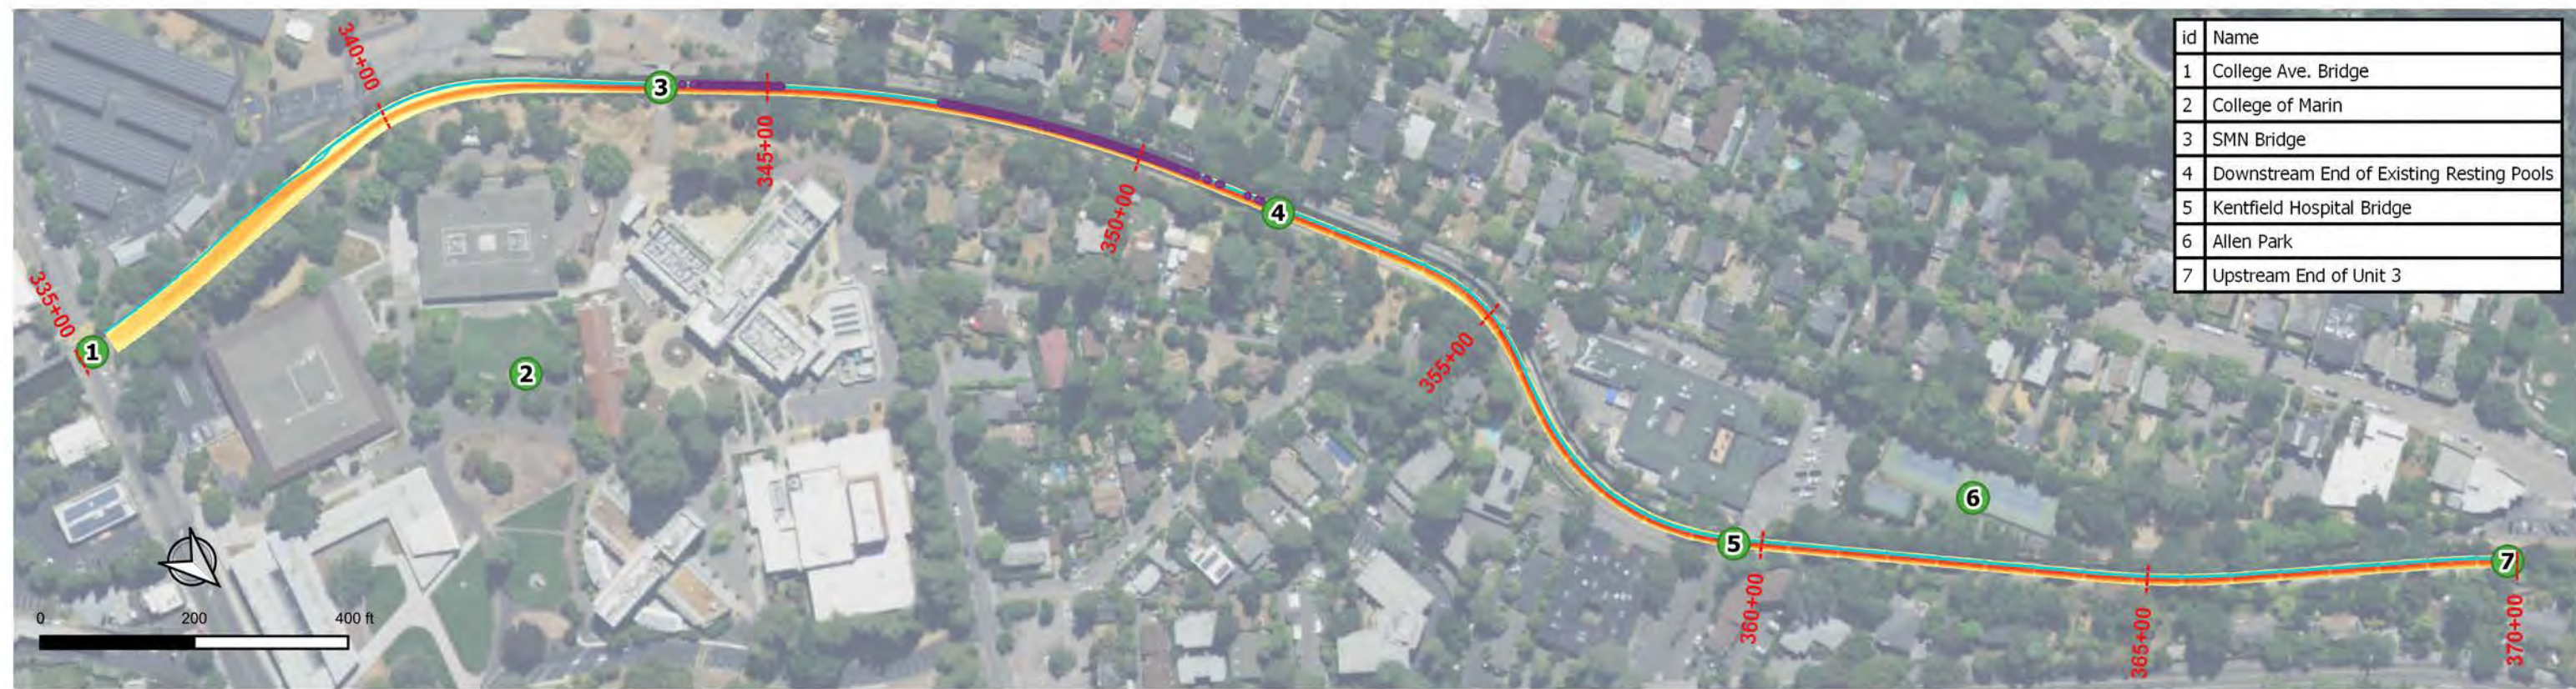
FIGURE 9

Ross, CA
Cortes Madera Creek, Existing Conditions
Species: Adult Steelhead
Flow: 35 cfs
Boundary Condition: 7 ft Tide

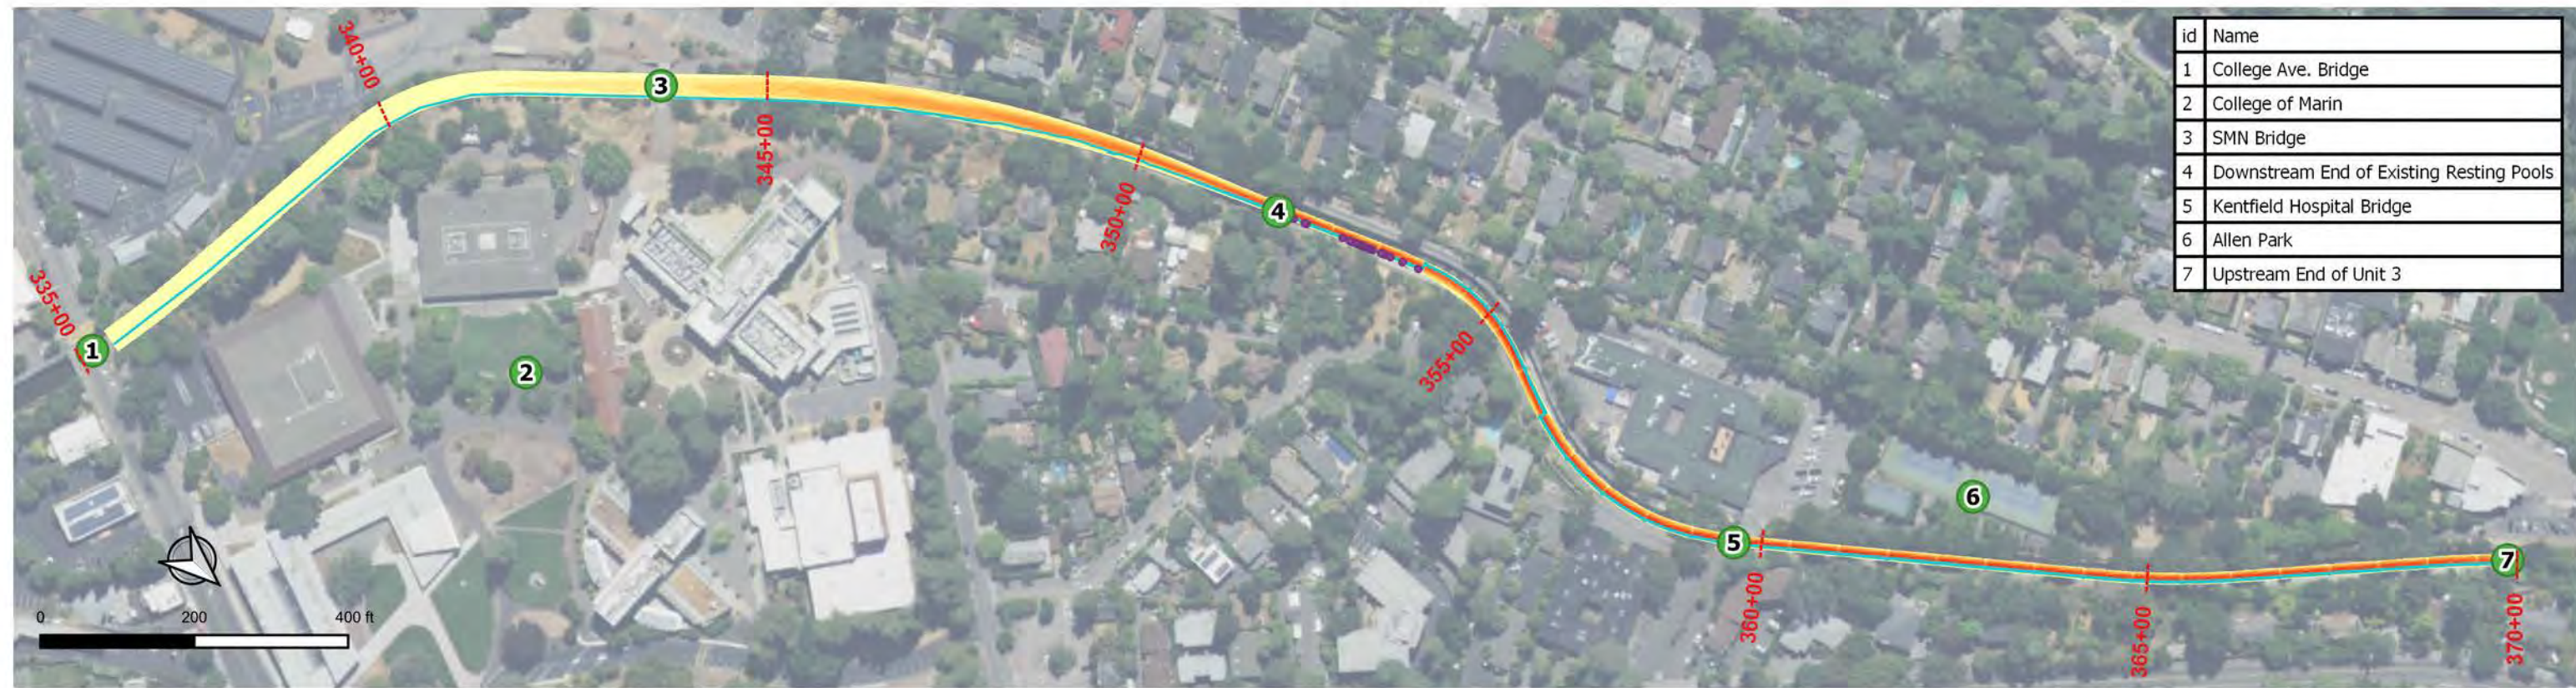
FIGURE 10

Ross, CA
Corte Madera Creek, Existing Conditions
Species: Adult Steelhead
Flow: 65 cfs
Boundary Condition: 0 ft Tide

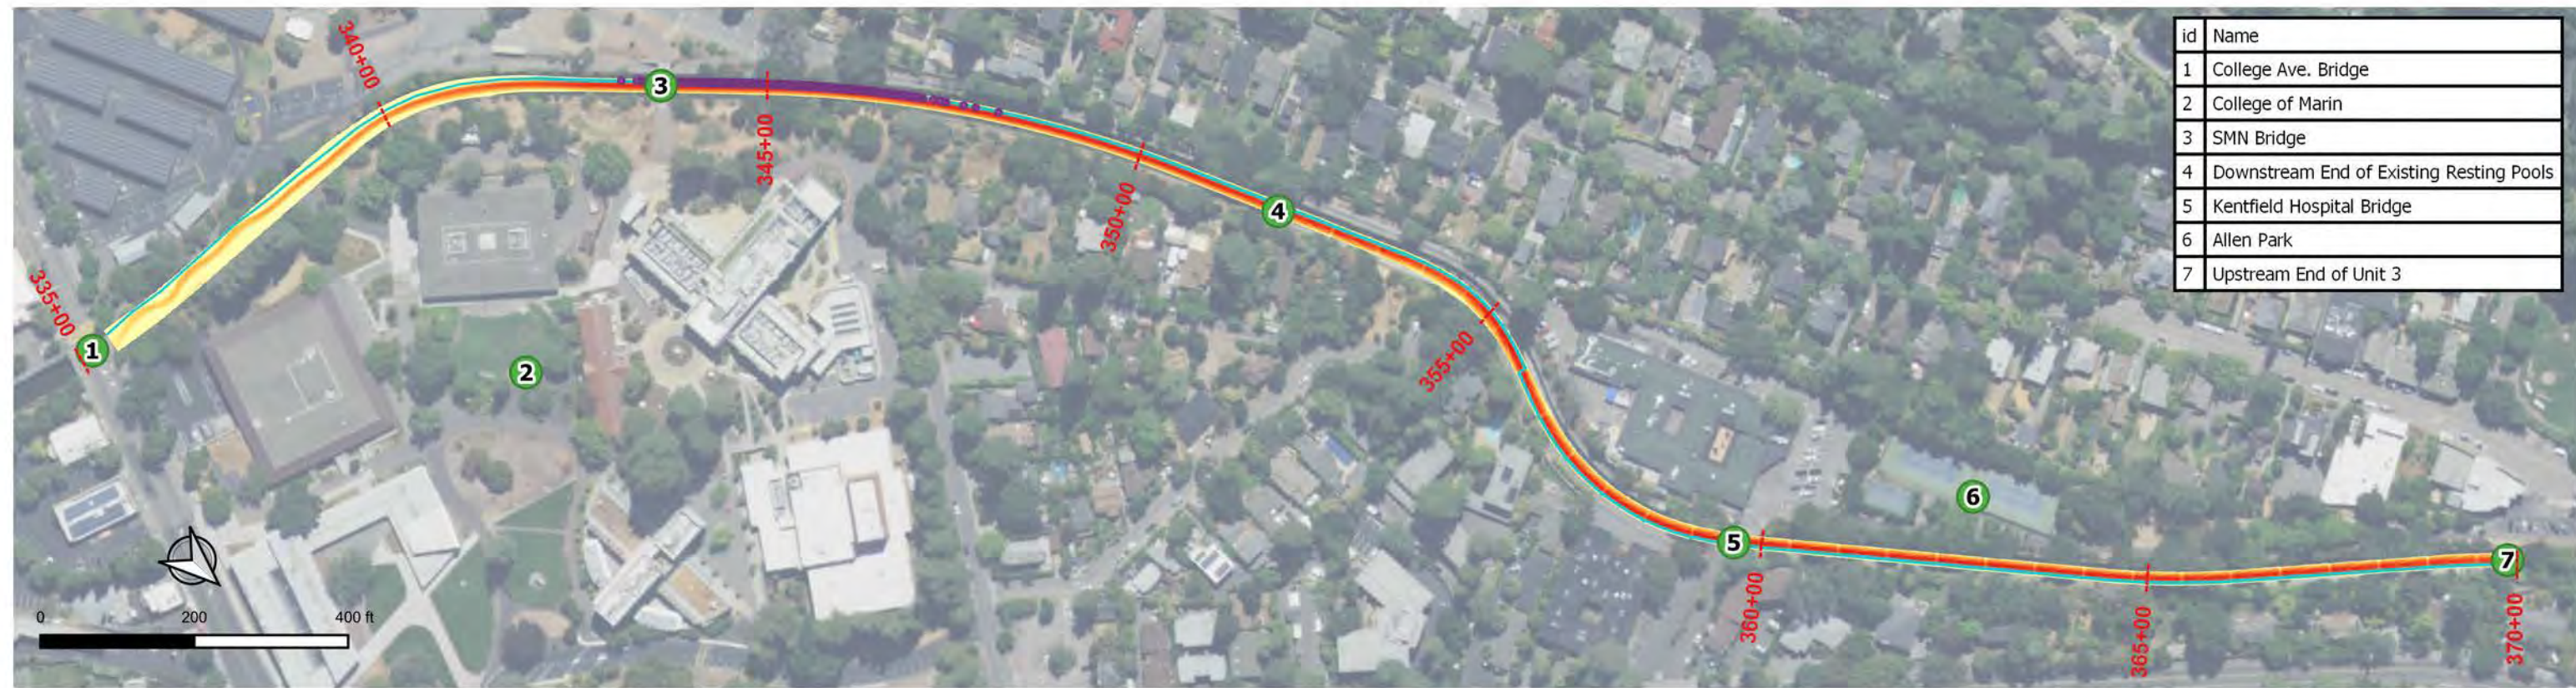
FIGURE 12

Ross, CA
Corte Madera Creek, Existing Conditions
Species: Adult Steelhead
Flow: 65 cfs
Boundary Condition: 7 ft Tide

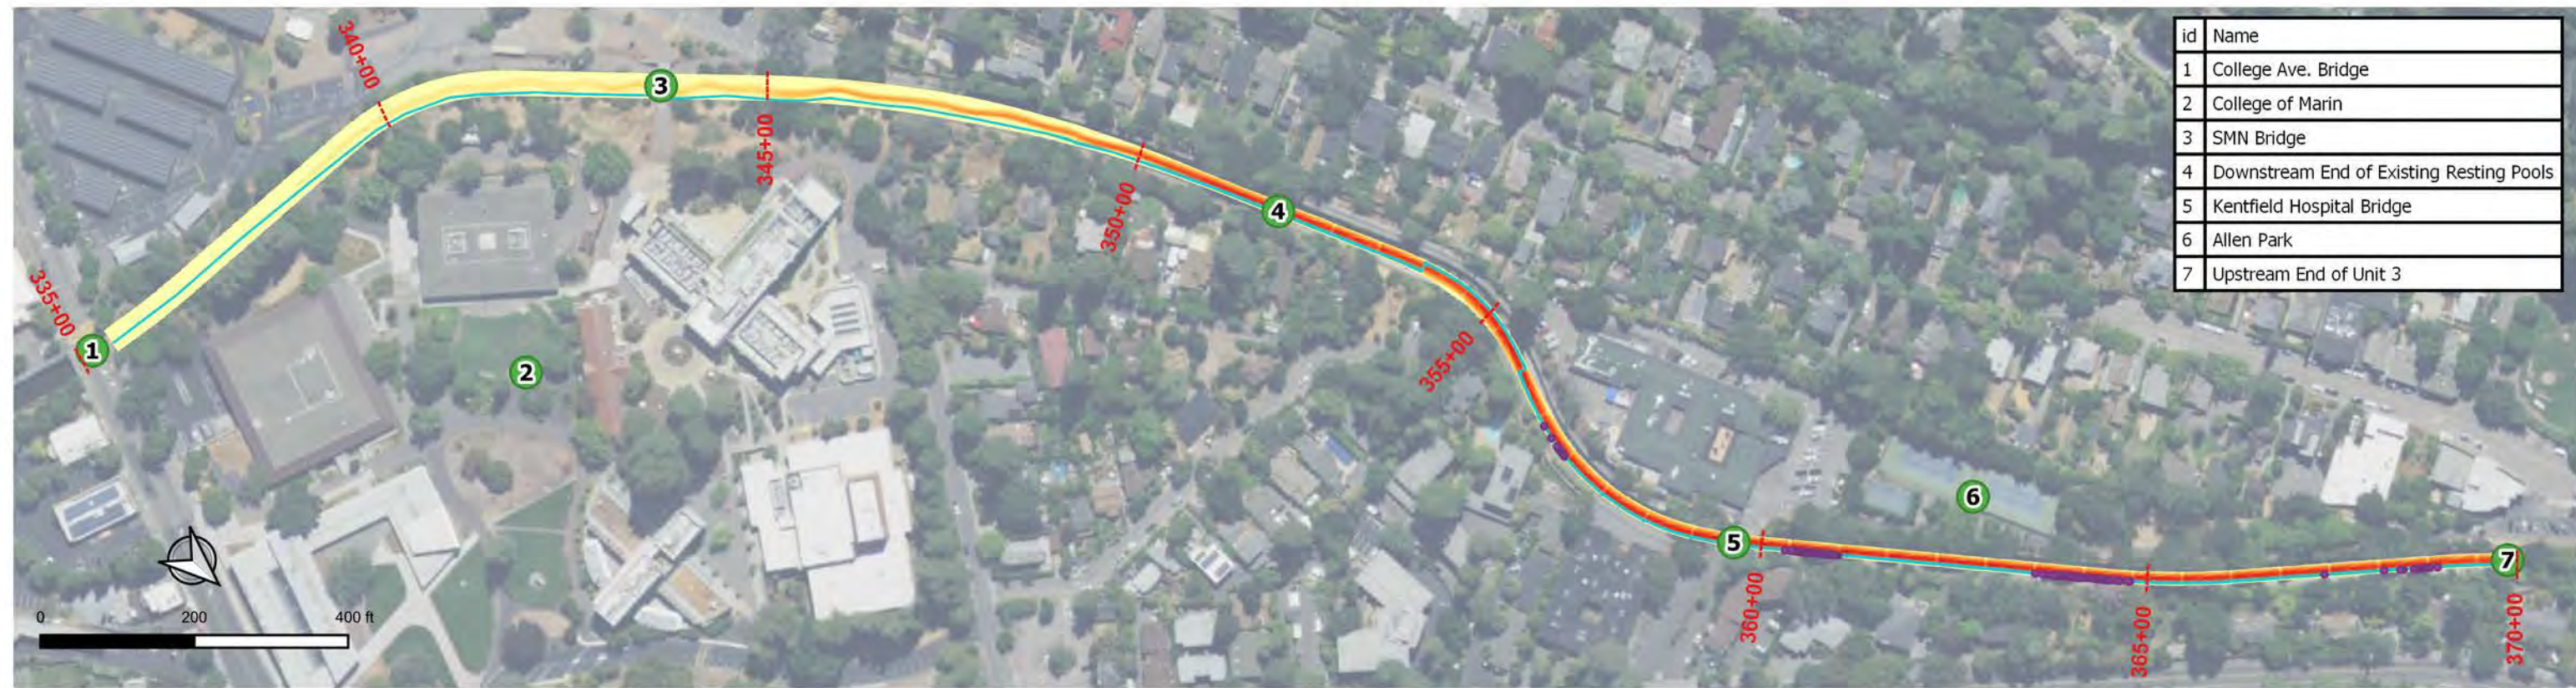
FIGURE 13
 Ross, CA
 Cortes Madera Creek, Existing Conditions
 Species: Adult Steelhead
 Flow: 100 cfs
 Boundary Condition: 0 ft Tide

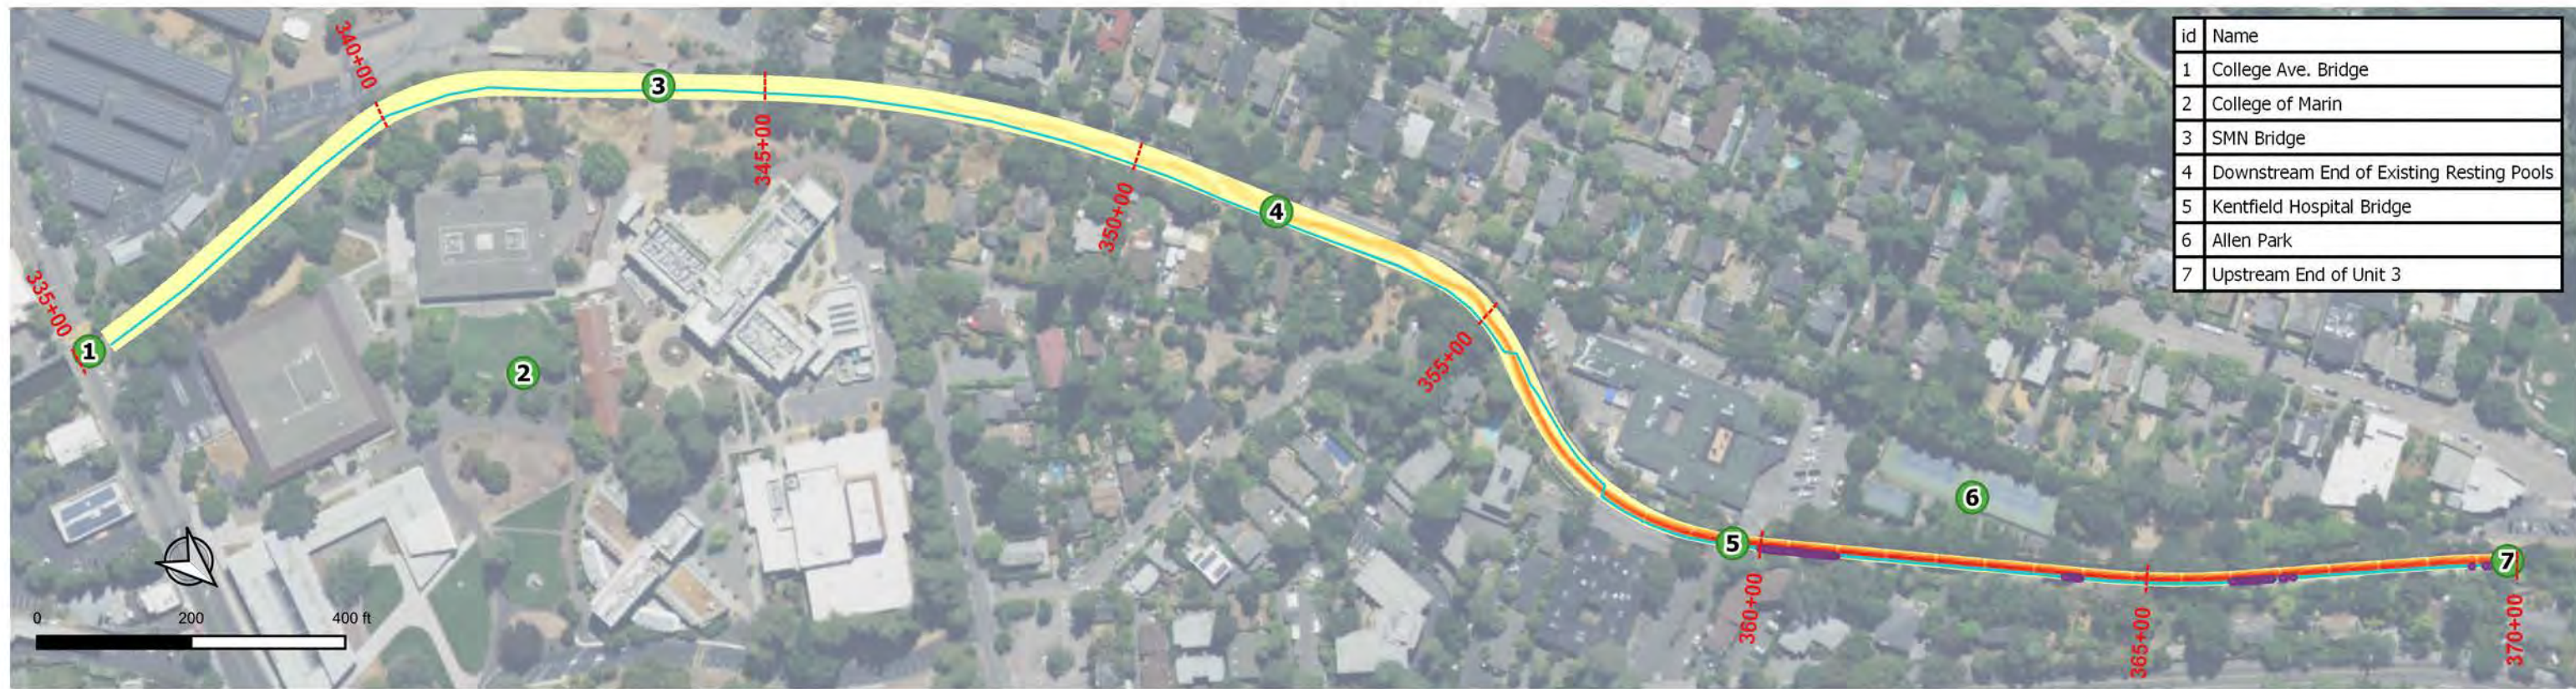
FIGURE 14
Ross, CA
Corte Madera Creek, Existing Conditions
Species: Adult Steelhead
Flow: 100 cfs
Boundary Condition: 4 ft Tide

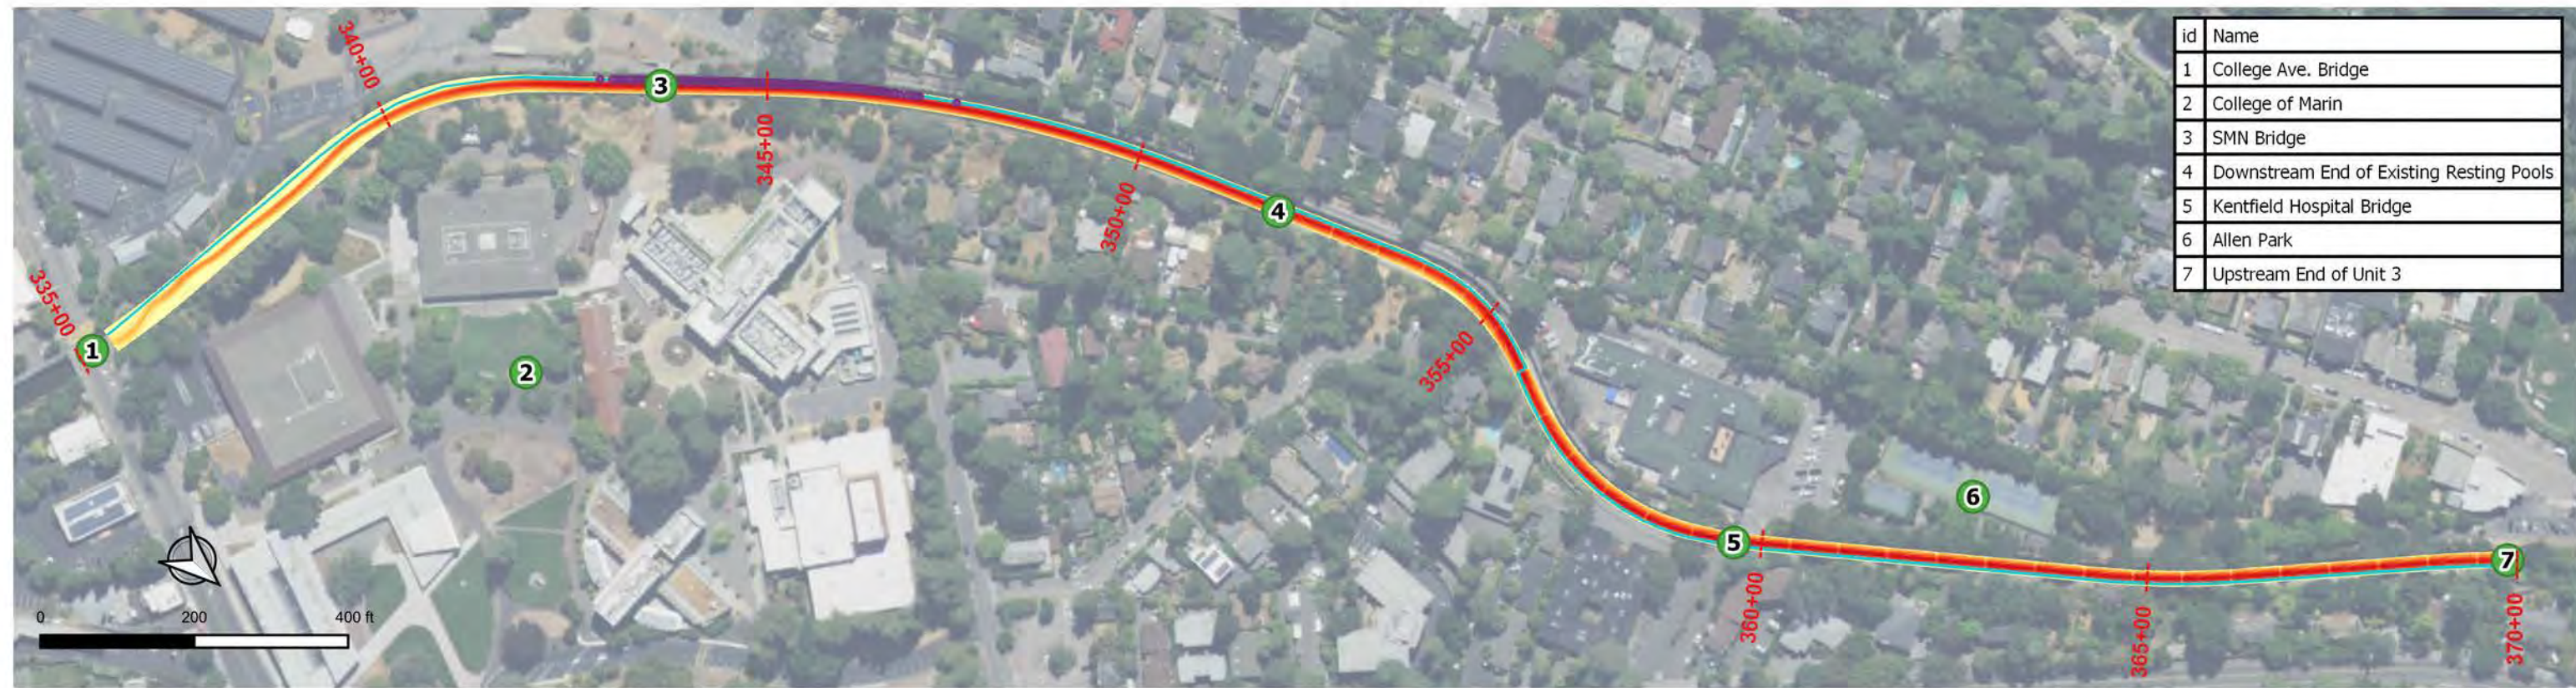
FIGURE 15
Ross, CA
Corte Madera Creek, Existing Conditions
Species: Adult Steelhead
Flow: 100 cfs
Boundary Condition: 7 ft Tide

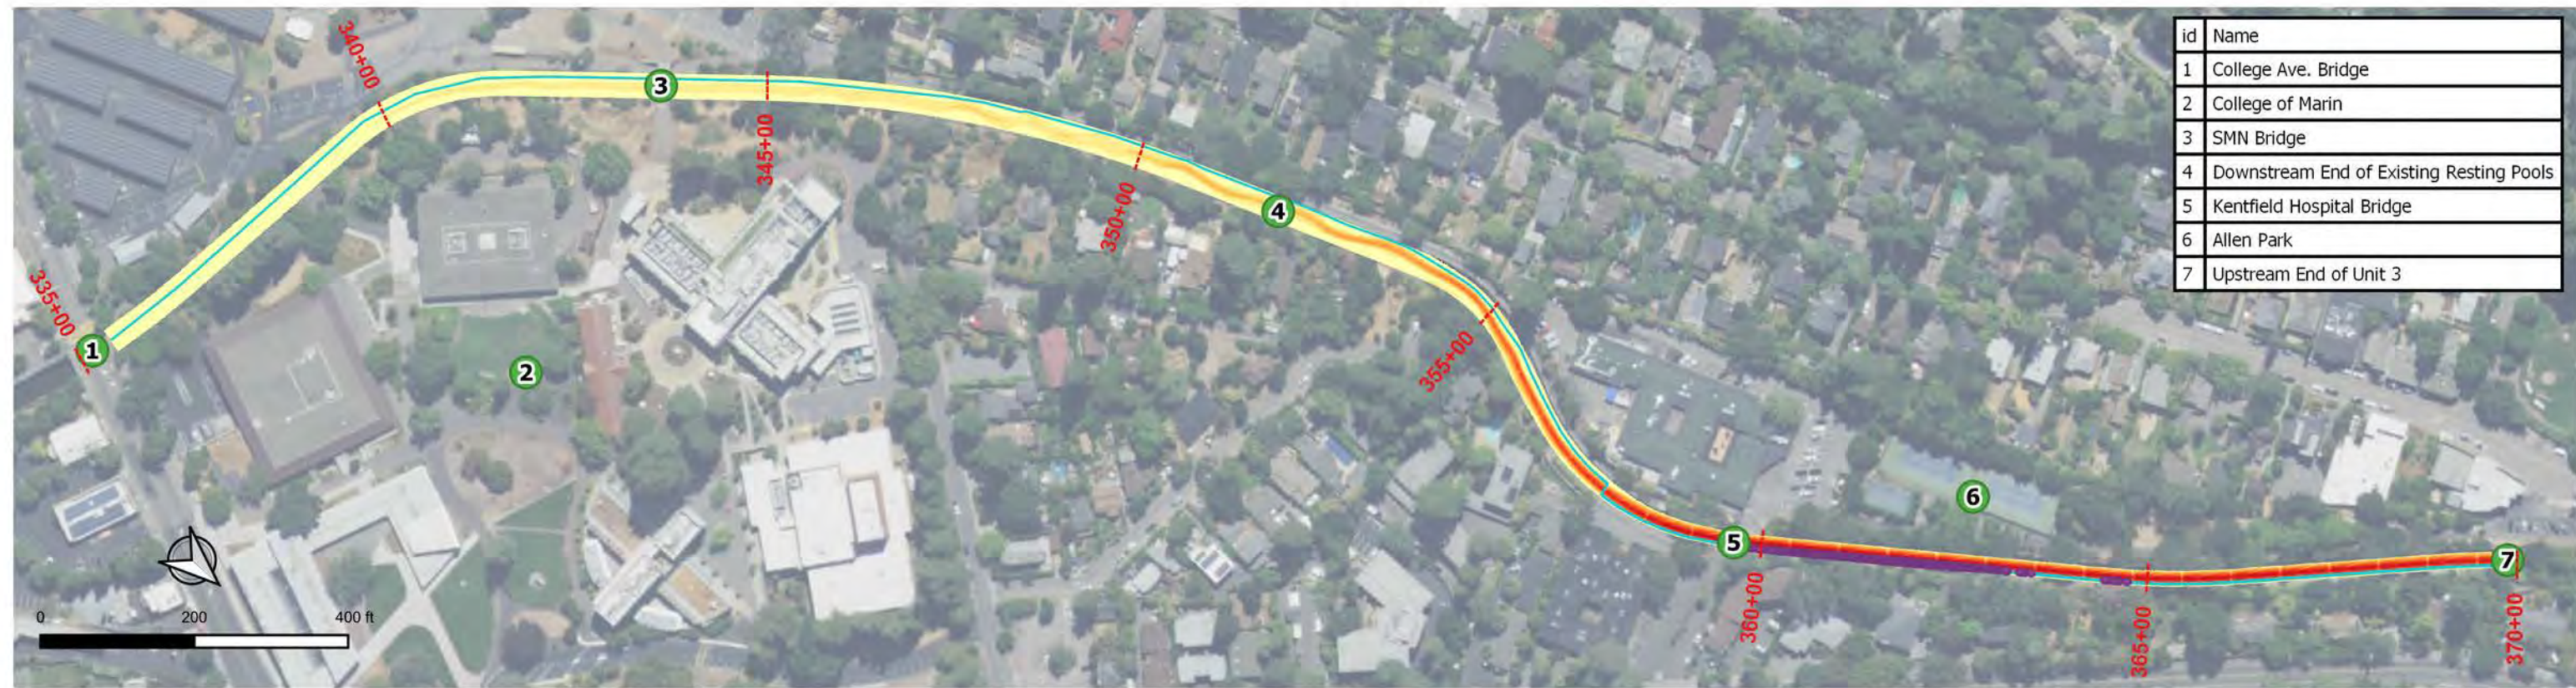
FIGURE 17

Ross, CA
Corte Madera Creek, Existing Conditions
Species: Adult Steelhead
Flow: 150 cfs
Boundary Condition: 4 ft Tide
