Basis of Design Report
Corte Madera Creek Fish Passage Project

Existing Fish Passage Conditions and
Analysis of Resting Pool Performance

December 2021

Michael Love & Associates
Hydrologic Solutions

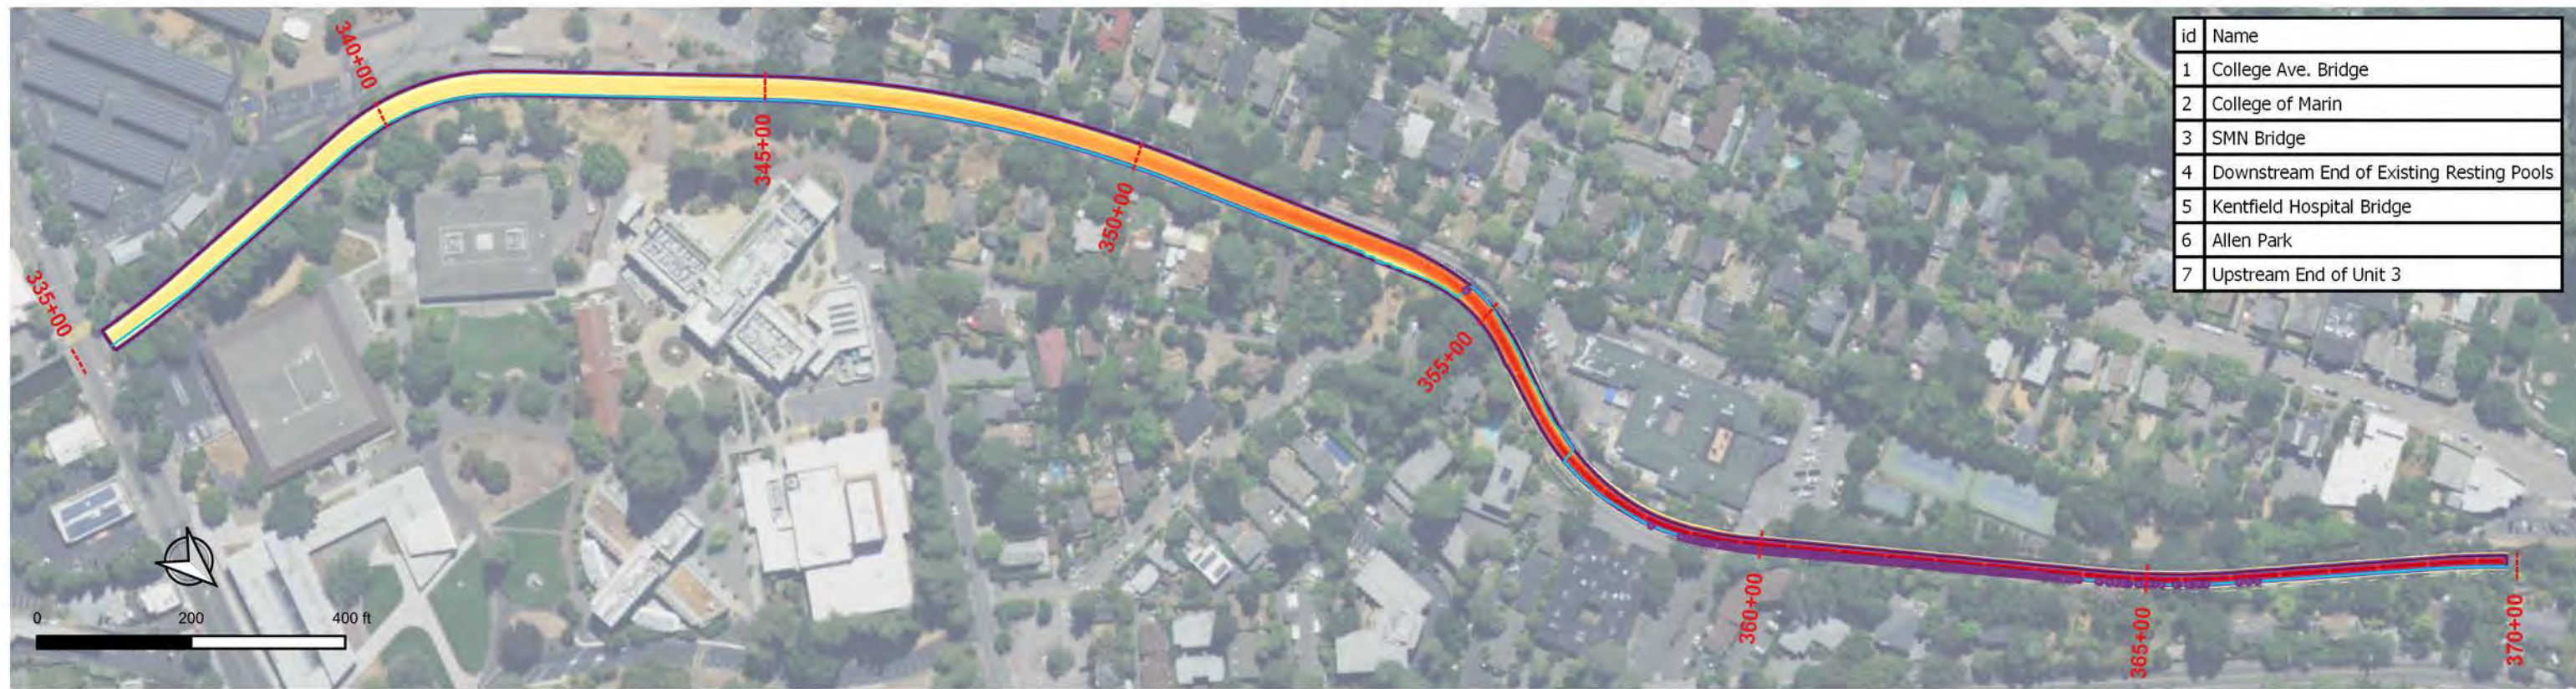
FIGURE 20

Ross, CA
Corte Madera Creek, Existing Conditions
Species: Adult Steelhead
Flow: 180 cfs (10% Exceedance)
Boundary Condition: 4 ft Tide

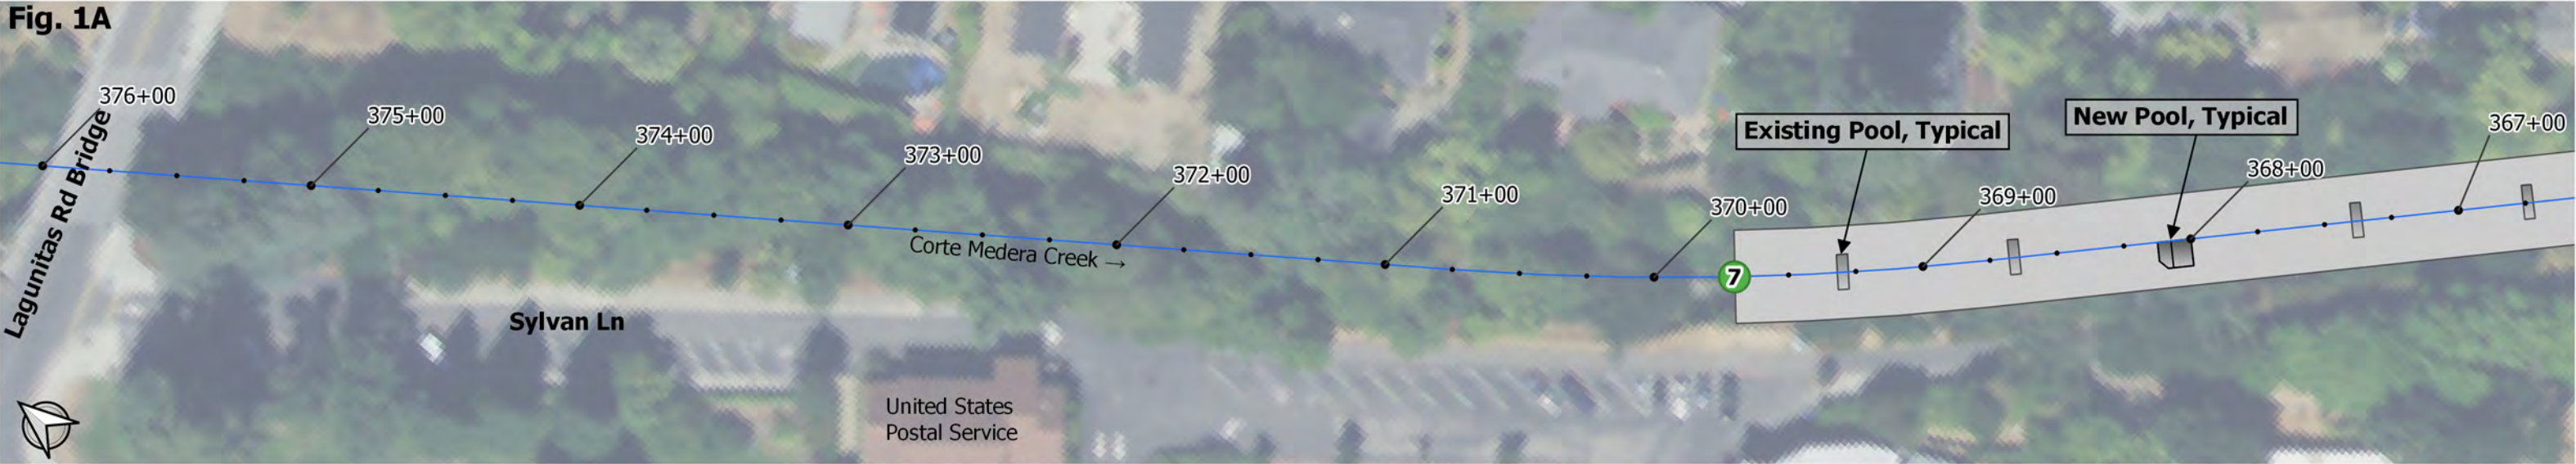
FIGURE 1
Ross, CA
Corte Madera Creek
Unit 3 Proposed Resting Pools
Alternative 2

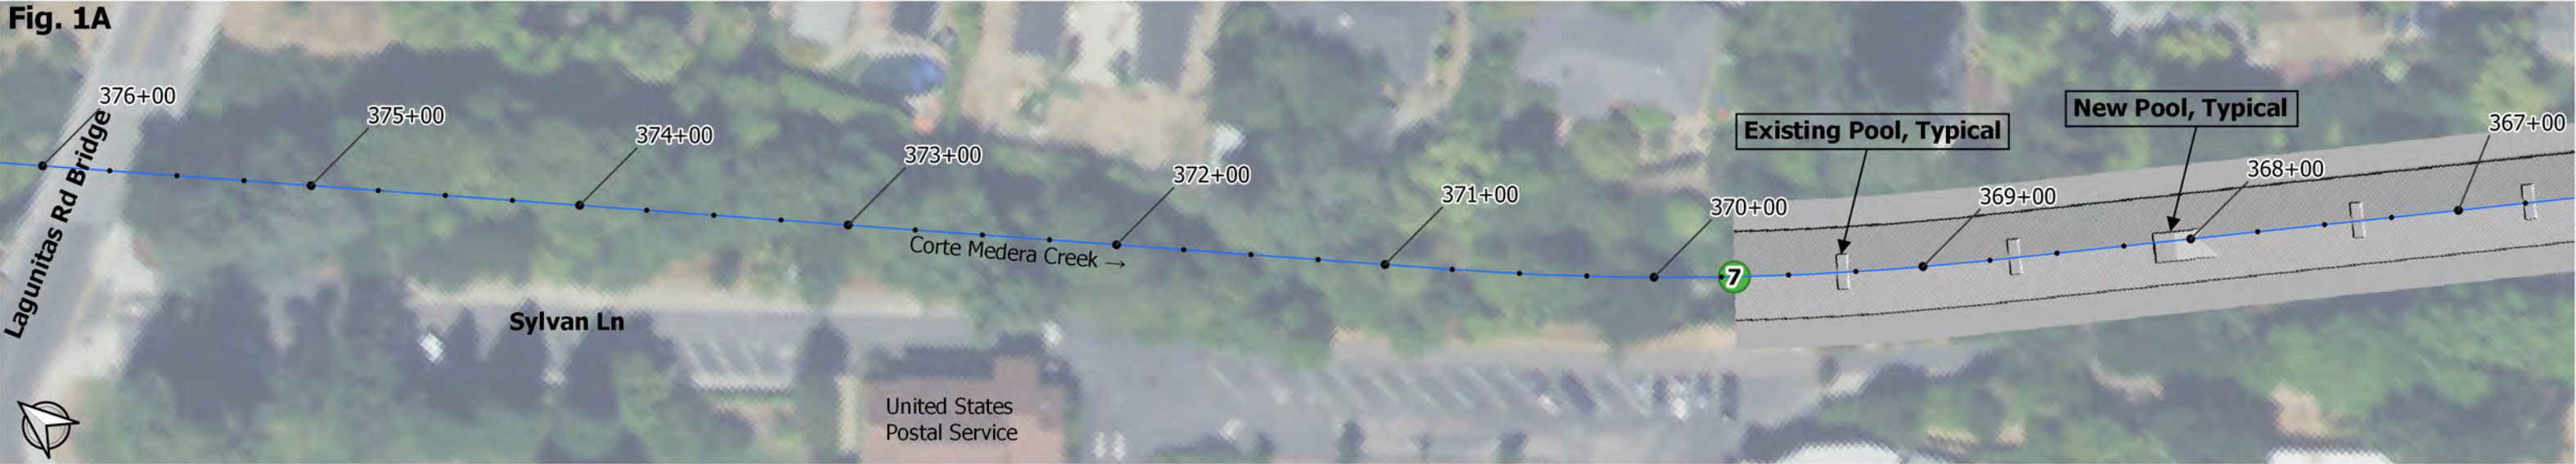
FIGURE 1
Ross, CA
Corte Madera Creek
Unit 3 Proposed Resting Pools
Alternative 1

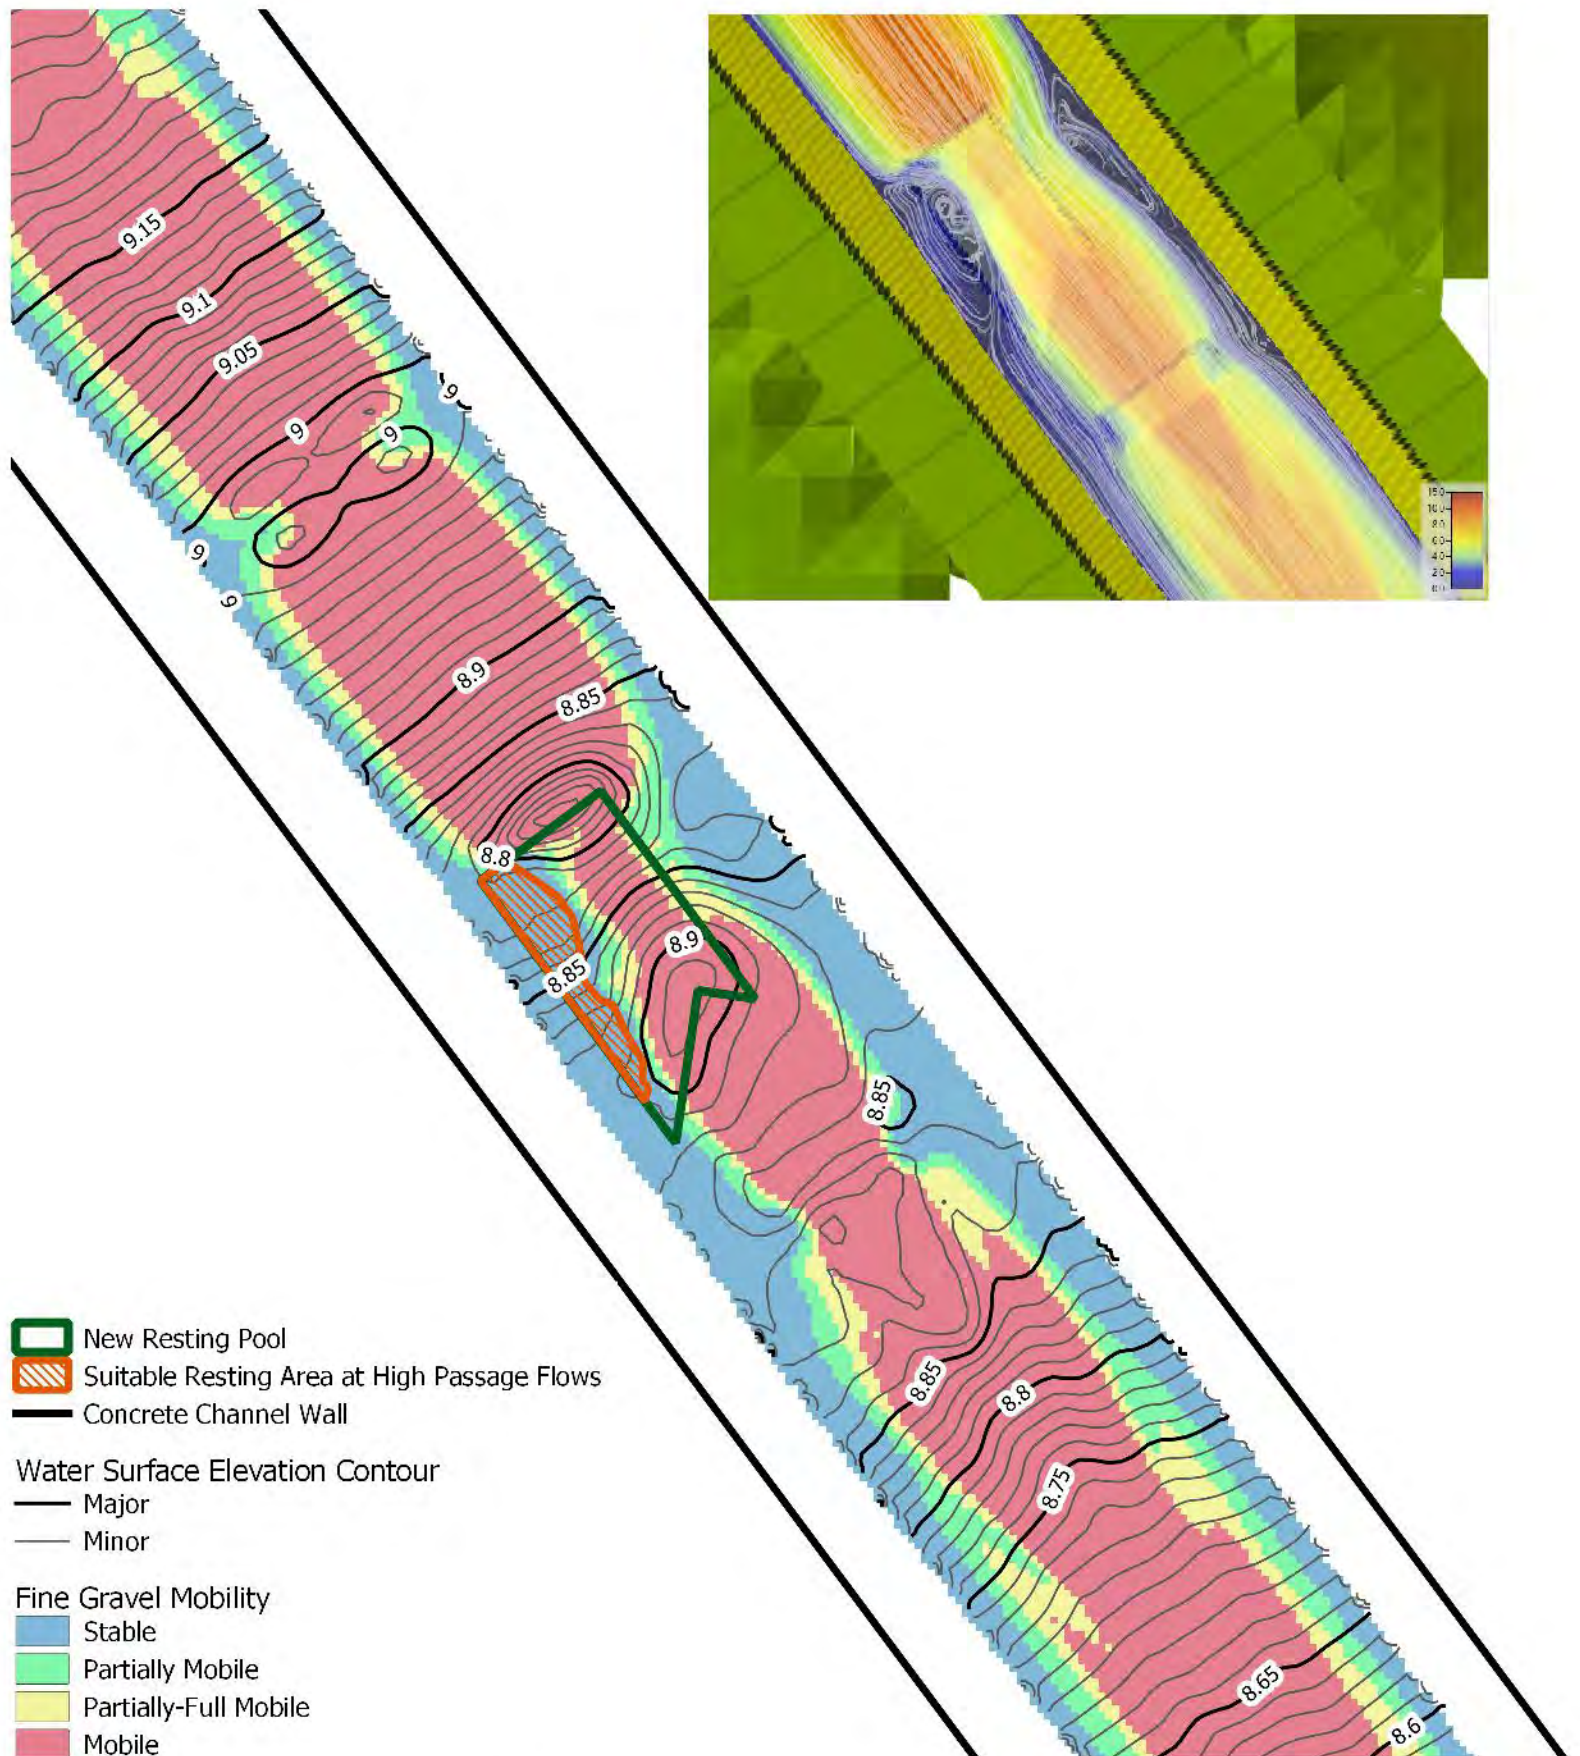
FIGURE 1

Ross, CA
Corte Madera Creek, Proposed Conditions
Species: Adult Steelhead
Flow: 180 cfs (10% Exceedance)
Boundary Condition: 0 ft Tide

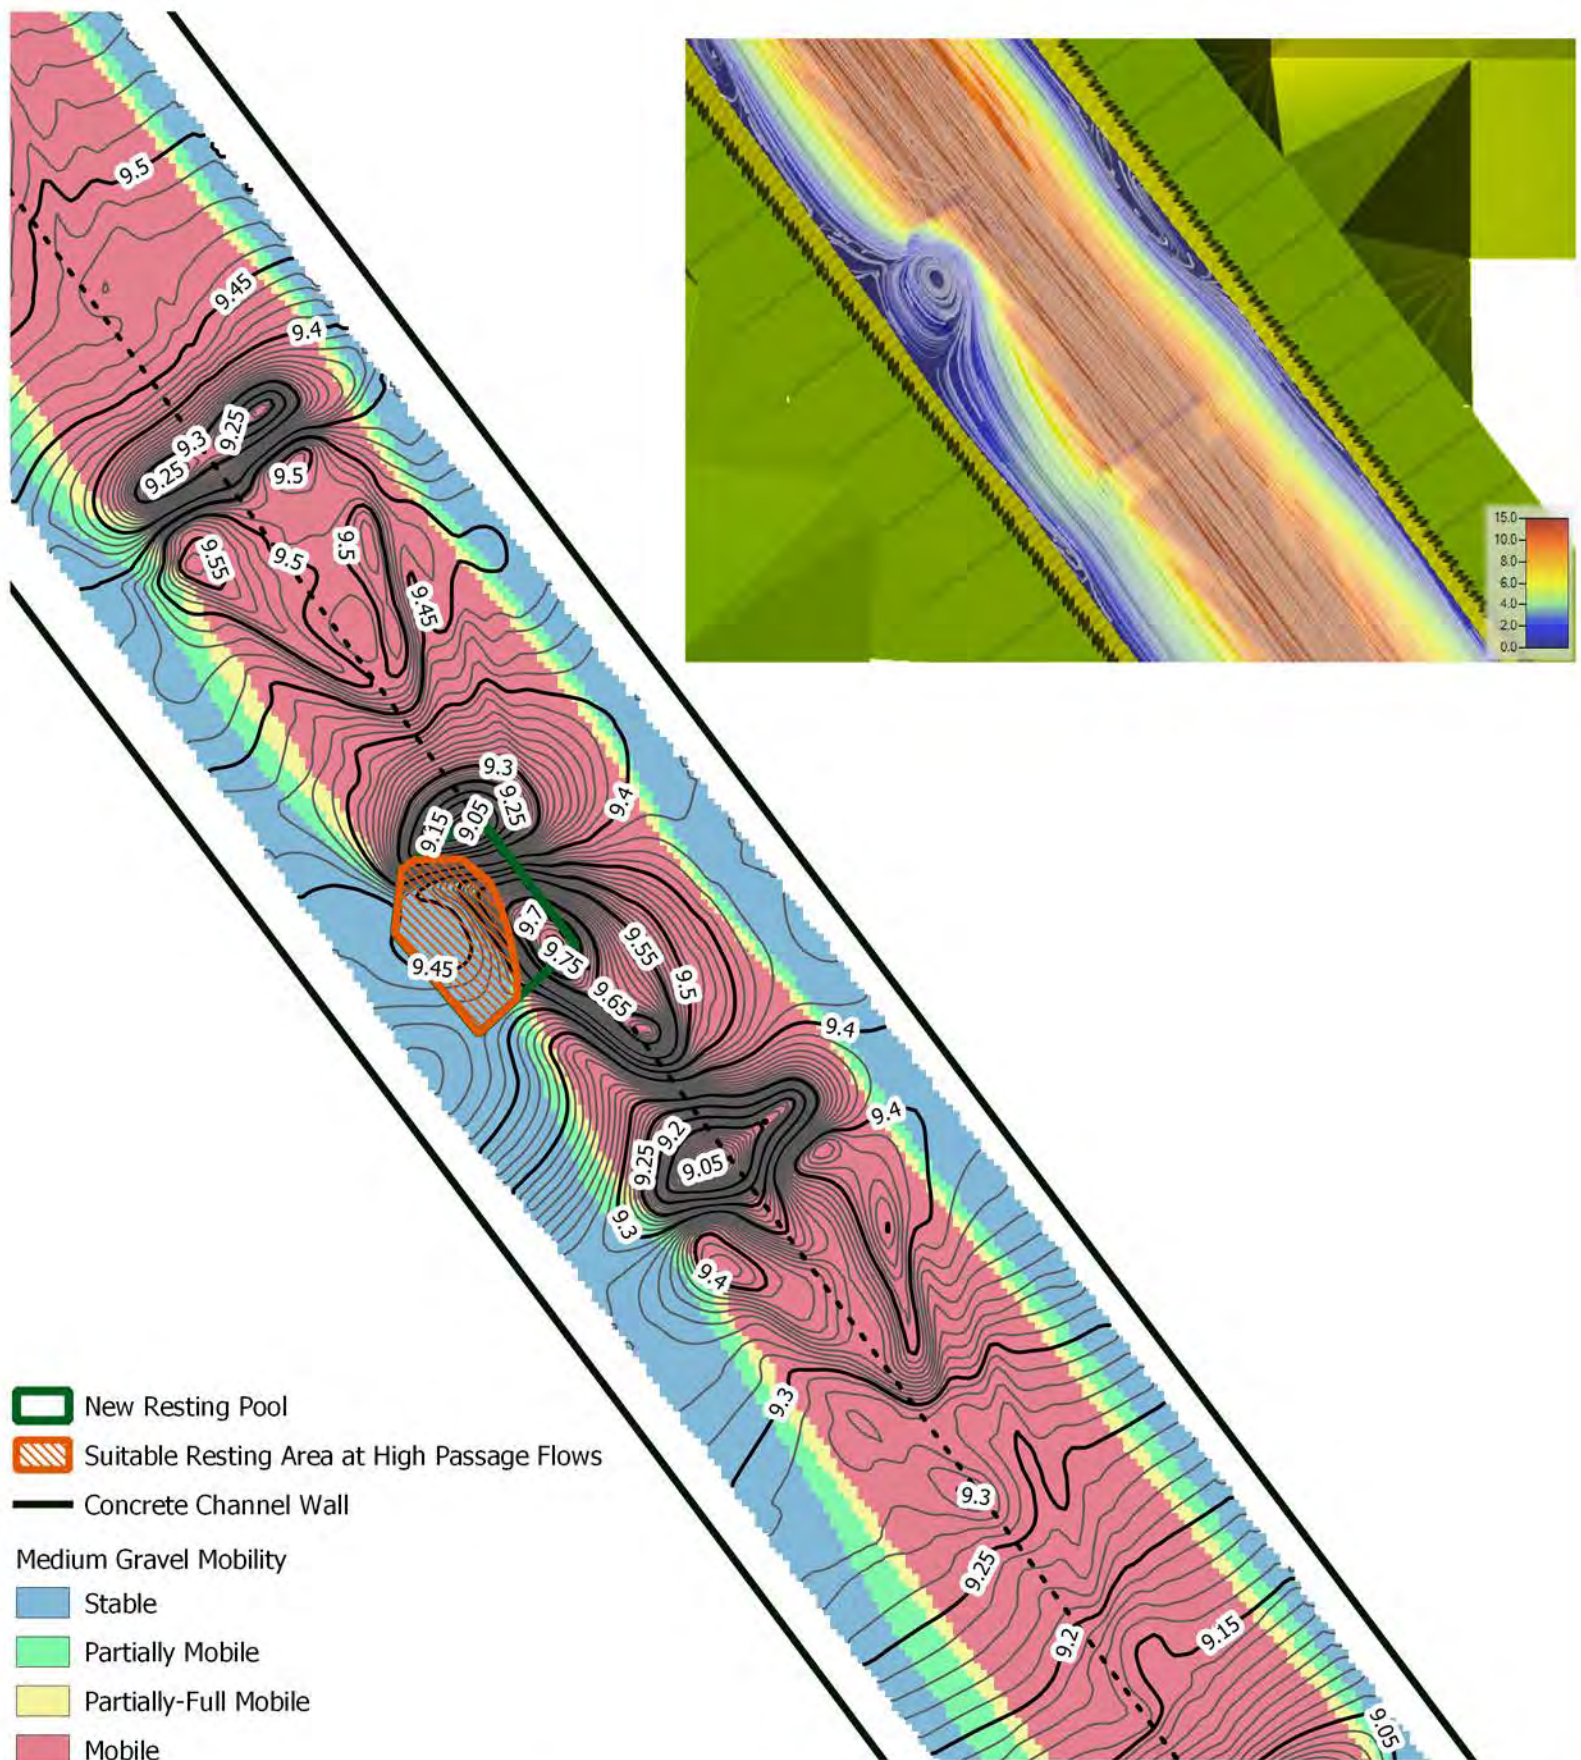
FIGURE 1.D - 200 cfs - Froude
Alternative 2
Ross, CA
Corte Madera Creek, Proposed Conditions
Species: Adult Steelhead
Flow: 200 cfs
Boundary Condition: 0 ft Tide
