The Tragedy of Ross Common

by Gerhard Epke (2019)

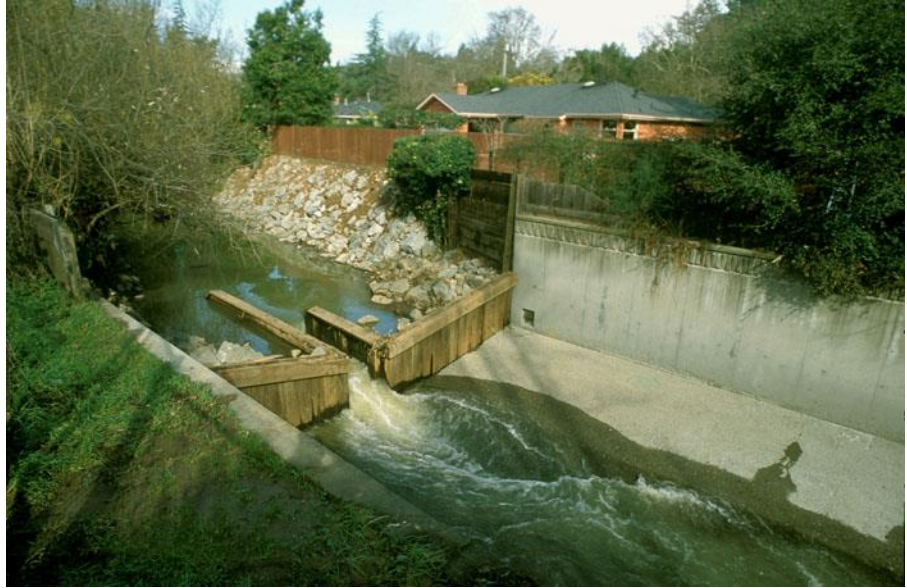
Where the concrete channel stopped, in 1971, behind the Ross post office. Photo by Charles Kennard

Coho salmon and steelhead used to migrate upstream to spawn during the winter months in such numbers that fishing shacks were built up near San Domenico, and photos from the 1950s show kids holding big fish. In the years after the concrete channel's construction, numbers of migrating fish have dropped off, and coho are considered extirpated from Corte Madera Creek. The reason for this is two-fold. At flows that attract spawning fish, the water velocity in the concrete channel is too fast and there are no places out of the fastmoving current where the fish can rest. In the event that they can swim up the channel, they are faced with jumping over a 3-foot wall, with no pool at the bottom to jump from.
