# Creek Bank Restoration and Repair

by Liz Lewis and Marla Lafer

2006

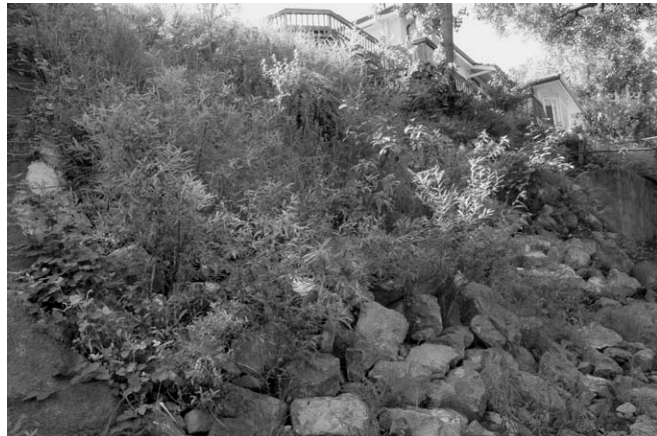
*This San Anselmo site is subject to severe creek flows, but this biotechnical solution using riprap, cables, and native plants held firm during the New Year's Eve flood.*
