Concrete Action to Clean the Creek

by Gerhard Epke
2018

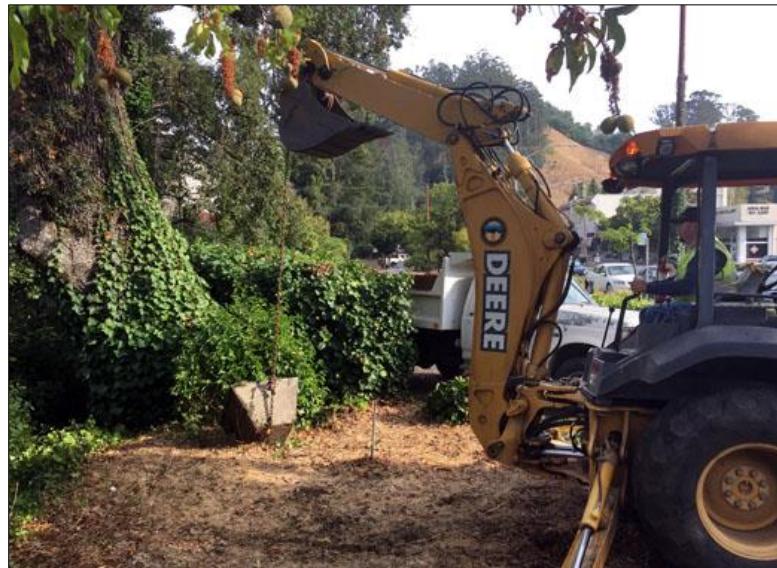
A concrete pier has just been lifted from the bed of San Anselmo Creek, for disposal. Photo by Gerhard Epke

After some trial and error, we have learned that surprisingly large pieces of concrete can be removed from the creek quite easily as long as they are not embedded in the bank or cemented to bedrock. A few strong bodies with long pry-bars dislodge the concrete from the creek bed and either roll it into an improvised sled or wrap it with a chain. Then comes the one crucial piece of equipment, which is a backhoe like the one owned by San Anselmo DPW. Operated from the top of the bank, the backhoe can drag and hoist the debris straight out of the creek and into a dump truck.
